Fire in the Sky:

TWA 800 In-Flight Breakup

Leadership ViTS Meeting

January 2011

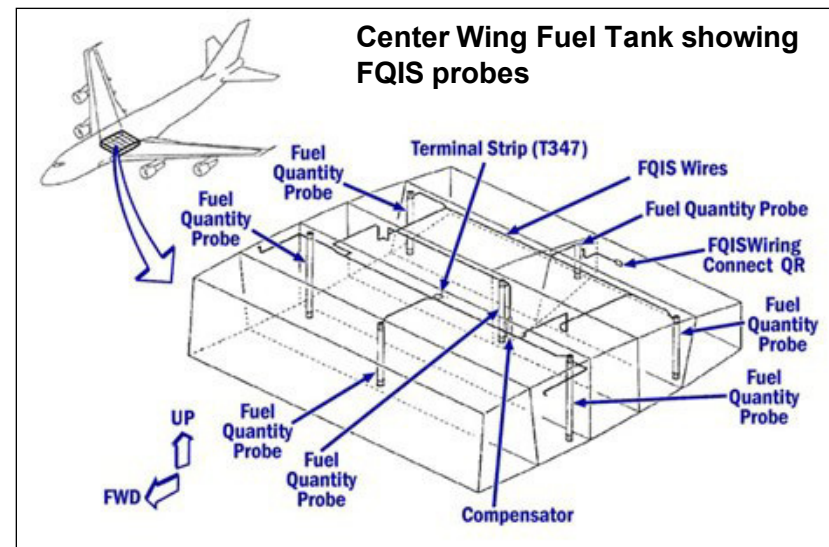
Boeing 747-100 Fuel System

- B-747 uses Jet-A fuel from seven fuel tanks. Each wing contains three tanks, and the lower fuselage holds a seventh tank known as the center wing fuel tank (CWT).
- Whenever the six wing tanks hold sufficient fuel for a flight, the CWT only contains residual fuel from the last flight.
- Inches below the CWT, three air-conditioning packs rest in an un-insulated, unvented area. The CWT absorbs the heat generated by the air-conditioning packs.
- Testing found that a near-empty tank heats quickly, speeding fuel evaporation and increasing flammability of the ullage (the unfilled portion of the tank above the surface of the fuel).

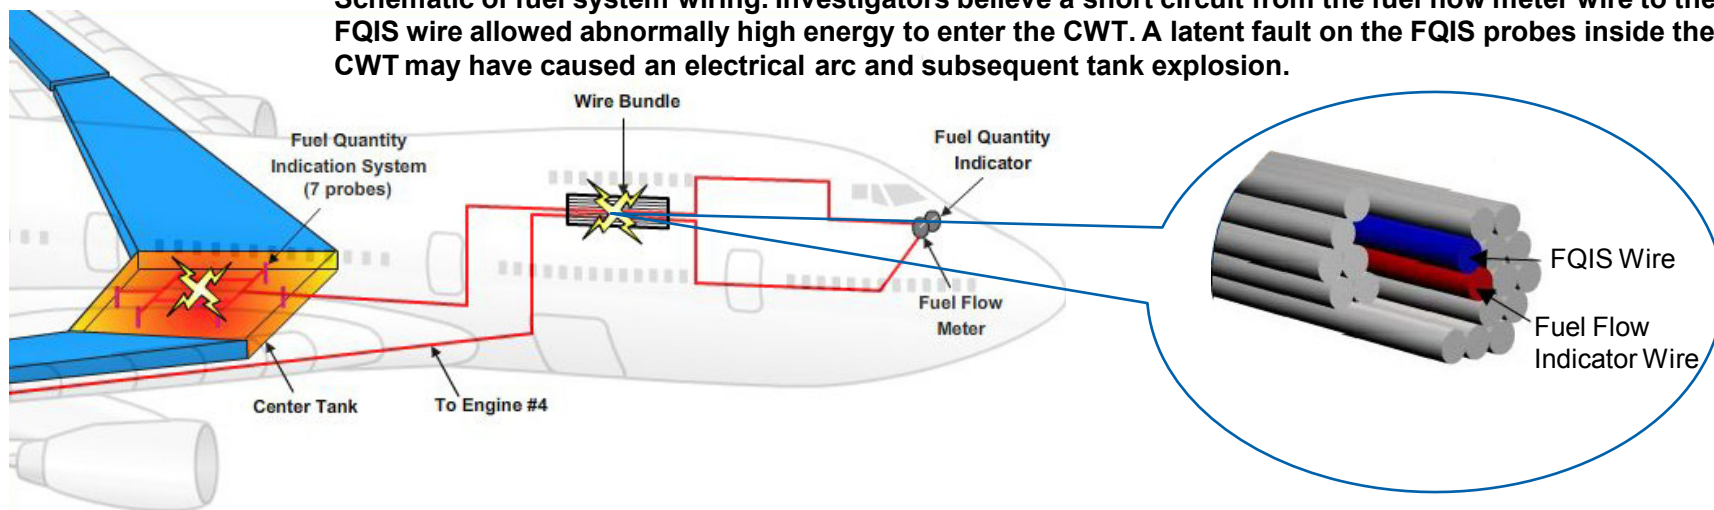
Schematic of fuel system wiring. Investigators believe a short circuit from the fuel flow meter wire to the FQIS wire allowed abnormally high energy to enter the CWT. A latent fault on the FQIS probes inside the CWT may have caused an electrical arc and subsequent tank explosion.

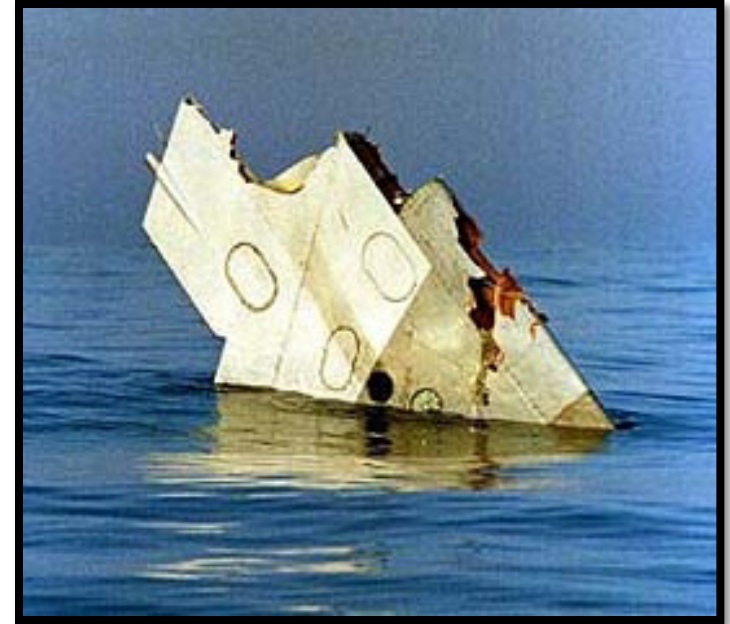
Wreckage from TWA 800

- Witnesses in the area observed a fireball in the sky and saw debris splash into the ocean.
- The widespread distribution of wreckage and eyewitness observations indicated that TWA 800 had experienced a sudden and catastrophic in-flight structural failure. There were no survivors.
