## PROBABLE CAUSE

## SYSTEM FAILURE CASE STUDIES

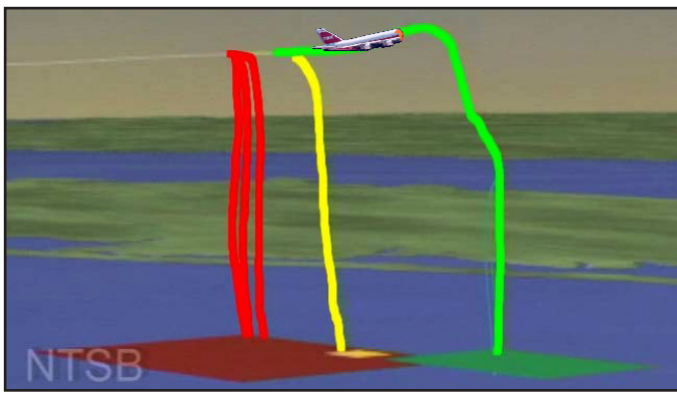
Figure 2: Red, Yellow, and Green Debris Fields

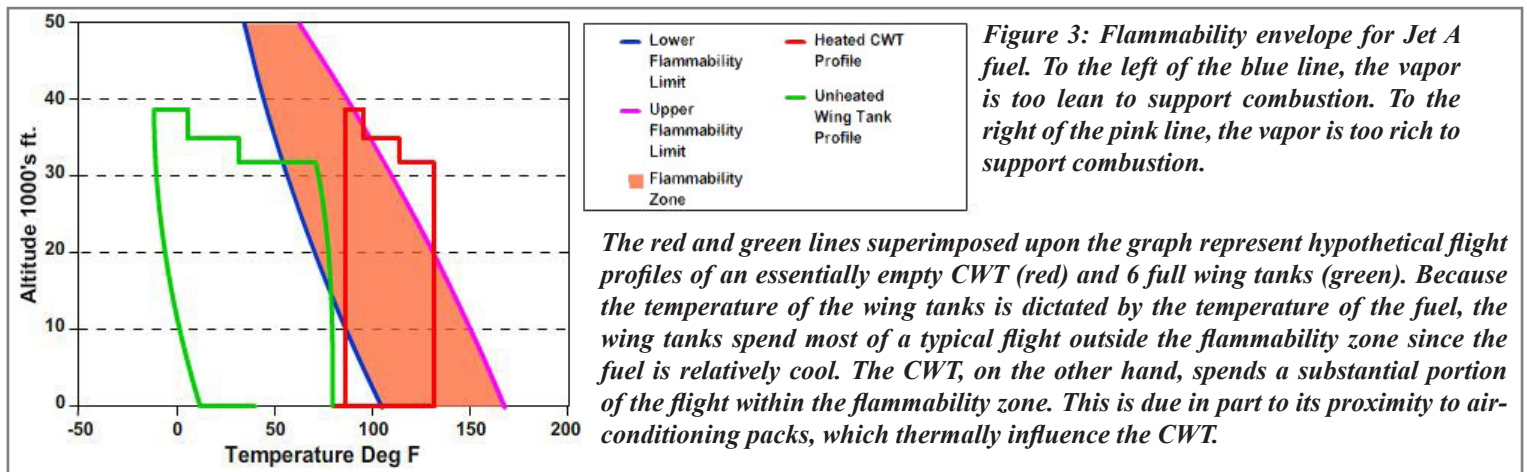
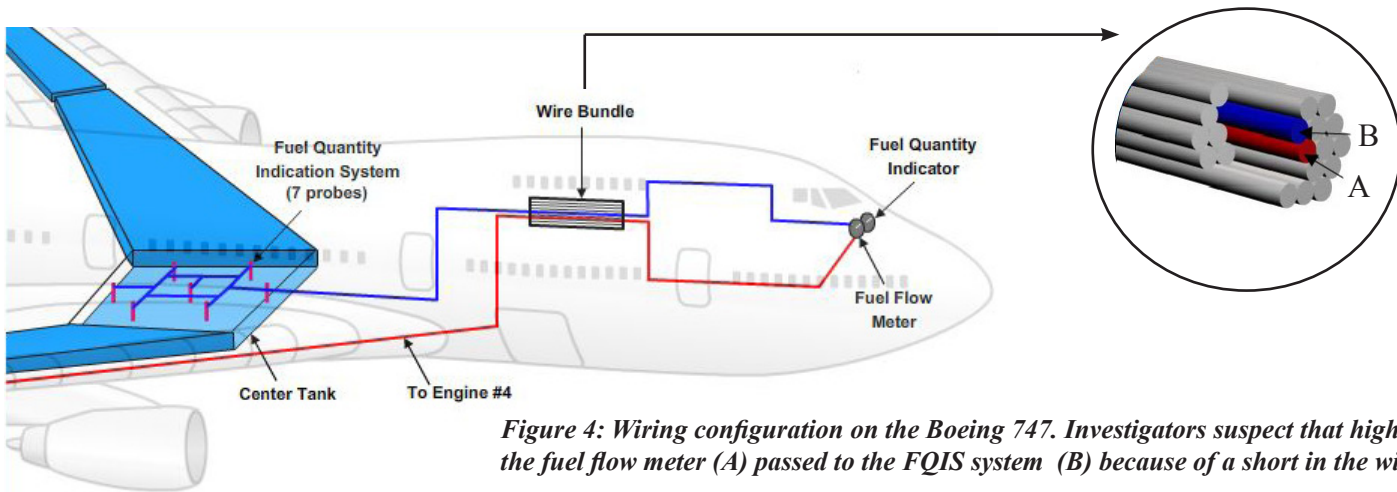
The minimum ignition energy for hydrocarbon fuels is 0.25 millijoules (mJ). To keep the vapor in the tank from igniting, the power supplied to FQIS wiring was intended to have a limit of 0.02 mJ, which would be extremely low when compared to other B-747 systems. The FQIS wiring runs from the fuel tanks to the flight deck along raceways shared with wiring from other systems such as the cockpit voice recorder (CVR), fuel flow meter, and cabin lights. Such circuits carry much higher voltages and energies than allowed in the FQIS. For example, some cabin lights operate at up to 350 VAC at 400 hertz. FQIS wires co-routed with these other wires in large bundles were found tightly bound together, so that a chafe or cut could affect more than one wire (see Figure 4).

Because FQIS wires are the only wires to enter the CWT and because they are co-routed within wire bundles containing circuitry from higher-voltage systems, investigators theorized that a high-voltage circuit contacted FQIS wires due to chafed, frayed, or otherwise damaged conditions. Once this higher voltage passed through FQIS wires to the FQIS probes inside the CWT, a latent fault on the probes, such as silver sulfide deposits, may have caused an electrical arc and subsequent tank explosion.

The CVR had recorded dropouts in the background electrical noise immediately preceding the explosion, which were indications that a short circuit had been affecting the energy in the electrical system intermittently. Further, the captain's comment concerning unusual behavior of the #4 engine fuel flow meter led investigators to focus on the wire routes used for the fuel flow meter system. Since wires for the fuel flow meters share a bundle with FQIS wires, NTSB theorized the captain's “crazy fuel flow” observation might actually have been a short circuit from the fuel flow meter wire to the FQIS

**Figure 4: Wiring configuration on the Boeing 747. Investigators suspect that high voltage from the fuel flow meter (A) passed to the FQIS system (B) because of a short in the wire bundle.**

wire. The same wire routes were then found to contain other potential electrical energy sources, such as the cabin lights that had been beneath the cockpit. The cabin lights had required maintenance on multiple occasions in the month before the accident. Any of these potential sources could have passed excessive energy to the FQIS system within the CWT (See Figure 4).

ers, such as those used on TWA 800, do not function fast enough to reliably prevent excessive energy from entering FQIS wires, as previously assumed. Later, NTSB recommended installing arc-fault circuit breakers and other current limiting devices, instead of simple thermal-mechanical circuit breakers to prevent energy transfers.
