Got Any Ideas?:

U.S. Airways Flight 1549

Leadership ViTS Meeting

April 2011

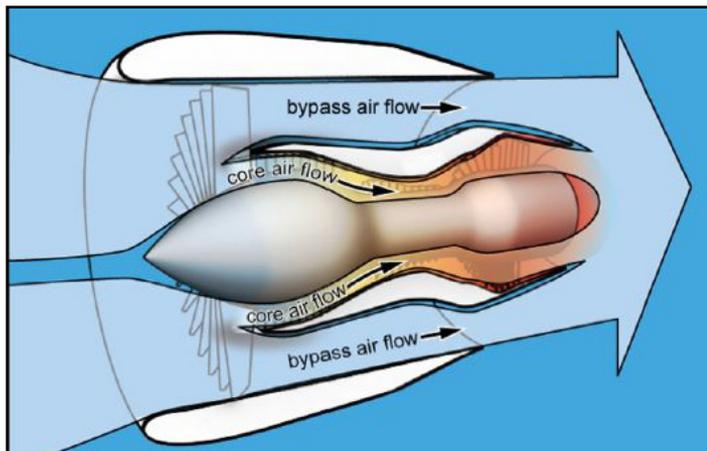
Centrifugal force from engine fan blades slings small foreign objects through the bypass duct, but the engine core is susceptible to damage from large objects.
