Communication Aberration: *HST Optical Systems Failure*

Leadership ViTS Meeting

July 2011

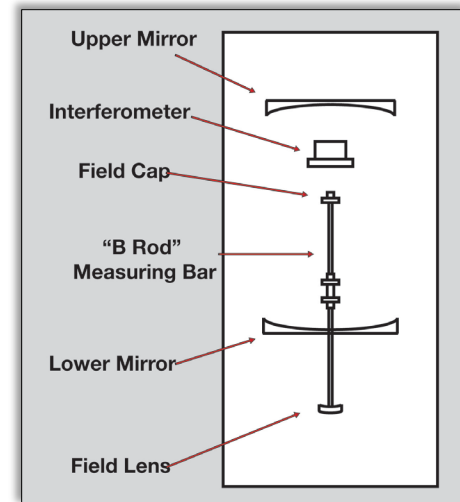
RNC side view. The "B Rod" measuring bar ensured accurate spacing between the components.

- To ensure proper spacing between the elements, the technician used a "B Rod" measuring bar fitted with an end cap that prevented the bar from moving laterally.

- Without informing anyone, the technician added washers to each of three bolts that held the field lens retainer in place, allowing the lens to fit, but altering the spacing by 1.3 mm.

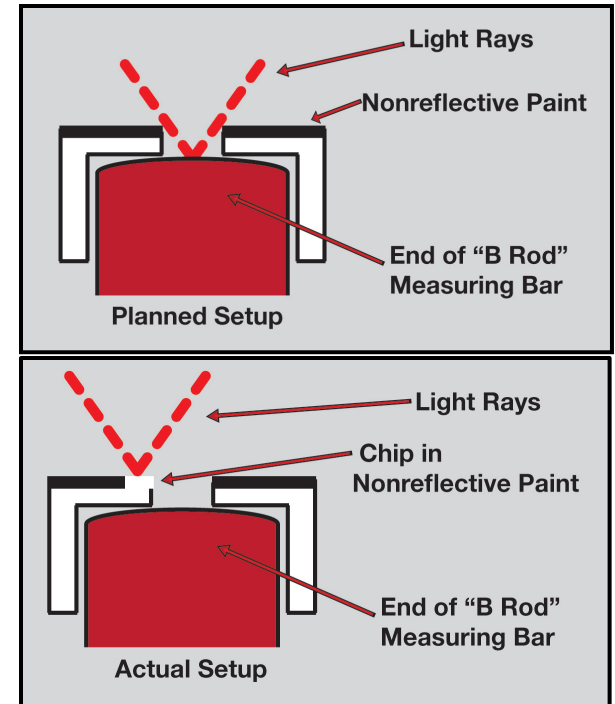
- Some of the non-reflective coating chipped away from the end cap, and the light beam reflected off of the end cap instead of the measuring bar, resulting in an erroneous reading. When the technician attempted to position the field lens based on the reading, it would not fit.

Diagrams depict field cap detail. Top: planned setup showing light rays reflecting off of measuring bar. Bottom: actual setup showing light rays reflecting off of field cap.

NASA established the Allen Commission to investigate, and the findings implicated the 1.3 mm misplacement of the field lens. The misplacement caused the RNC to project the wrong optical template. Then, the computerized polisher, which shaped the mirror based on the RNC's output, polished the mirror into a hyperbola that was slightly too flat near the edges. The incorrectly shaped mirror failed to direct incoming light to a single focal point, blurring each image before it reached the camera.

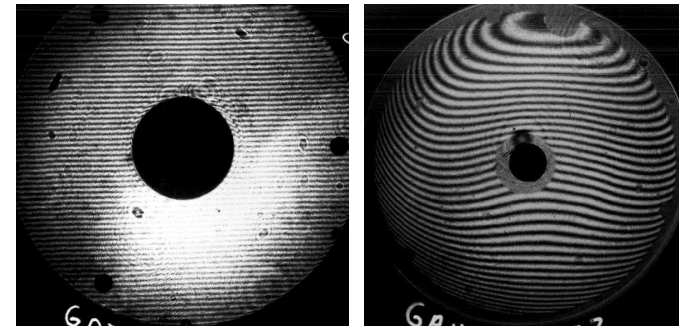
- In 1981, late in the polishing process, Perkin-Elmer measured the primary mirror's center of curvature using a refractive null corrector and an inverse null corrector.
- The resulting interferograms had wavy lines – outcomes that contradicted interferograms from the RNC and indicated a flaw in the mirror.
- The optics fabrication group at Perkin-Elmer considered the refractive and inverse null correctors to be less accurate than the RNC, so they assumed the flaw was in the refractive and inverse null correctors, not the mirror or the RNC. No one attempted to resolve the discrepancy.
- The flaw in the primary mirror's shape was not discovered until after HST entered orbit in 1990.

- When Perkin-Elmer performed vertex tests using refractive and inverse null correctors, it did not share the results with NASA because the results contradicted interferograms from the RNC, and they assumed the RNC was infallible.

Left: Interferogram from RNC indicating a perfectly shaped mirror Right: Interferogram from inverse null corrector indicating spherical aberration.
