SYSTEM FAILURE CASE STUDIES

JULY 2011 VOLUME 5 ISSUE 7

Communication Aberration

Optical Systems Failure on Hubble Cripples Data Collection

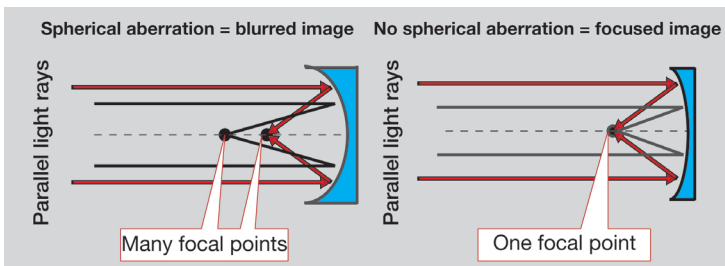
Figure 3: The diagram on the left depicts a spherical mirror directing light rays to several points of focus. The aspheric mirror depicted on the right eliminates spherical aberration by directing light rays to a single focal point.

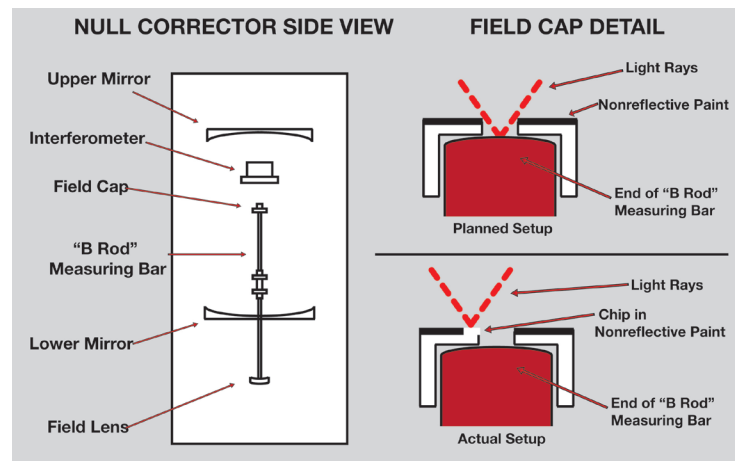
According to the HST Optical Systems Failure Report, some of the non-reflective material coating the field cap's exterior had chipped off. When the technician measured the spacing, the interferometer's beam reflected off of the field cap instead of the B Rod, resulting in an erroneous reading (Figure 4). Therefore, when the technician attempted to position the field lens based on the reading, the lens would not fit. Pressed for time and assured of the RNC's infallibility, the technician added washers to each of three bolts that held the field lens retainer in place. This forced the lens to fit and altered the prescribed spacing by 1.3 mm – a colossal deviation in a device whose measurements depended on precision up to millionths of an inch. Nevertheless, the technician chose not to inform RNC designers, metrology experts, or managers of the alteration. Generating a non-conformance report to document the change should have been standard procedure, but investigators later found no evidence that such a report had ever existed.

Figure 4: The RNC was designed to allow scientists to predict an optical template based on RNC element spacing, but damage to the field cap caused an erroneous reading that led technicians to make unauthorized adjustments to the RNC.

NASA established the Allen Commission to investigate, and the findings implicated the 1.3 mm misplacement of the field lens. The misplacement caused the RNC to project the wrong optical template. Then, the computerized polisher, which shaped the mirror based on the RNC's output, polished the mirror into a hyperbola that was slightly too flat near the edges. The incorrectly shaped mirror failed to direct incoming light to a single focal point, blurring each image before it reached the camera.

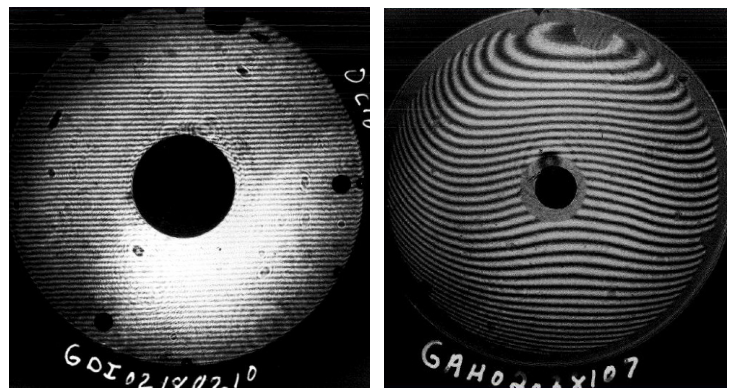
Late in the polishing process, Perkin-Elmer measured the primary mirror's center of curvature using a refractive null corrector and an inverse null corrector. The resulting interferograms had wavy lines – outcomes that contradicted the interferograms from the RNC (Figure 5). However, because the optics fabrication group at Perkin-Elmer considered the refractive and inverse null correctors to be less accurate than the RNC, it discounted the data and did not attempt to resolve the discrepancy. In a report to Congress, William Colvin, NASA's Inspector General, indicated that those results "concerned Perkin-Elmer managers, but they did not disclose the results or their concerns outside of the optics fabrication group . . . to our best determination, Perkin-Elmer did not share the discrepant results of the vertex test with NASA."

Figure 5: The interferogram on the left came from the RNC. The straight lines indicate no interference, meaning the mirror matches the optical template. The interferogram on the right came from the inverse null corrector. The wavy lines indicate interference resulting from errors in the shape of the mirror.

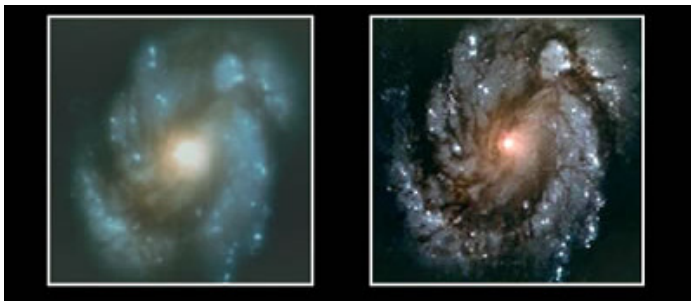
Figure 6: HST recorded the left image prior to the servicing mission that corrected the optical systems. HST recorded the right image after repairs.

Perkin-Elmer settled a lawsuit with NASA in which the contractor paid \$25 million for withholding test results. In 1993, NASA launched a repair mission that became an astounding success. After astronauts installed new optics to compensate for the error, Hubble exceeded its original performance specifications by 50% (Figure 6). Hubble has now been orbiting Earth for more than two decades, making it one of the longest and most successful science missions to date.
