# Loss of Detection:

## *D.C. Metro Railway Collision*

### Leadership ViTS Meeting

August 2011

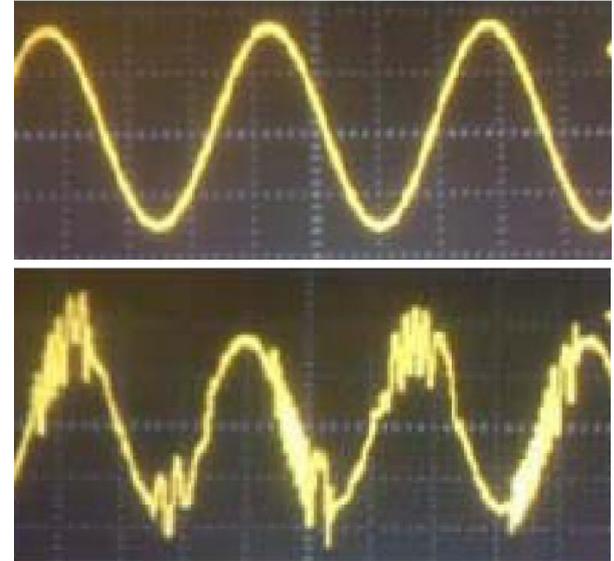
- WMATA followed a manufacturer-recommended maintenance plan for upkeep of the track circuit modules, but the tests could not detect the presence of parasitic oscillation, where a track circuit transmitter module emits a spurious signal that mimics a valid track circuit signal.

Top: Valid track circuit signal. Bottom: Parasitic oscillation (credit NTSB).

The NTSB found that the accident occurred because of parasitic oscillation in the track circuit module. This oscillation travelled from the module transmitter to the module receiver through the equipment racks on which the modules were mounted. When the maintenance crews replaced the impedance bonds for circuit B2-304, they calibrated an increase in the power of the output transistors. The adjustment increased the amplitude of the spurious signal, giving it sufficient strength to drive the receiver module. This energized the track circuit and caused it to read as vacant.

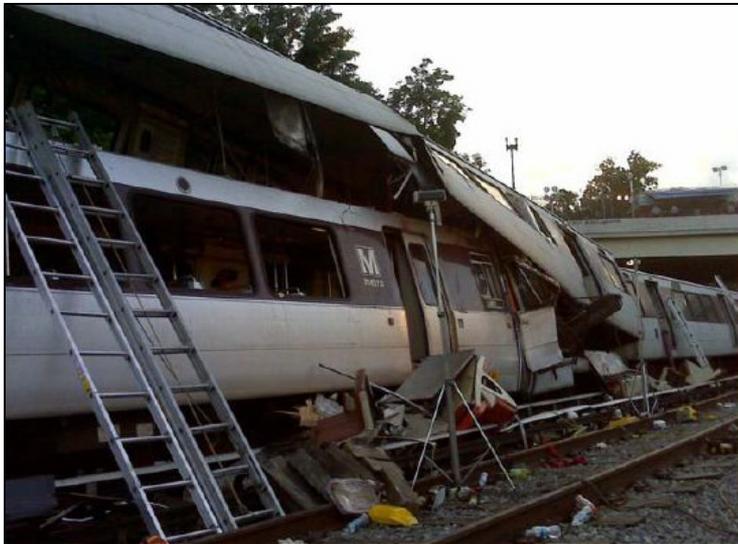
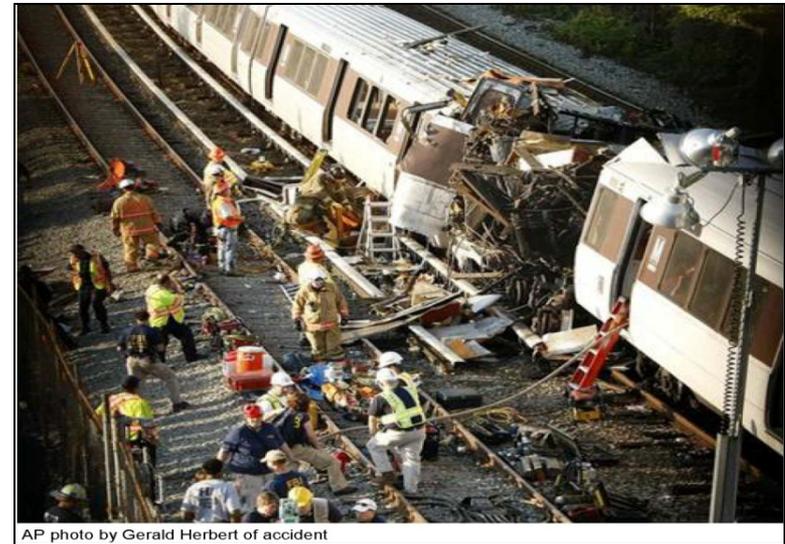
- Upon impact, the end car of train 214 telescoped into the lead car of train 112, eliminating passenger survival space inside train 112 for a distance of 63 feet. Nine people aboard train 112, including the train operator, died in the crash. More than 50 passengers were injured, and damage to train equipment was estimated to cost \$12 million.

**A scene of devastation followed the metrorail collision near the Fort Totten station in Washington D.C.**
