## SYSTEM FAILURE CASE STUDIES

AUGUST 2011 VOLUME 5 ISSUE 8

# Loss of Detection

### Malfunctioning Train Control System in Washington D.C. Causes Deadly Crash

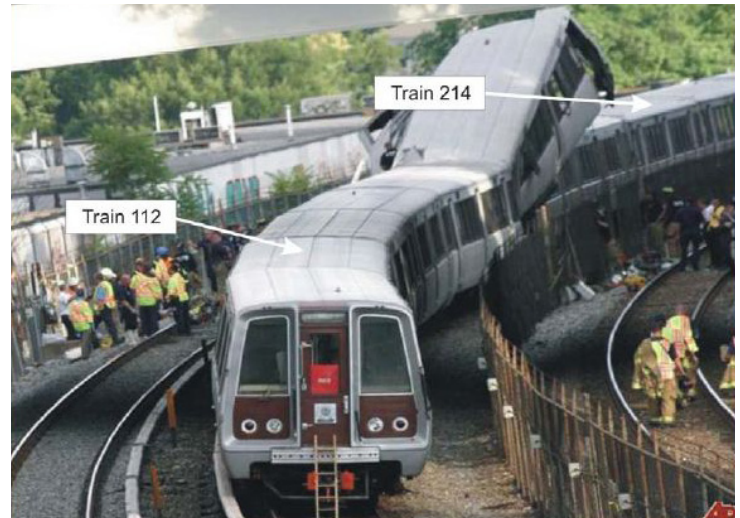
**Figure 1: Train 112 was travelling at more than 40 mph when it crashed into stopped train 214.**

Meanwhile, Metrorail train 112, which was following train 214, was receiving 55 mph speed commands. If track circuit B2-304 had been working properly, train 112 would have received speed commands to slow or stop due to the presence of train 214. Since the system read the track circuit as vacant, it allowed train 112 to travel at the maximum allowable speed of 55 mph. Sight distance tests by National Transportation Safety Board (NTSB) investigators after the crash showed that only 450 feet would have separated the two trains by the time train 112’s operator saw train 214 stopped on the tracks ahead. Even though evidence proved that train 112’s operator activated the emergency brakes, there was not enough distance to stop before impact. Train 112 barreled into train 214 at significant speed. Upon impact, the end car of train 214 telescoped into the lead car of train 112, eliminating passenger survival space inside train 112 for a distance of 63 feet (Figure 1). Nine people aboard train 112, including the train operator, died in the crash. Dozens of passengers were injured; emergency responders reported transporting more than fifty people to local hospitals. The damage to train equipment was estimated to cost \$12 million.

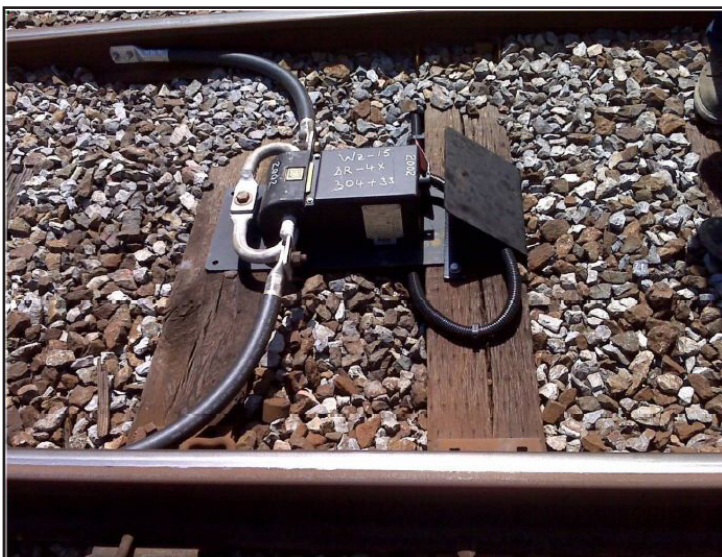
Since the impedance bonds and track circuit modules were manufactured by different companies, engineering crews needed to adjust transmitter power settings to compensate for differing resistances between the old and new impedance bonds. The crew leader stated that while the team made these adjustments, she noticed a phenomenon known as “bobbing,” in which the track circuit display transitioned from ‘vacant’ to ‘occupied’ and back even though no trains were present. After leaving the site, the crew leader opened a work order to address the bobbing issue, but investigators would discover no action was taken regarding the work order from the time it was opened until the day of the accident (5 days later). The ATC maintenance technicians performing periodic testing after the new impedance bond was installed were unaware of the open work order and did not report the bobbing because it cleared by itself. The maintenance crew thought the ATC installation crew would return to continue working.

**Figure 2: Each impedance bond acts as a transmitter for one track circuit and a receiver for the adjacent track circuit.**

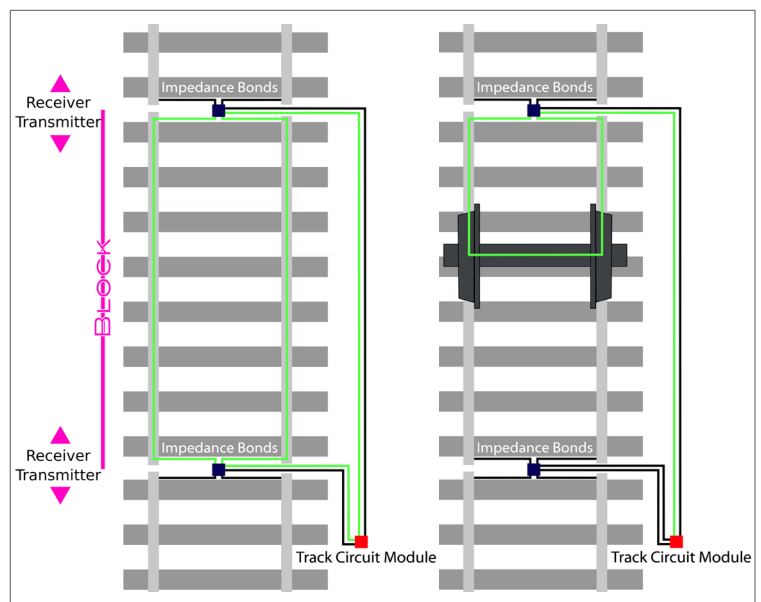
**Figure 3: Diagram of unoccupied (left) and occupied (right) track circuits. The green line indicates the signal path. Track circuit modules (indicated in red) are located in a control room at the nearest train station. An energized track circuit indicates a vacant block. A de-energized track circuit indicates the presence of a train.**

The NTSB determined that the accident occurred because track circuit module B2-304 failed to detect the presence of train 214, resulting in the transmission of speed commands to train 112 until the point of impact. The module failed to detect the train because of a phenomenon called parasitic oscillation, in which a track circuit transmitter module emitted a spurious signal that mimicked a valid track circuit signal. This oscillation travelled from the module transmitter to the module receiver through the equipment racks on which the modules were mounted (Figure 4). When the spurious signal arrived at the receiver module, it produced a decaying pulse that eventually became synchronized with the track circuit frequency. NTSB determined that when maintenance crews replaced the impedance bond for track circuit B2-304, they calibrated an increase in the power of the output transistors, and this adjustment increased the amplitude of the spurious signal, giving it sufficient strength to drive the receiver module. This energized the track circuit and caused it to read as vacant.

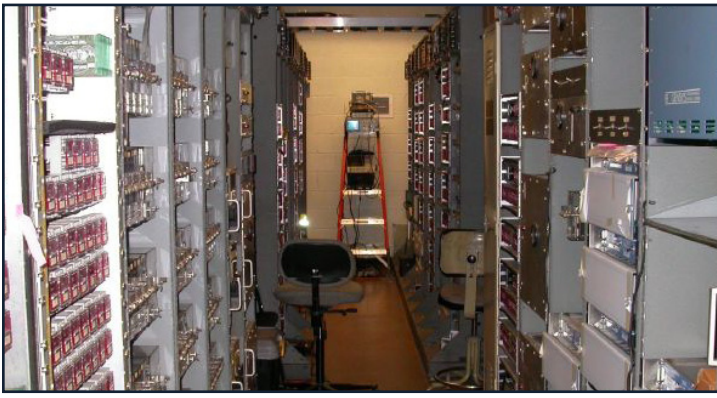
**Figure 4:** *Equipment racks inside the train control center housed track circuit modules which transmit to and receive audio frequency signals from impedance bonds in the track circuits.*
