Porthole to Failure:

The Sinking of the Ocean Ranger

Leadership ViTS Meeting

December 2011

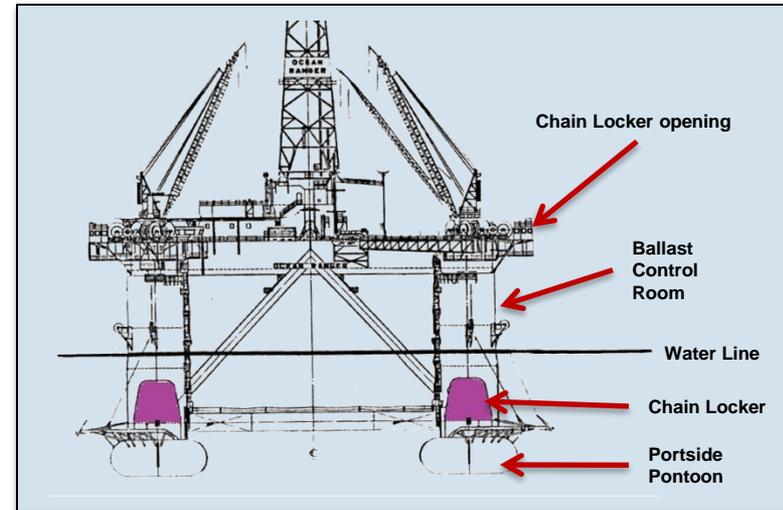
Figure 1: *Ocean Ranger* schematic, as viewed when facing the bow.

- The operator needed to observe current sea conditions to properly adjust ballast in the pontoon tanks, so four circular glass portlights (windows) were provided in the control room. Each portlight had a steel cover known as a deadlight that could be fastened from the inside to prevent wave damage to the windows in storm conditions.

- The ballast control operator used lighted pushbutton switches which were arranged in line diagrams on a 'mimic' type control board to operate valves and ballast pumps. This electrically powered mimic board was the only way the crew could view valve position.

- If electric power to the control valves was lost, their fail-safe design was to close (pneumatic pressure powered valve movement).

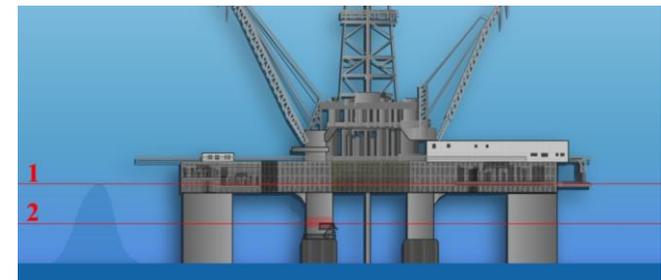
Figure 2: Diagram showing approximate levels of the chain locker openings (1) and the Ballast Control Room (2)

- At approximately 7:45 p.m., a large wave impacted *Ocean Ranger* and shattered windows in the Ballast Control Room. Salt water soaked the ballast control console, and power to the control panel was lost, either short-circuited by water or secured by the crew to prevent shock.

- The forward list brought the tops of the corner columns within range of the tallest waves, and water entered the chain lockers' exposed openings.
- When the crew realized its efforts were to no avail, it sent a mayday and boarded the lifeboats. By the time help could arrive, it would be too late.
