SYSTEM FAILURE CASE STUDIES

DECEMBER 2011 VOLUME 5 ISSUE 12

Porthole to Failure

Mobile Offshore Drilling Unit Capsizes in Severe Storm; 84 Dead.

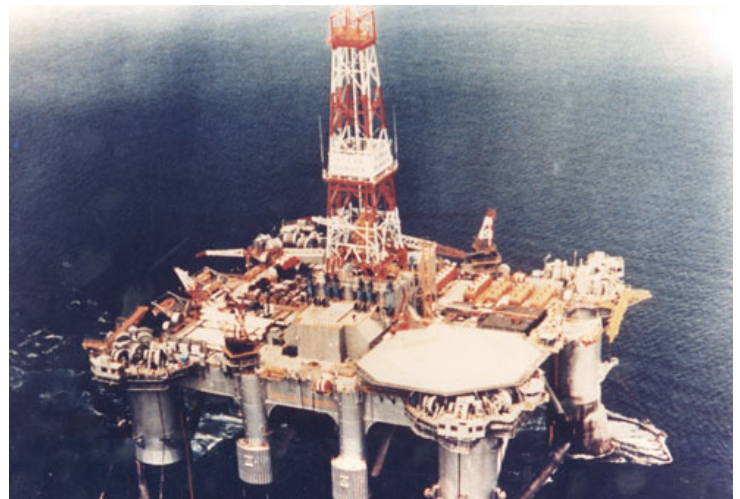
Figure 1: The *Ocean Ranger* was the world's largest and most advanced drilling platform of its day.

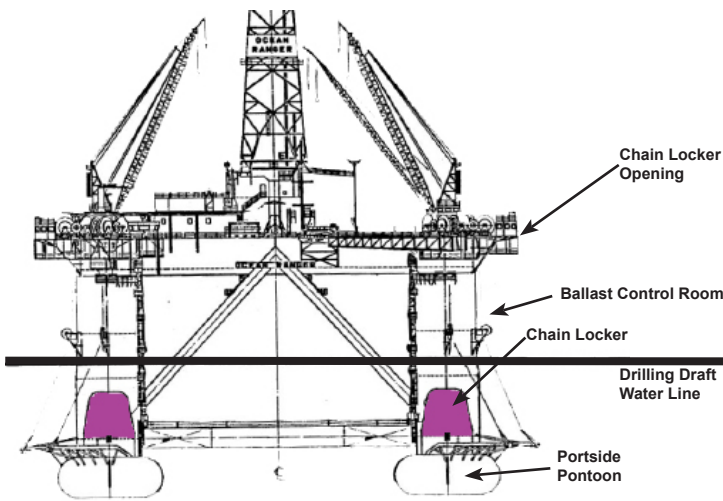
Figure 2: *Ocean Ranger* drilling platform and support structure

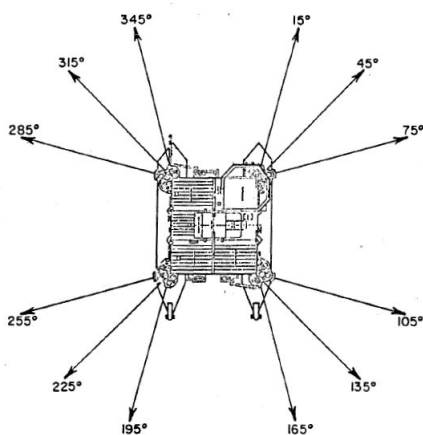
Figure 3: Top view showing the 12 anchors that steadied the oil rig over the wellhead.
