# Safe Anyway:

## *RAF Nimrod XV230 Crash over Afghanistan*

### **Leadership ViTS Meeting**

January 2012

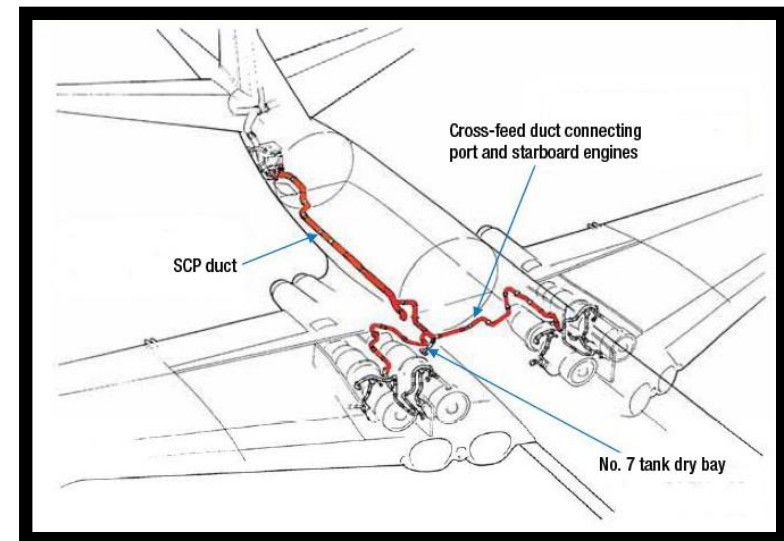
Figure 1: Nimrod schematic

- After 1975, 35 Nimrods had supplementary conditioning packs (SCP) installed to provide extra cooling. The SCP operated using hot bleed air from the engines.
- To feed the SCP, designers added a special conduit, the SCP duct, as a branch off of the original cross-feed duct. The temperature of the cross-feed/SCP duct could exceed 400 °C.
- In 1982, the Nimrods received an air-to-air refueling (AAR) modification that placed refueling pipes in the aircraft's bomb bay. Additionally, fuel tanks received blow-off valves that relieved tank pressure during AAR by ejecting excess fuel into the atmosphere.

- The cross-feed duct's placement among fuel and hydraulic lines contradicted good engineering practice because it placed a potential ignition source (the hot duct surface) in the vicinity of a potential fuel source (possible fuel leaks) without designating the area as a fire zone.

- Although Refrasil, a fluid-impermeable substance, covered the cross-feed duct, it deteriorated over time and was discontinuous in certain places.
- The addition of the SCP duct posed the same risks as the original cross-feed duct, and since it spanned the entire length of the No. 7 dry bay, it increased the area where an accident could occur.

- Not long after Nimrod's AAR capabilities were installed, engineers discovered the location of the No. 5 tank was such that during flight, fuel exiting the No. 5 blow-off valve could enter a port engine intake. The valve was disabled, but though a similar risk existed for blow-off valves on the starboard side of the aircraft, recommendations to probe the risks further were shelved, and further analysis was never conducted.

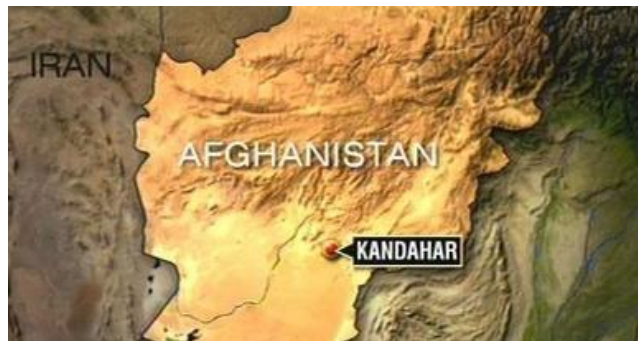
Figure 2: Nimrod XV230 crashed near Kandahar, Afghanistan.  
Photo Credit: whdh.com
