## SYSTEM FAILURE CASE STUDIES

JANUARY 2012 VOLUME 6 ISSUE 1

# Safe Anyway

#### British Reconnaissance Aircraft Crashes over Afghanistan, 14 Dead.

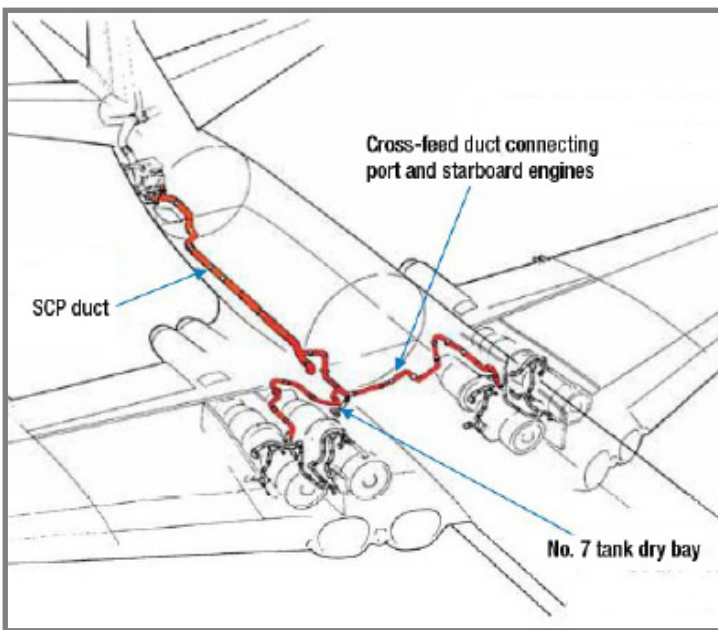
**Figure 2:** Nimrod's original design placed the cross-feed duct near the bottom of the No. 7 tank dry bay. After Nimrod was modified to include a supplemental conditioning pack, designers added the SCP duct as a branch from the original cross feed duct.

In 1979, Nimrod XV230 underwent a major fleet upgrade adding radars and other sensors. To cool the powerful new gear, designers added a supplementary conditioning pack (SCP) in the aircraft's tail region. The pack used engine bleed air branched off of the original cross-feed duct (Figure 2). Temperatures in the duct were hot: as much as 400°C.

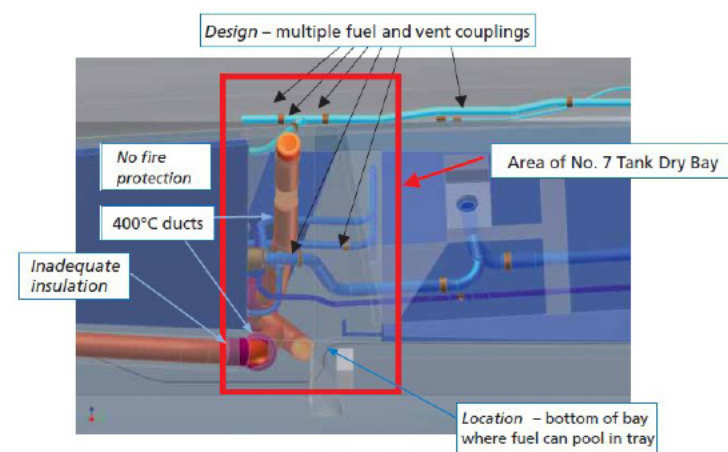
The cross-feed duct rested near the bottom of the No. 7 dry bay, beneath a labyrinth of fuel lines and other conduits. This design contradicted good engineering practice because it placed a potential ignition source (the extremely hot duct surface) in the vicinity of a

potential fuel source (possible fuel leaks from adjacent fuel lines) without designating the area as a fire zone and providing fire detection and suppression systems (Figure 3). Defense Standard 00-970 (at the time known as AvP970) states that configurations containing both potential ignition sources and potential fuel sources must be designated as fire zones, and that fuel lines must be placed as far from heat sources as possible.

**Figure 3: The red box indicates the area of the No. 7 tank dry bay. Many fuel lines occupied this space, and their proximity to the cross-feed/SCP duct should have caused the dry bay to be designated as a fire zone.**

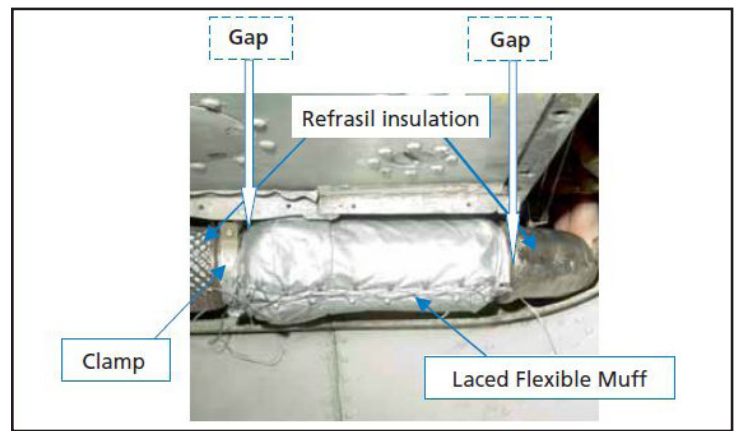
Designers selected Refrasil insulation to cover the cross-feed duct and prevent its extremely hot surface from damaging nearby structures. Refrasil is a fluid-impermeable substance which also protected the duct from contacting fuel leaking from above. The BOI found that at the time of the accident, the cross-feed duct was insufficiently protected from leaking fluids. In some sections, the Refrasil had deteriorated, in other sections, the duct was left un-insulated, and in still other sections, absorbent muffs (not made of Refrasil) could trap fuel against the duct's hot surface where it could self-ignite (Figure 4).

**Figure 4: Section of cross-feed duct showing discontinuity of Refrasil insulation. Flexible muffs were used in place of Refrasil in several places. Note gaps between insulation types.**
