Out of Line:

San Bruno Pipeline Explosion

Leadership ViTS Meeting

March 2012

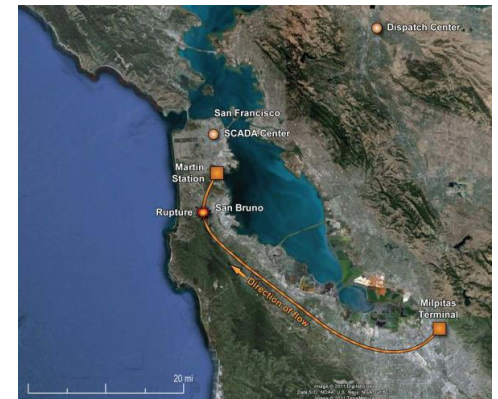
Line 132 originates at Milpitas Terminal and ends at Martin Station.

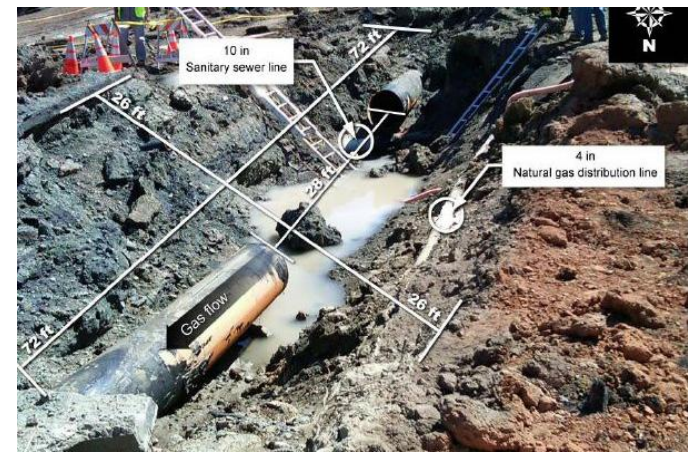
Figure 1: The ruptured segment of pipe, discovered 100 feet away from the crater, was 28 feet long and weighed approximately 3,000 pounds.

The National Transportation Safety Board (NTSB) issued a report that attributed the explosion to a gas leak from a pipe segment, designated as segment 180, buried 3 feet beneath the intersection of Earl Avenue and Glenview Drive. Investigators discovered the ruptured segment 100 feet away from the crater that marked ground zero. Post-accident inspection revealed that segment 180 contained several shorter lengths with incomplete longitudinal welds—a defect that weakened the pipe's structural integrity and allowed a pre-existing crack in the seam to propagate. When subjected to the 396 psig pressure spike, the pipe ruptured despite the fact that this value still fell within the limits of the line's MAOP of 400 psig. The gas that spewed above ground ignited, decimating a neighborhood, claiming lives, and injuring dozens of residents.

- The poorly welded seam in segment 180 would have been visible to the naked eye during a 1956 relocation. No record of inspection or testing could be located.
- In 1988, a gas leak was identified in Line 132, 8.78 miles from the rupture site. The leak was attributed to a defect in the pipe's longitudinal seam and 12 feet of pipe were replaced. No record of testing and inspecting of the line for similar flaws was ever located.
- After a deadly 2008 natural gas explosion involving a PG&E distribution line, the NTSB investigation cited inappropriate pipe material as a cause of the accident and made recommendations for improving safety. PG&E did not act on the recommendations before the San Bruno explosion.
