SYSTEM FAILURE CASE STUDIES

Out of Line

Gas line ruptures, causes explosion in California suburb: 8 dead.

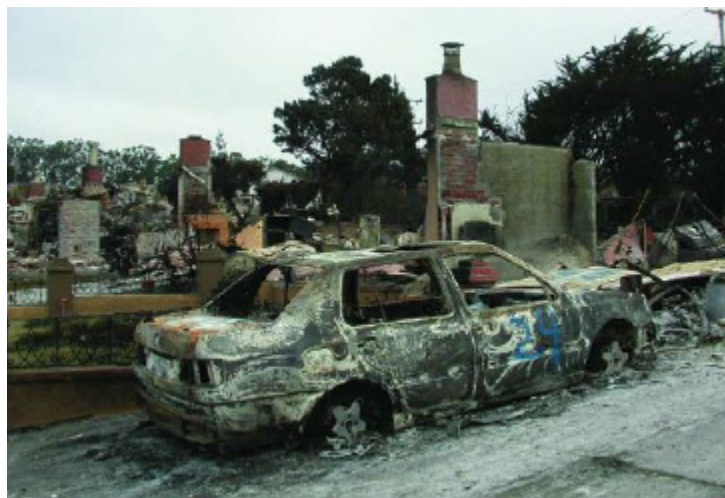
Figure 1: The 2010 gas explosion and fire in San Bruno, California decimated the entire neighborhood of Crestmoor.

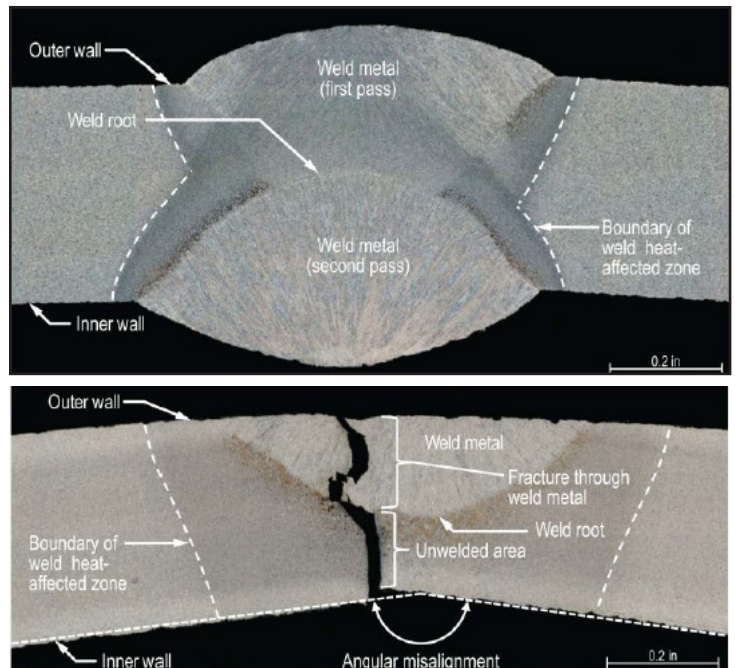
Results of the post-accident investigation showed that segment 180 was part of the 1956 relocation project. Per NTSB, the poorly welded seam in segment 180 would have been visible upon inspection. That the flaw escaped notice while the segment was relocated indicates a deficiency in PG&E quality control practices at the time, particularly since the relocation provided a good opportunity to inspect and test Line 132, and no record of such activities was located.

NTSB's analysis of PG&E's Integrity Management Program (IMP) revealed that the program was based on incomplete and inaccurate information about its pipes. PG&E records classified segment 180 as a seamless pipe, but in fact, the segment was composed of seam-welded pipe and contained several shorter lengths of pipes with incomplete longitudinal welds. Furthermore, steel grades, though unknown, were given "assumed" values and no steps to verify and correct the assumed values had taken place. NTSB stated that if overseeing bodies had required PG&E to correct its records, knowledge of the aging pipe's true properties may have prompted PG&E to test and ultimately repair or replace the faulty segment.

Figure 4: Top image shows a cross-section of a properly welded longitudinal seam. Bottom image shows a cross-section of the longitudinal seam in the ruptured pipe segment.

NTSB made several recommendations to PG&E such as establishing a comprehensive response plan for large scale emergencies, installing equipment to assist in identifying leak locations, adding automatic shutoff valves, and improving its integrity management program. NTSB also called upon overseeing bodies, including the CPUC and PHMSA, to enforce stricter pipeline safety regulations. In addition, NTSB called upon PHMSA to strike the grandfather clause from the CFR.
