The Poldercrash:

Turkish Airlines Flight 1951

Leadership ViTS Meeting

April 2012

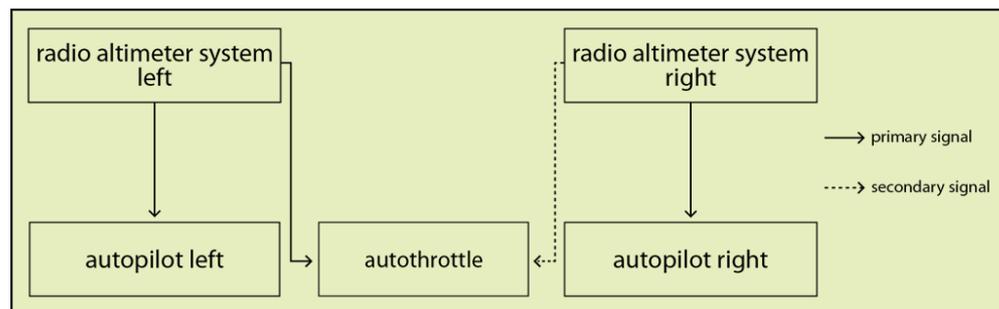
- A low range radio altimeter (LRRRA) system of two independent radio altimeters provides redundancy in the event that one radio altimeter fails, or the inputs from one are recognized as erroneous by the autothrottle. The left radio altimeter was the primary in the mishap aircraft, additionally transmitting altitude data to the cockpit left side (pilot's) instrument display. The right radio altimeter transmitted altitude data to the cockpit right side (copilot's) instruments. In the event the left radio altimeter signal becomes erroneous, the autothrottle will use data from the right radio altimeter system.

Figure 1: **Overview of the 737-800 radio altimeters connected to autopilot controls and autothrottle**

- Faulty left-side radio altimeter input commanded the autothrottle into “retard flare” mode, selection normally applied during final landing phase below 27 feet.

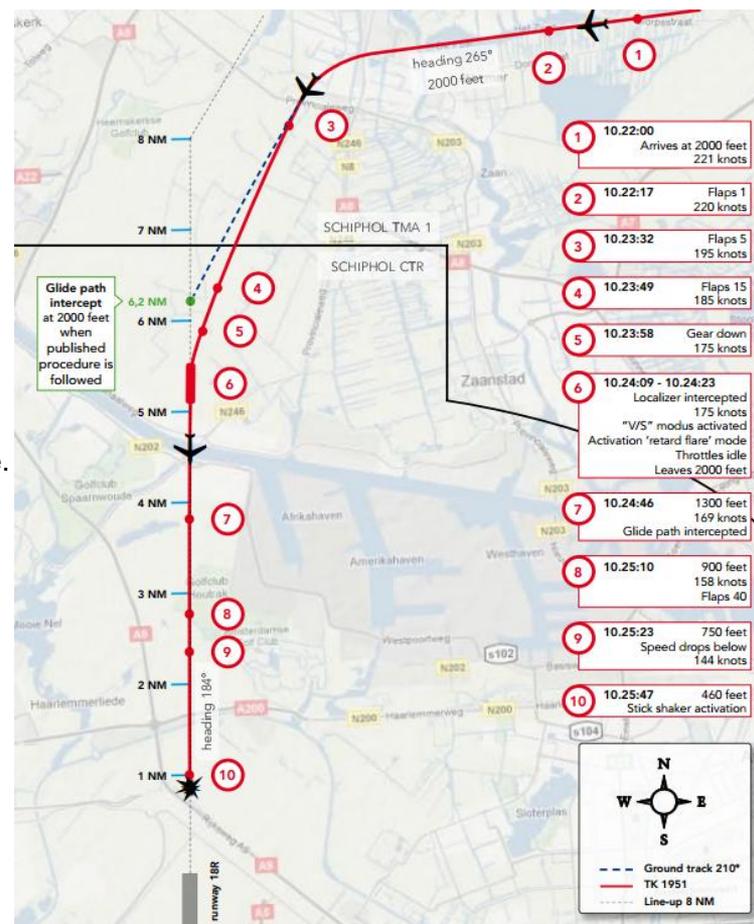
- TK1951 was directed to descend to 2,000 feet and turn toward the final approach course for the Polderbaan.
- The descending turn placed aircraft above the normal approach path and almost one mile closer to the runway than procedurally established by local Air Traffic Control (ATC) and needed to intercept from above. Although not unsafe, this placed pressure on the cockpit crew to complete pre-landing tasks and required rapid descent with a very low thrust setting.

- The crew was intent on completing the landing checklist—postponed by late glide path entry.
- The right hand auto pilot, using correct altitude input from the right LRRRA, struggled to keep TK1951 on the correct glide path as long as it could by raising the aircraft’s nose. The aircraft lost airspeed and approached a stall condition.

Figure 2: Glide path of TK1951 compared to normal glide path

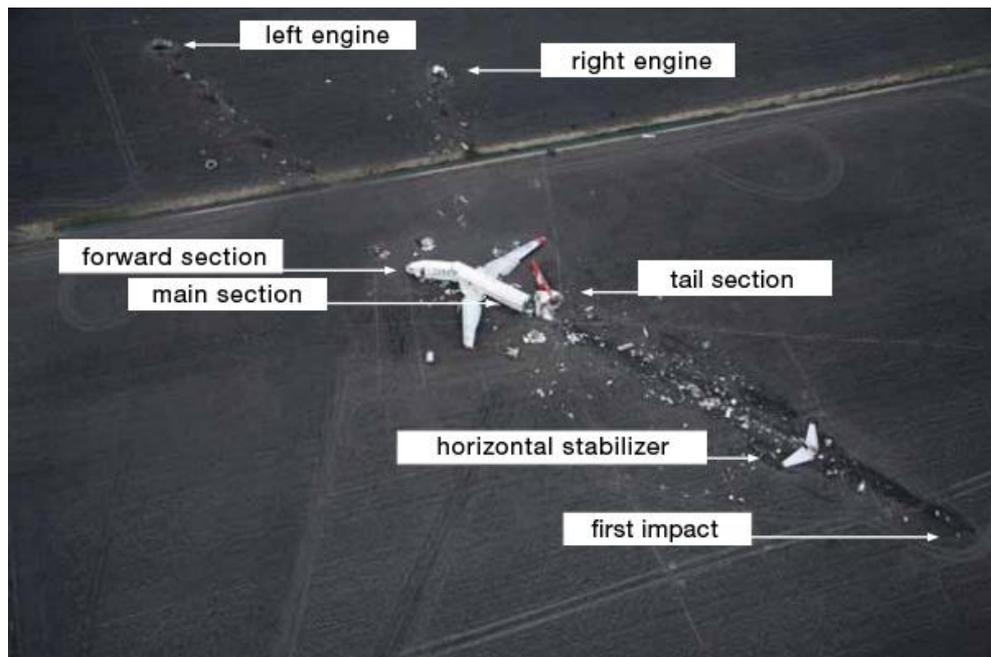
Figure 3: The crash site and wreckage of TK1951.

- Flight TK1951 impacted farmland and was destroyed; breaking into three main sections.
- Survivors escaped through emergency exits, a tear in the aircraft's fuselage, and an opening at the rear of the main section of the fuselage.
- Flight recorder data revealed that no other systems failed during flight.

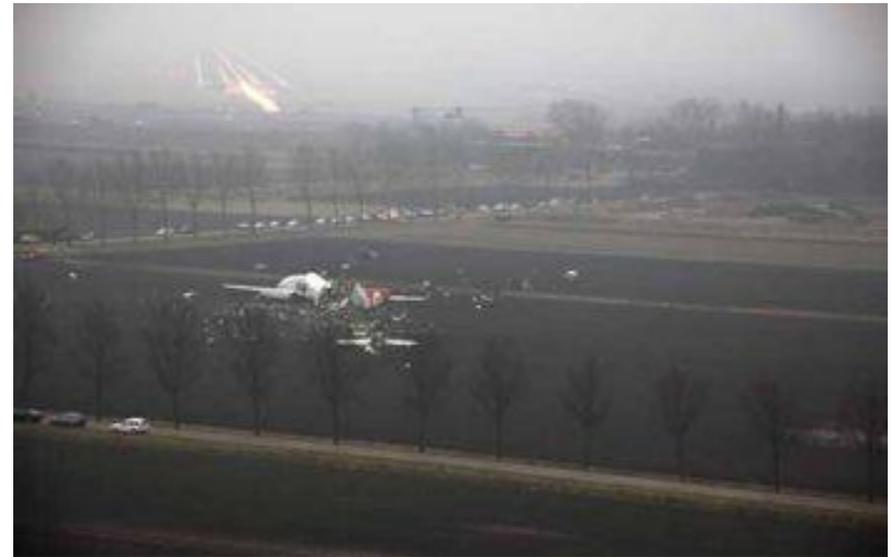
Figure 4: Remains of Turkish Airlines Flight TK1951; the runway lights of the Polderbaan can be seen in the distance.
