SYSTEM FAILURE CASE STUDIES

APRIL 2012 VOLUME 6 ISSUE 4

The Poldercrash

Boeing 737-800 crash lands short of Polderbaan runways; 9 people dead

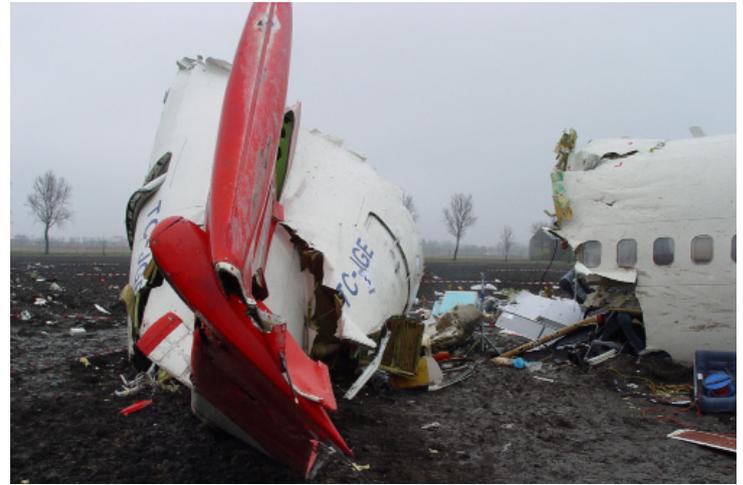
Figure 2: Tail section, broken off of flight TK1951; crashsite located approx. 1.5 kilometers outside of Schiphol Airport.

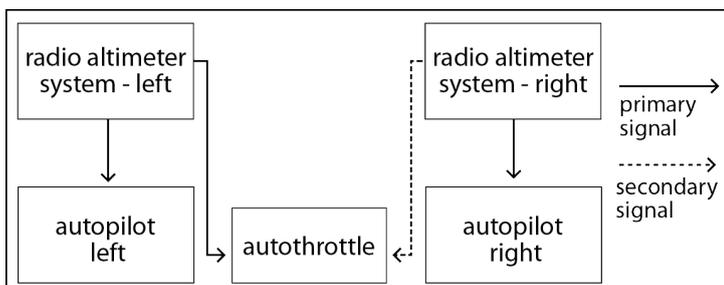
To alleviate pilot workload and allow precision landings in low visibility, the 737-800 may be flown and landed “hands-off” using the autopilot for the flight controls and an autothrottle system for engine thrust. Of particular interest to this mishap, the autothrottle, which receives radio altitude data (Figure 1), automatically controls the

Figure 1: Overview of the 737-800 radio altimeters in relation to autopilot controls and autothrottle.

speed of the aircraft by regulating the thrust on both engines during an automated approach. A low range radio altimeter (LRRRA) system of two independent radio altimeters provides redundancy in the event that one radio altimeter fails, or the inputs from one are recognized as erroneous by the autothrottle. The left radio altimeter provides the primary signal to the autothrottle, additionally transmitting altitude data to the cockpit left side (pilot's) instrument display. The right radio altimeter transmits altitude data to the cockpit right side (copilot's) instruments. If the left radio altimeter signal becomes erroneous, the autothrottle will use right radio altimeter data.

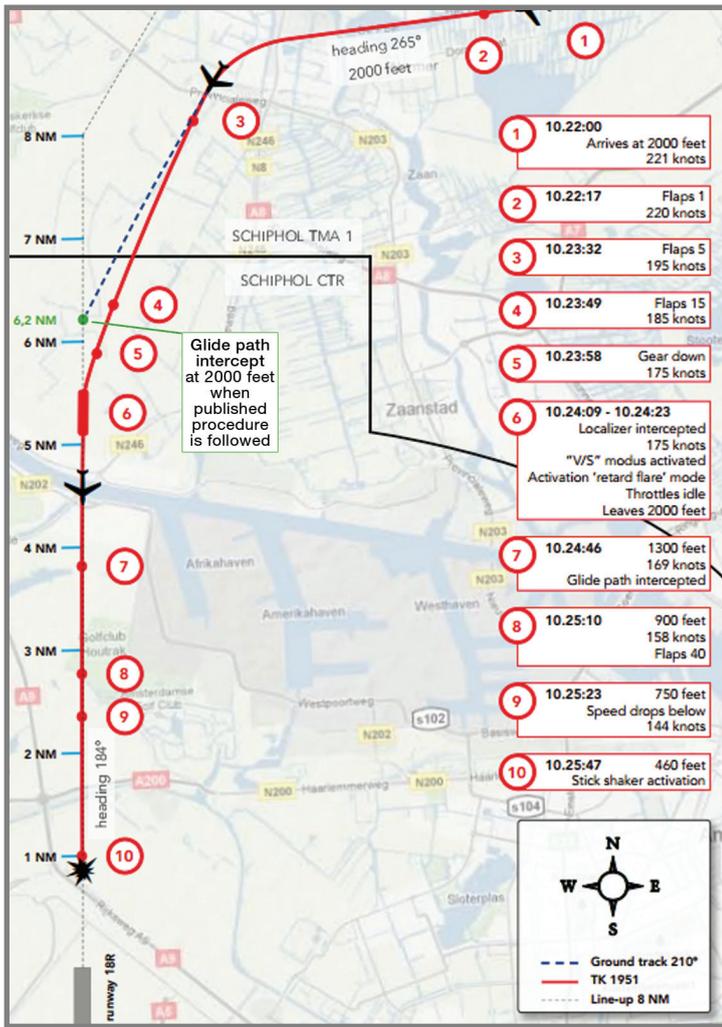
Figure 3: Flight TK1951's approach and timeline of events compared with the typical approach for runway 18R.

The crew of TK1951 was directed to descend to 2,000 feet and turn toward the final approach course for runway 18R, the Polderbaan (Figure 3). The descending turn placed the aircraft above the normal approach path and almost one mile closer to the runway than procedurally established by local Air Traffic Control (ATC). Whether flown manually or automatically (as in this case), Instrument Landing System (ILS) procedures and equipment are optimized to allow the aircraft to fly to and intercept its final glide path from below. However, TK1951 had to intercept from above. Although not inherently unsafe, this condition placed pressure on the cockpit crew to complete pre-landing tasks in a short time and required rapid dissipation of altitude and airspeed energy with a very low thrust setting. Weather conditions added to approach difficulty; cloud cover obscured outside visual cues of descent rate and altitude.

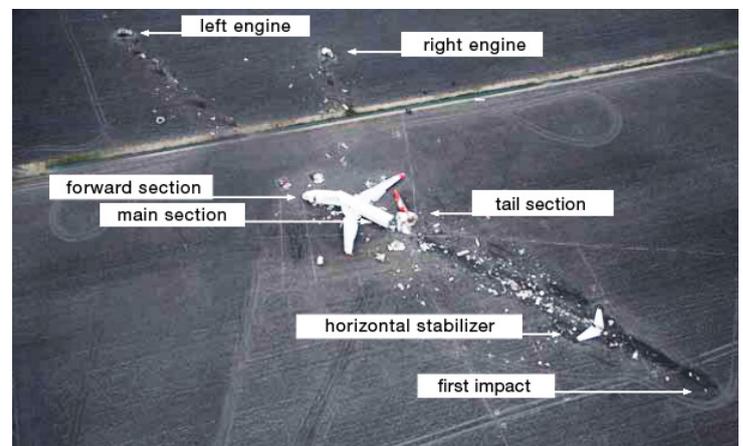
Figure 4: The crash site and wreckage of TK1951.

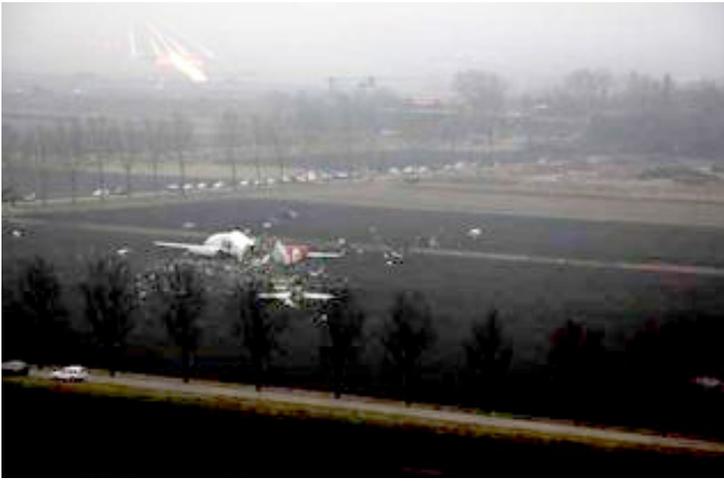
Figure 5: Remains of Turkish Airlines Flight TK1951. Runway lights of the Polderbaan can be seen in the distance.

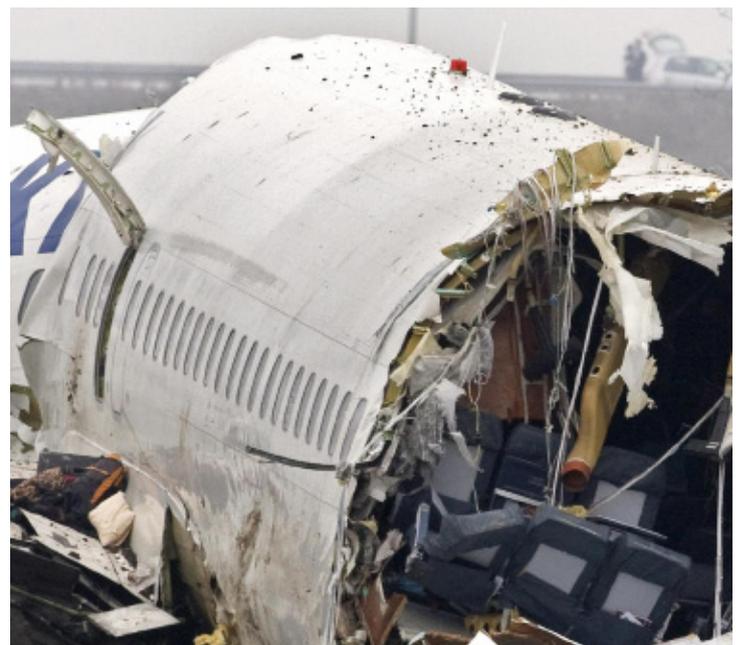
Flight TK1951 struck farmland and was destroyed, breaking into three main sections. Survivors escaped through emergency exits and through openings in the fuselage where the aircraft was torn or broken (Figure 6). Flight recorder data revealed that no other systems failed during flight.

Figure 6: Section of fuselage from the Flight TK 1951 crash site.
