JUNE 2012 VOLUME 6 ISSUE 5

Balloon Mishap in the Outback

Nuclear Compton Telescope Balloon Mishap

SYSTEM FAILURE CASE STUDY

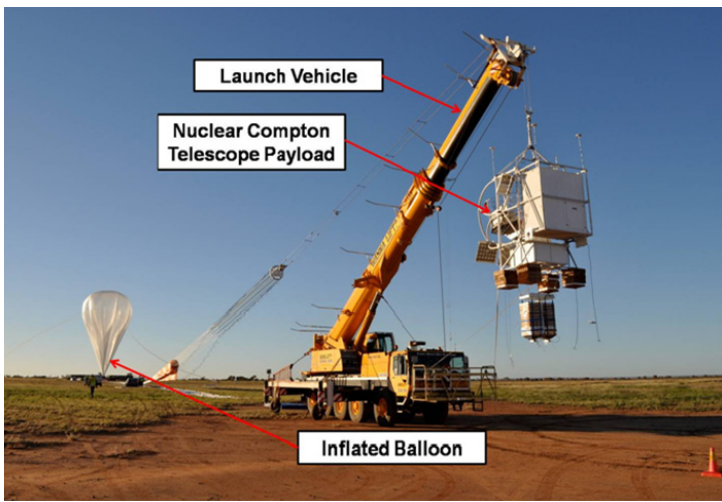
Figure 1: Launch configuration for the NCT during the day of the launch, preparing for release of balloon. Note the inflated balloon bubble.

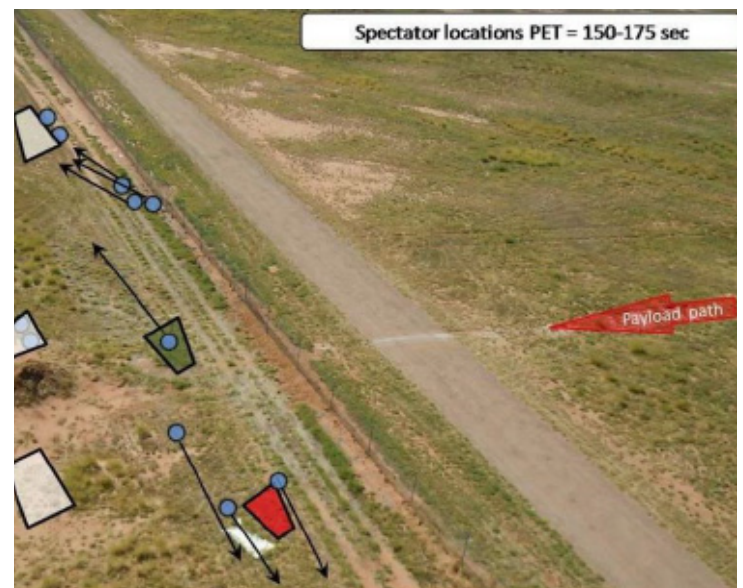
After the balloon bubble was inflated, but before spool release, the CSBF Launch Director noticed that some spectators had gathered downwind of the balloon's projected payload flight path (Figure 2). He requested that these spectators be moved. The UNSW SD responded and put out the request over the radio. An off-duty CSBF crew member, who was among the spectators, and the deputy UNSW SD heard the request.

The crew member, located south of the eventual flight path, moved spectators to the north while the deputy SD, located north of the eventual flight path, moved spectators south. This confusion and the final wind shift placed many spectators directly in the launch line.

Pre-launch flight safety assessments had only considered the ascent and over-flight phases, not the launch phase. The ground safety plan defined a hazard zone for balloon layout and launch, but it was unclear whether the hazard zone was fixed or moving with the launch vehicle.

Figure 2: Spectator locations (blue) in comparison with the payload path. Source: Mishap Investigation Board Report

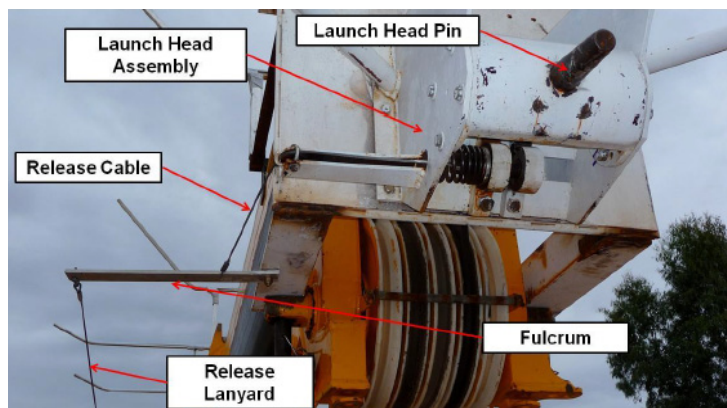
After the launch vehicle regained traction and repositioned, the Launch Director attempted to launch the balloon, but after pulling the lanyard to release the pin (Figure 3), the balloon failed to release.

Figure 3: The launch head assembly showing release lanyard and pin. The release lanyard must be activated manually.

The MIB recognized that the Program was not aware of hardware limitations that might give rise to a failure during a launch vehicle maneuver, or that the payload release system needed to be analyzed for launch limitations.

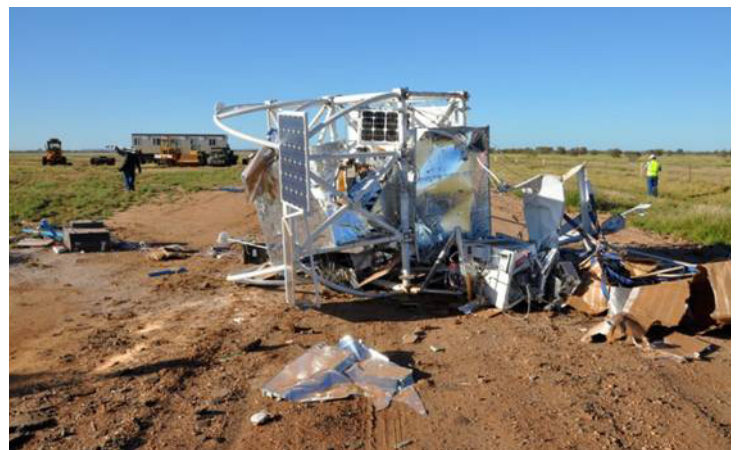
Recognizing the unsafe proximity to the spectators and that the launch vehicle could not proceed any further, the Launch Director directed the launch vehicle to back away from the fence. Conditions made it unsafe to abort; by releasing the balloon without the payload, there was a possibility that the balloon train could fall on the spectators. The launch vehicle backed away from the fence, again losing traction in the soft ground. Intending to abort, the Launch Director attempted a left turn to move away from the spectators. The restraint cables failed under excessive side loading and the payload was inadvertently released (Figure 4).

Figure 4: NCT payload crash site; the NCT sustained major damage.

The payload was dragged along the ground through the fence and collided with spectator vehicles. Fortunately, the spectators evaded the incoming payload without injury.
