MARCH 2013 VOLUME 7 ISSUE 2

Breathe

Survival and the United States' Most Advanced Fighter Jet

SYSTEM FAILURE CASE STUDY

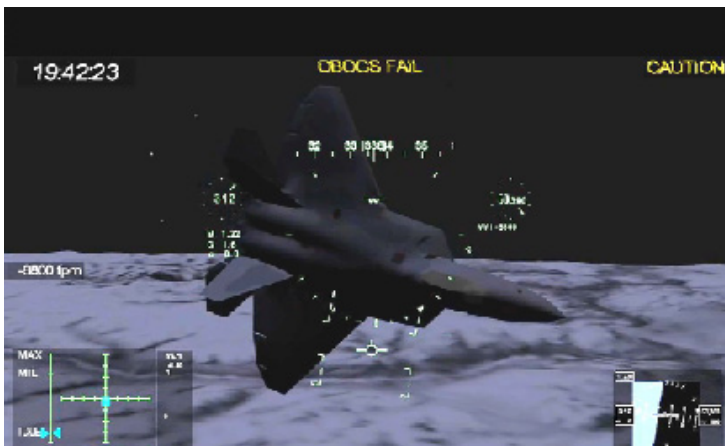
At 7:39:57 p.m., data from the flight leader Rocky 01’s Intra-Flight Data Link (IFDL) showed Rocky 03 at 13 nautical miles ahead. Rocky 01 directed Rocky 03 to return to a 2-nautical-mile trail formation. Rocky 03 acknowledged; it was the mishap pilot’s last radio call. Rocky 03 initiated a climbing right hand turn to rejoin, achieving a maximum altitude of 51,720 feet mean sea level (MSL), and crossed Rocky 01’s projected flight path. Rocky 03 then descended into trail formation.

Figure 2. Rocky 03 during bank to return to trail formation.

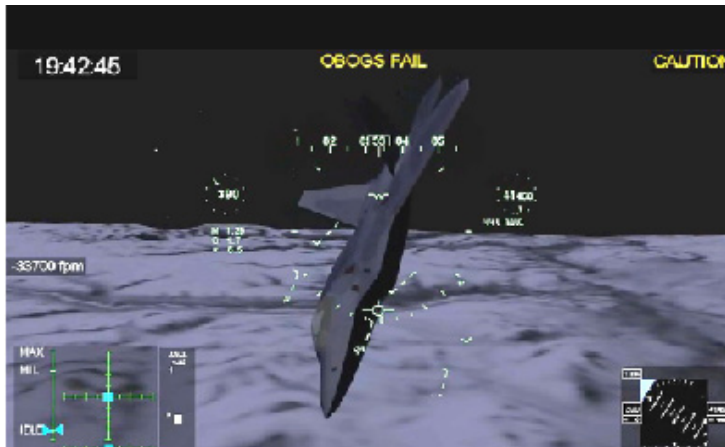
Rocky 03 retarded the throttles to idle power and continued the controlled descending right hand turn to a lower altitude in accordance with procedure until 7:42:45 p.m. There had been no pressure to the pilot’s oxygen mask since 7:42:37 p.m. For the next 8 seconds, the Rocky 03 made no throttle, pedal, or stick movements, but maintained a relatively stable bank.

Figure 3. Rocky 03 descending to lower altitude.

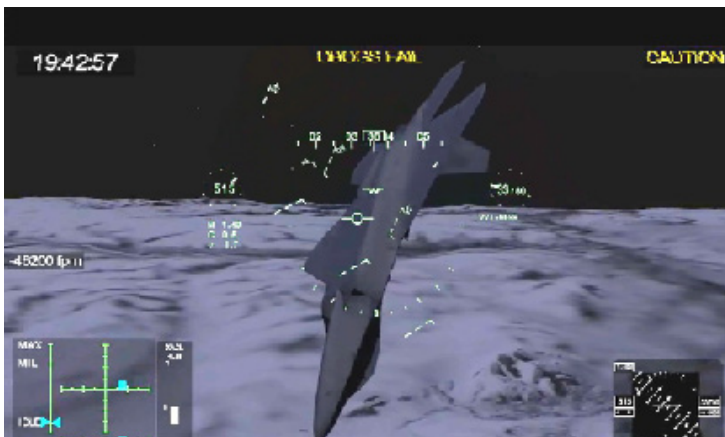
At 7:42:53 p.m., the pilot input a combination of right forward stick and right pedal, which initiated a 240-degree descending right roll at greater than 45 degrees per second. The pilot had rolled through inverted and was plummeting down at a rate of -57,800 feet per minute. There were no stick inputs and only very minor pedal inputs for the next 15 seconds. As the jet descended rapidly past 19,000 feet MSL, a CABIN PRESSURE caution warned that cabin pressure had risen above normal. Upon passing 12,400 feet MSL, an AIR COOLING caution activated—a normal occurrence 60 seconds after a C BLEED HOT caution if the avionics were not receiving adequate cooling air.

Figure 4. Rocky 03 rolling 240 degrees to inverted.

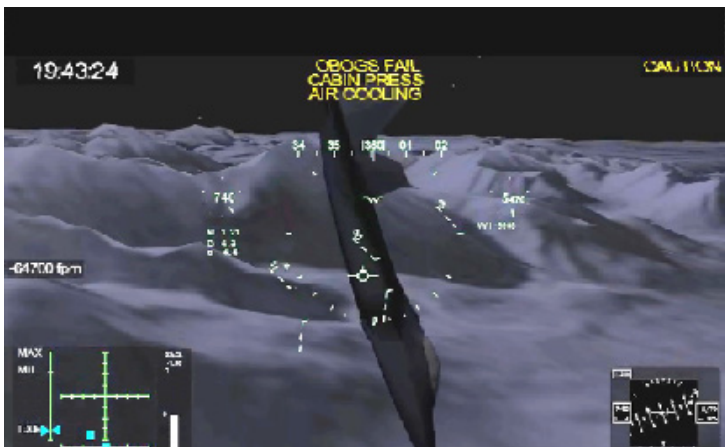
At 7:43:24 p.m., the pilot attempted a dive recovery at 5,470 feet MSL by pulling aft on the stick, producing a 7.4-g pull up maneuver, but was too late. The aircraft impacted the ground 3 seconds later at a rate of -57,900 feet per minute, inflicting fatal injuries to the pilot and destroying the aircraft.

Figure 5. Rocky 03 attempting a dive recovery maneuver.

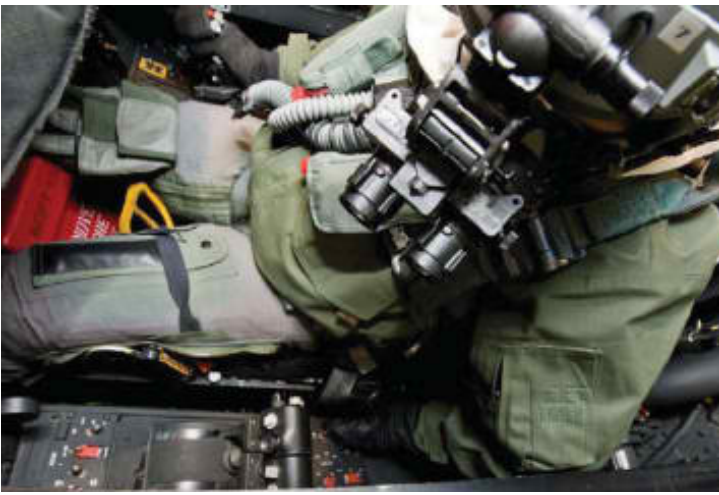
A post-crash assessment of pilot maneuverability within the F-22A cockpit while wearing Category III cold weather gear and NVGs revealed that the equipment’s bulk greatly reduced pilot mobility. The NVGs hit the top of the cockpit canopy and interfered with the pilot’s ability to look from side to side and down at the consoles. In addition, NVGs possess a notoriety for causing channelized attention because of their narrow line of sight. During the post-crash assessment, wearers of the NVGs and cold weather gear needed to shift their torso in the seat while bracing themselves at various points in the cockpit to perform a complete visual scan. The gear also limited tactile sensation, which could lead to inadvertent flight control inputs.

The small, manual pull-ring that activated the EOS was also tested by the investigation team. Although the investigation team was able to activate the EOS in the cold weather gear and NVGs, they stated that the retrieval of the ring would be difficult. Further, if the initial activation failed, which requires tugging on the ring upward then forward with as much as 40 pounds of force, it was also possible to drop the ring between the seat frame and cushion.

Struggling to reach or locate the ring, once dropped, may have resulted in inadvertent flight control inputs due to loss of tactile senses and the bulk of the cold weather gear.

Figure 6. USAF Accident Investigation Board member wearing Category III cold weather gear and NVGs in F-22A cockpit.
