NASA SAFETY CENTER
SYSTEM FAILURE CASE STUDY

MAY 2013 VOLUME 7 ISSUE 4

The North Sea Piper Alpha Disaster

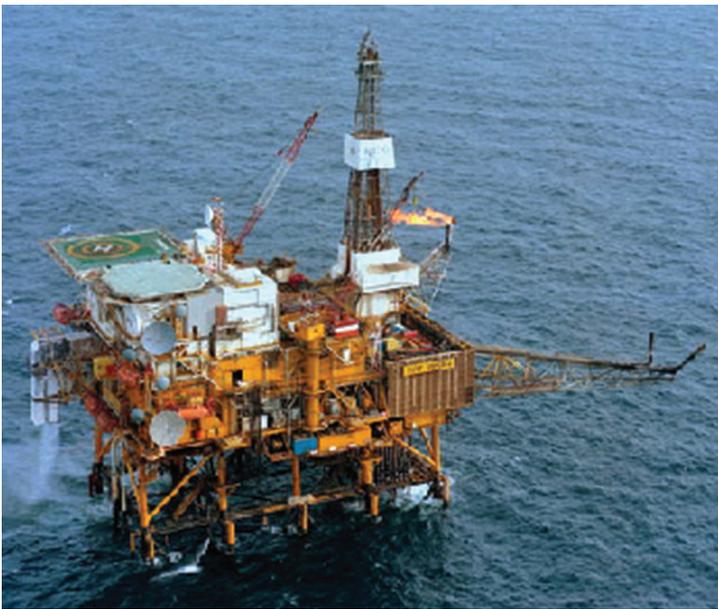
Figure 1. Piper Alpha before the fire. Source: BBC.

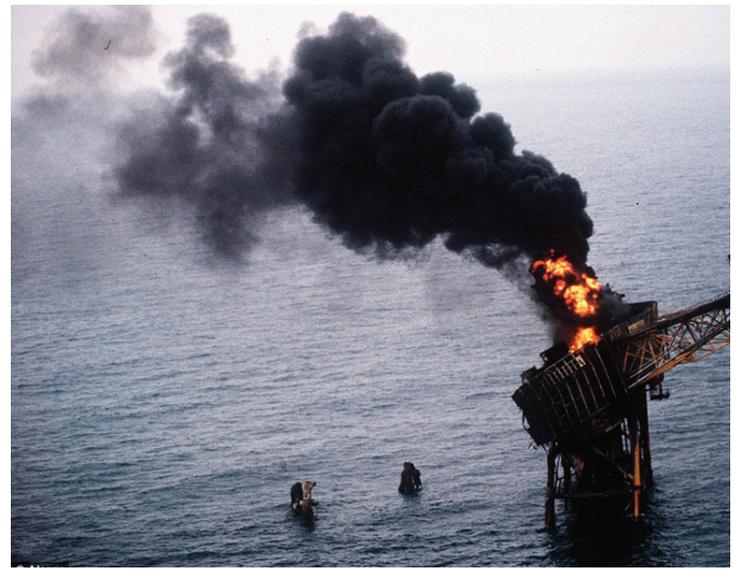
Figure 3. The remaining oil wells module continued to burn for weeks until famed firefighter, Red Adair, and his team extinguished the remains. Source: BBC.
