A Loaded Magazine

The Honolulu Fireworks Disposal Explosion

Senior Management ViTS Meeting

July 2013

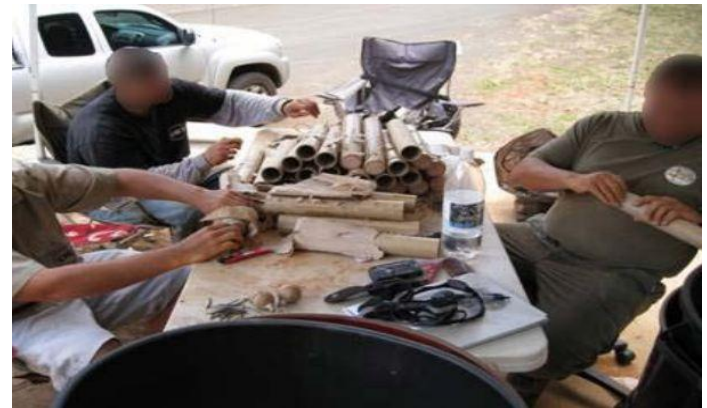
- December 2010: After changing their process multiple times, DEI settled on removing the aerial shells from the mortar tubes, slicing the shells open, and then soaking them in diesel. Black powder from the burst charges was collected and stored without disposal. To expedite disposal, DEI was disassembling large quantities of fireworks while waiting for batches of shells to soak.

- A surplus of explosive components accumulated inside the magazine entrance, near tools and containers capable of producing sparks and static discharge.
- DEI's hazard analysis of its disposal activities failed to identify and control key hazards of the disposal process.

DEI workers disassembling fireworks. Source: CSB.
