## NASA SAFETY CENTER SYSTEM FAILURE CASE STUDY

# A Loaded Magazine

## The Honolulu Fireworks Disposal Explosion

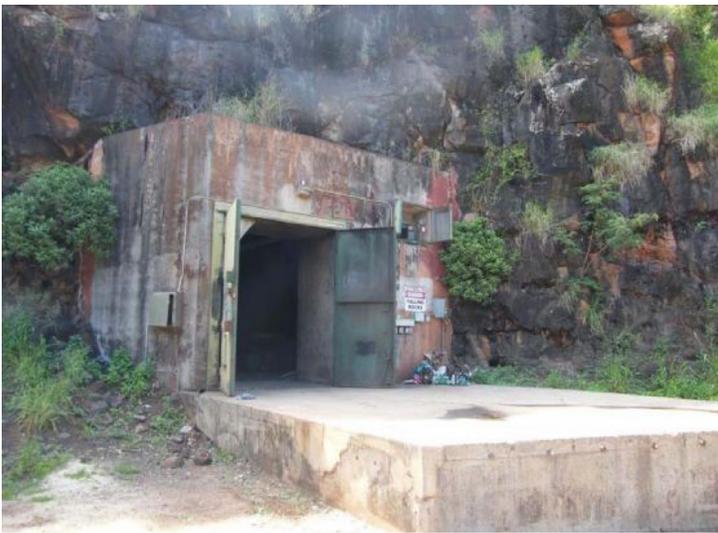
Figure 1. The location of the explosion was the Magazine A-21 at the Waikele Self Storage complex. Source: CSB.

to rain. DEI workers quickly moved tools, chairs, boxes of shells, black powder, and partially disassembled fireworks into the entrance of the magazine. Five of the workers stayed inside the magazine while the project supervisor walked outside onto the loading dock to make a phone call. Seconds later, at approximately 8:50 a.m. Hawaii-Aleutian Standard Time, an explosion and fire occurred inside the magazine.

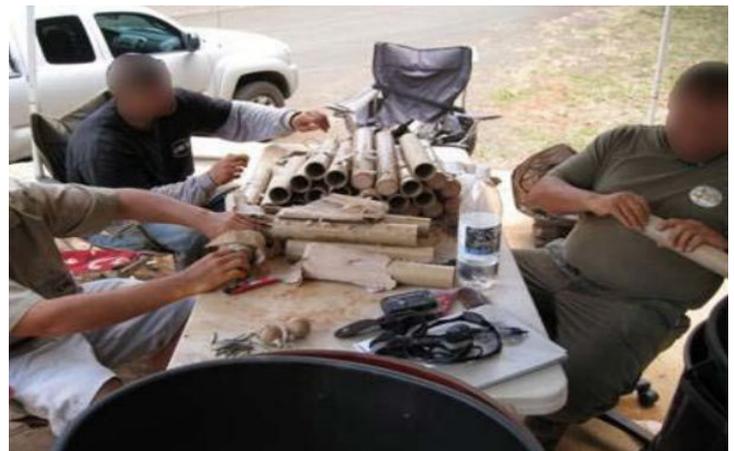
after diesel soaking for 1 week, and altered its process, opting to disassemble the tubes and separate the explosive components. DEI personnel slit the aerial shells with box cutters to improve diesel penetration during soaking. The black powder was collected in plastic containers lined with plastic garbage bags and stored at the back of the magazine in lieu of disposal. VSE was aware of this change, but expressed no concern. The permit did not evaluate or address fireworks disassembly or diesel soaking and DEI had no plan to dispose of the black powder. The initial shipment was destroyed by December 2010 without incident.

Figure 2. DEI workers disassembling firework mortar tubes and separating the contents. Source: CSB.

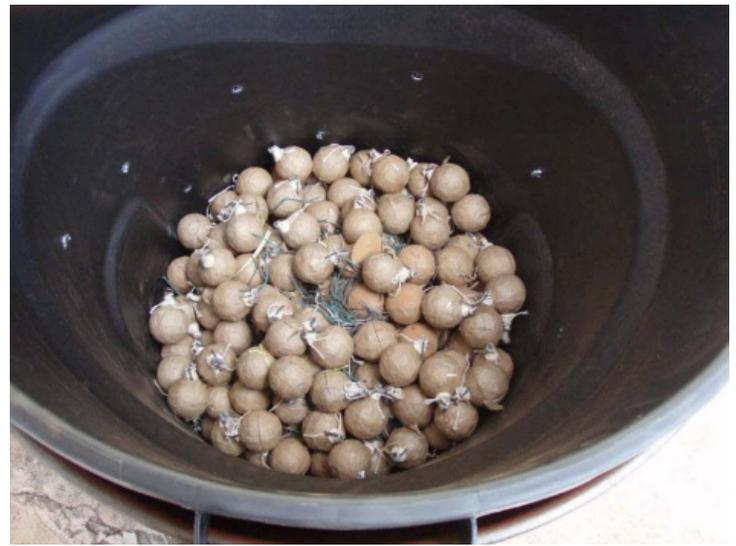
The CSB investigation's final report determined that changes in DEI's fireworks disposal process resulted in the accumulation of a large quantity of explosive components just inside the magazine entrance, creating the essential elements for a mass explosion and deflagration. DEI's hazard analysis of its fireworks disposal process was insufficient. DEI failed to identify key hazards of handling, disassembling, and storing explosive material, and did not adequately control the identified and evaluated hazards. DEI personnel disposing of the fireworks lacked the training, experience, and knowledge of procedural safeguards for the safe conduct of the fireworks disposal.

Figure 3. Aerial shells in a plastic container awaiting diesel soaking. Source: CSB.
