NASA Quality Leadership Forum

Premature Wear of the “Curiosity” Mars Rover Wheels

March 13, 2019

Jet Propulsion Laboratory, California Institute of Technology

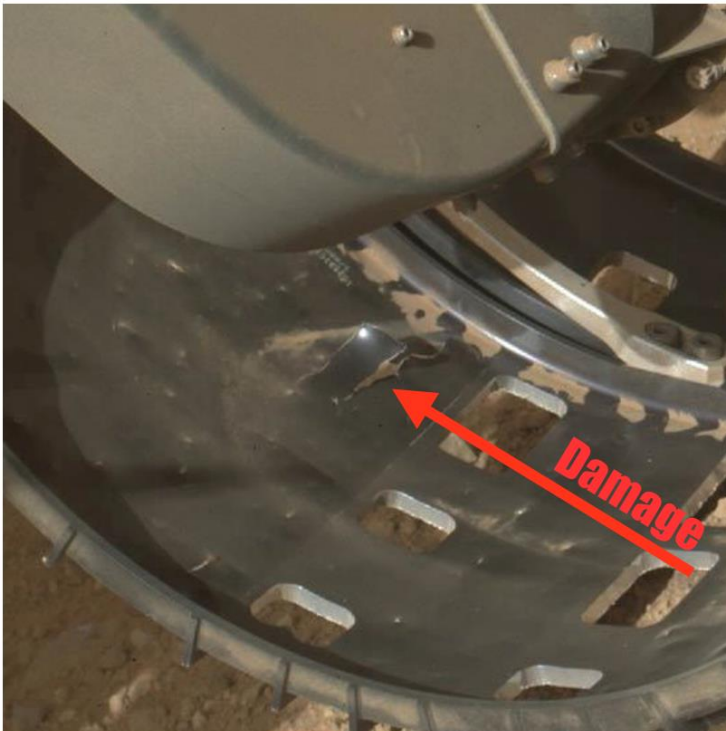
- ← Detail view of the inner surface of Curiosity's left front wheel on sol 411. Arrow points to tear

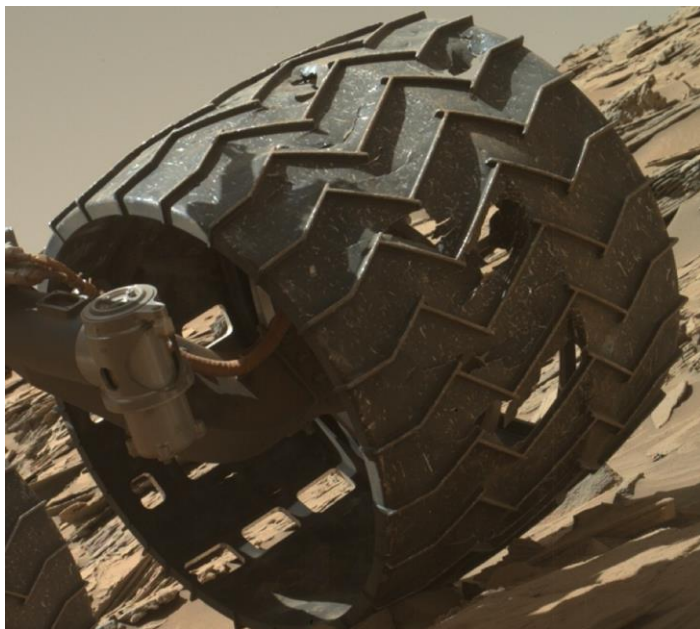
- By sol 463 (11/24/13), a large rip had opened above the Morse-code holes in the left front wheel that was much larger than expected and exceeded any damage seen in testing
- The progressive damage to MSL wheels has continued (image below left)

← MAHLI full-wheel imagery of Curiosity's left-middle wheel taken on April 18, 2016 (sol 1,315)

- Corrective actions to prevent further wheel damage:
 - Track wear progression and drive so as to minimize wear
 - Avoid hard surfaces and ventifacts
 - Drive backwards on “wheel hostile” terrain
- These measures have proven effective in managing the rate of damage: the rover will be able to complete its extended mission-- and likely further mission extensions
 - Will slow Curiosity’s progress and limit it’s paths

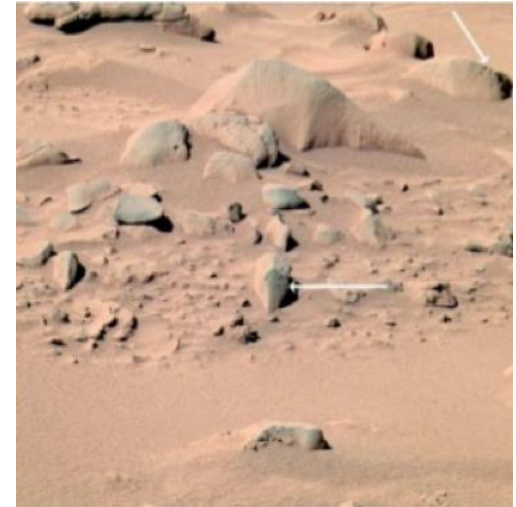
- The impact of ventifacts is exacerbated by a dynamic mechanical load on the wheels

White arrows point to ventifacts found in the Gusev plains →

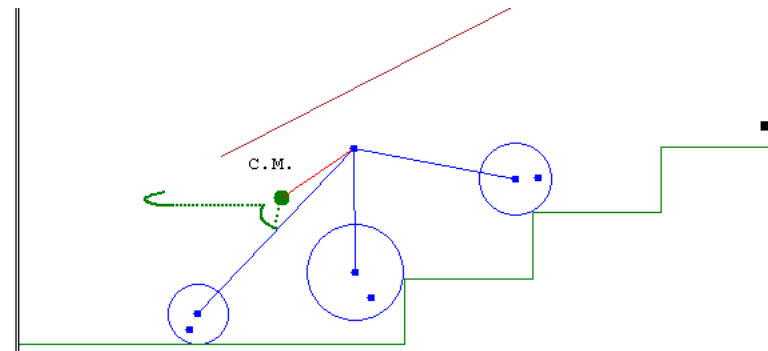
The rocker-bogie mobility system (the wheels surmounts the face of a vertical obstacle (rock) by having the center and rear wheels force the front wheels against the obstacle
