Lessons from Balloon Experimental Twin Telescope for Infrared Interferometry (BETTII) Close Call

Balloon Experimental Twin Telescope for Infrared Interferometry (BETTII)

Mishap Investigation Performed per NPR 8621.1

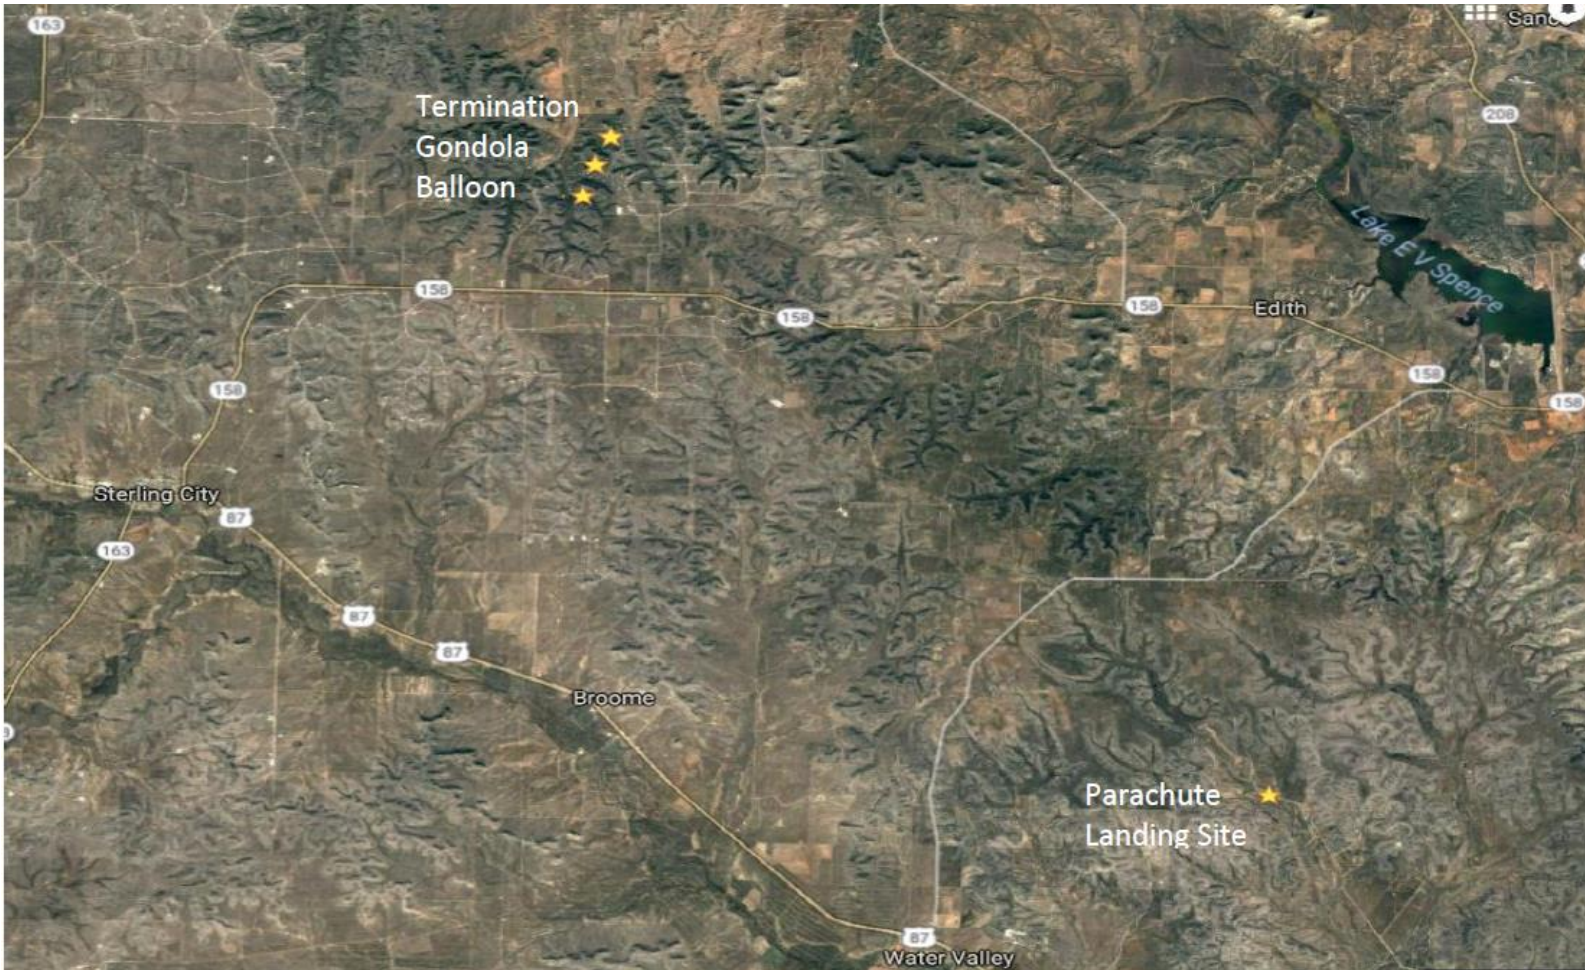
BETTII Flight Termination

The parachute with the Universal Termination Package hardware was located on the afternoon of June 9, 2017, approximately 20 miles south of the termination position. Landing some 120 minutes after termination.

The balloon landed approximately 1.5 miles south-southwest of the termination.

The BETTII payload was located approximately $\frac{3}{4}$ mile southwest of the termination site.

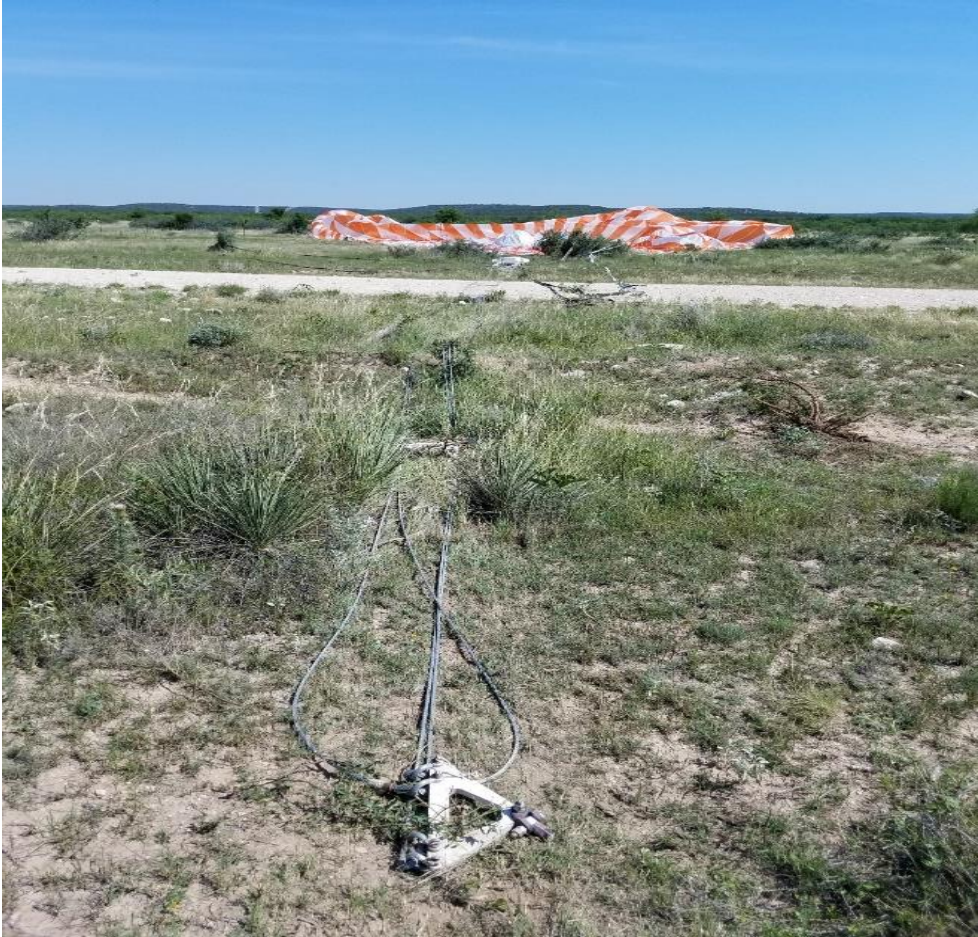
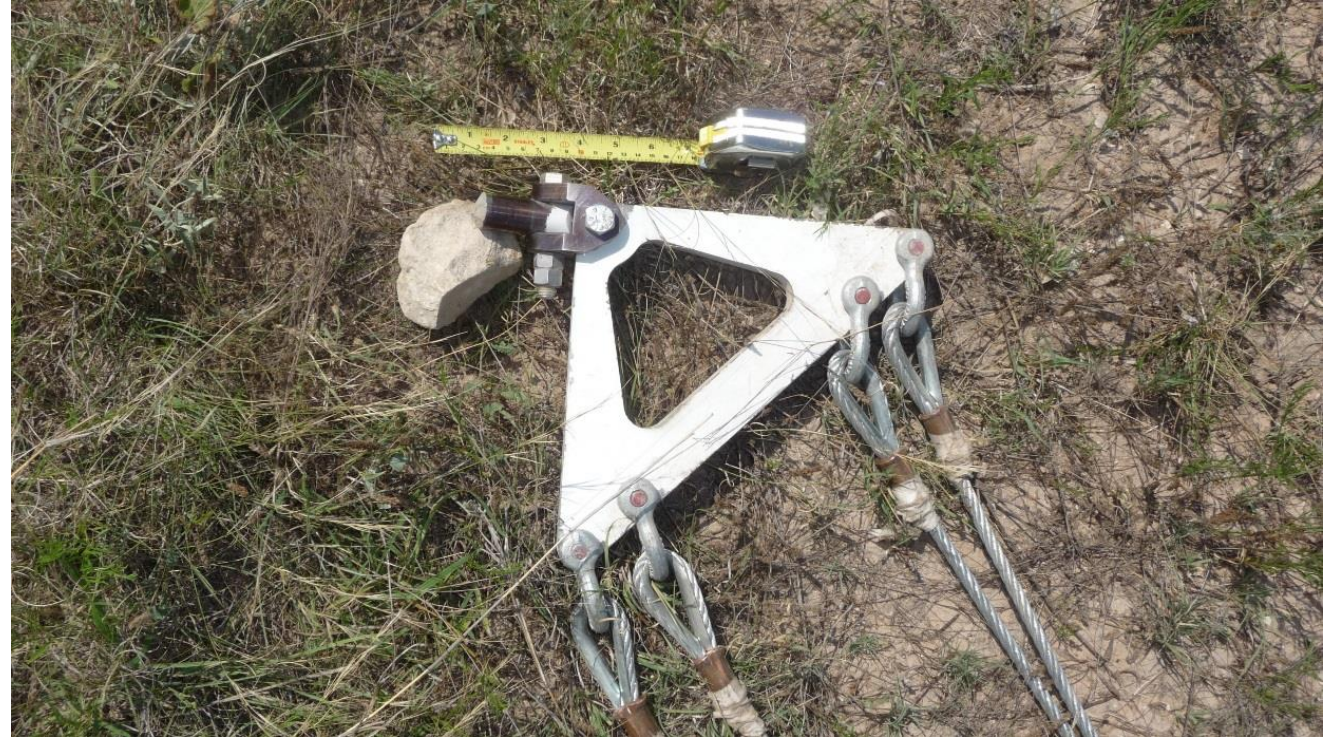
BETTII Parachute Landing Site

Parachute and associated cable with truck plate was located. The separation of the gondola from the parachute was identified as the fracture of the BETTII Rotator Pin.

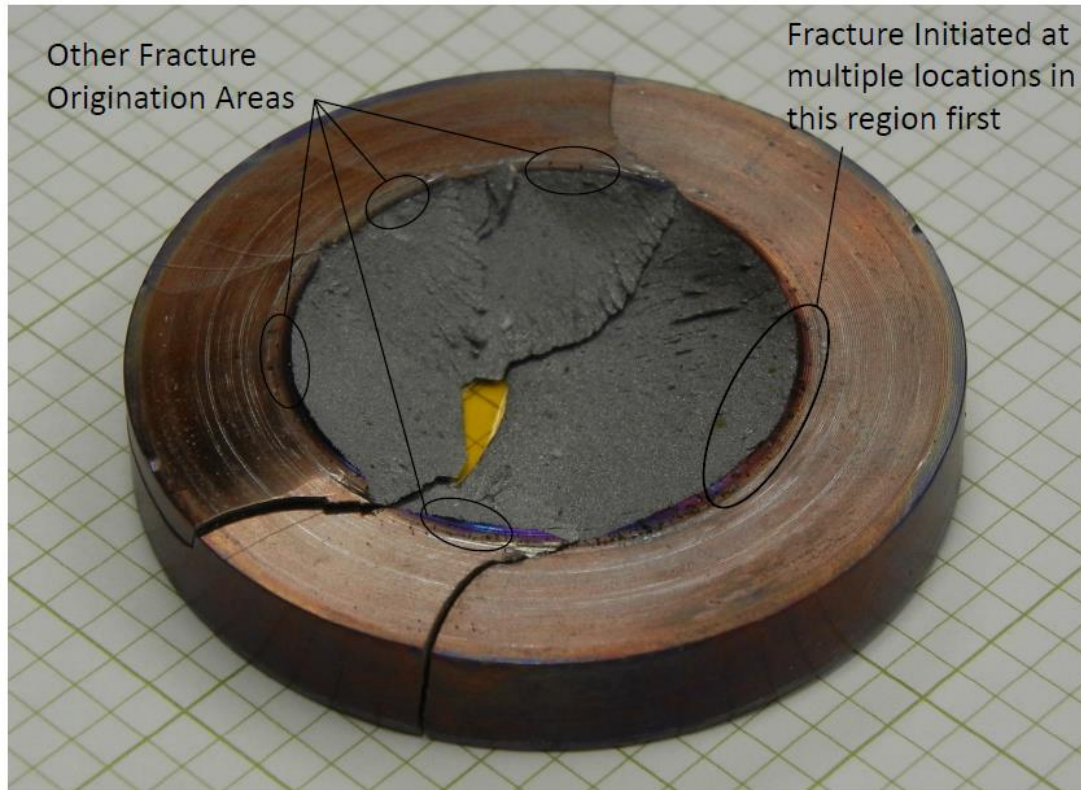
Proximate Cause

The rotator pin failed due to a single overload event.

- The fracture was primarily brittle fracture, with multiple fracture origins around the circumference at the flange-to-shaft interface.
- Loading on the flange at the time of fracture was uneven, producing a bending moment.
- Although there are indications of pre-fracture rubbing on the shaft, it does not appear to be a cause of fracture.

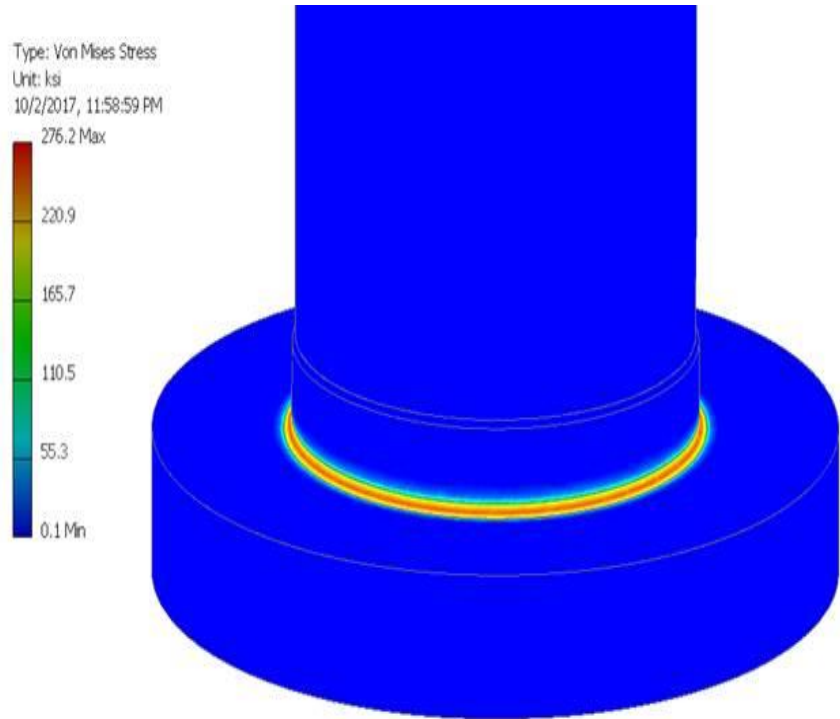
Proximate Cause

- Failure of the Rotator Pin which was designed with a sharp radius and constructed from a high strength/low toughness material.
- FEA of Balloon Interface Pin. Maximum Von Mises stress calculated to be 276 ksi at a 7g loading. Custom 455-H900 which reports a yield strength of 1" bar as 245 ksi (UTS = 250ksi)
