Soyuz MS-10 abort caused by sensor failure at booster separation

written by Chris Bergin | November 1, 2018

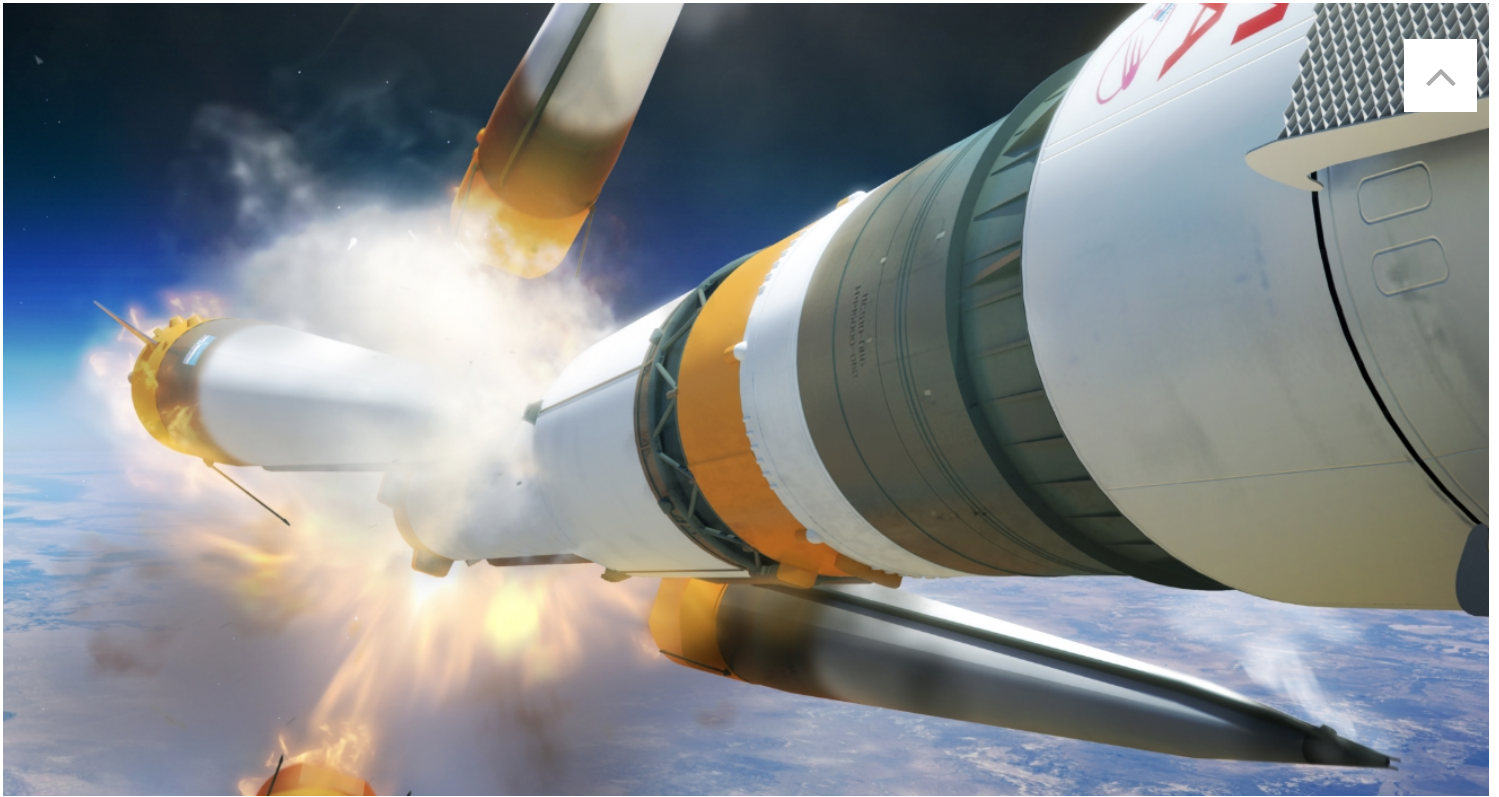
[According to L2 information](#), the problem began at 118-119 seconds into ascent, when the D booster did not properly separate from the core due to the valves on oxygen tank failing to open.

The valves release a vent of liquid oxygen, which helps to push the booster away from the core. The reason for the valves failing to open was due to a sensor – located near the top of the booster – failing to trigger the valves.

With the core still firing, the expended boosters naturally fall away. However, with the vent valve failing to push the booster away, the booster effectively slid down the core – or, only partially separated and recontacted with the vehicle – ruptured

An envisioning of the booster sep issue – by Nathan Koga for NSF/L2

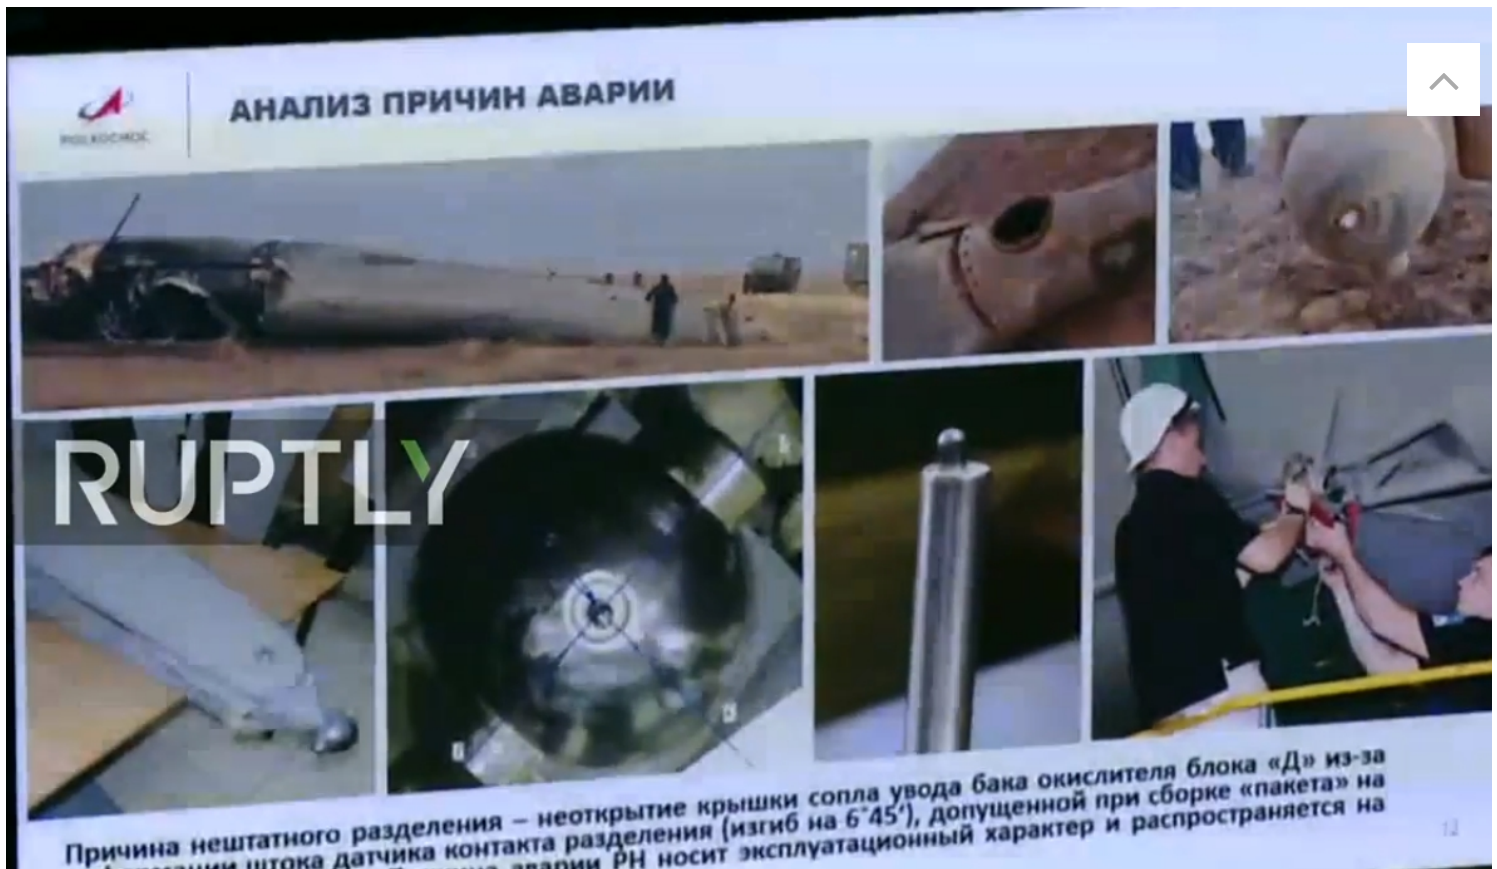
Aiding the investigation was the recovery of some of the Soyuz FG, notably the failed booster. It is understood that provides clues into the sensor failure, with an image of the recovered booster showing it was in a good enough condition to provide hands-on evaluation of its hardware.

It has been noted the valves did open, but only as a result of the impact with the core stage. This explains why venting was observed in the live coverage.

It also showed "deformation" of the sensor rod – which was the focus of one slide provided by the agency.

A slide showing the failed booster on the ground – via Roscosmos

It was noted that due to the assembly issue with the Soyuz FG that launched with Soyuz MS-10, additional work has been taking place on Soyuz launch vehicles that have passed through processing to the point of booster mate.
