# NASA and Orbital Reach Differing Conclusions on Antares Failure

[Jeff Foust](#) October 29, 2015

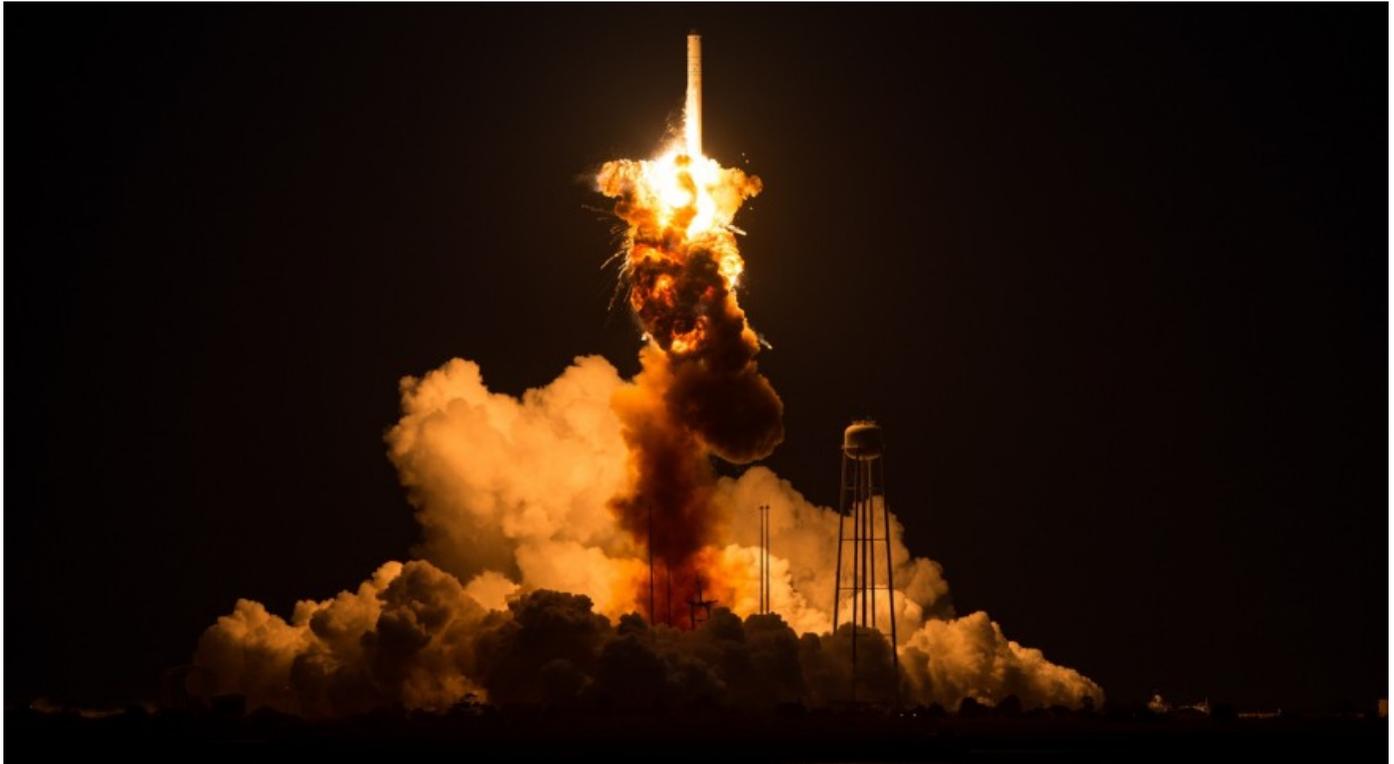
An Orbital Sciences Corp. Antares rocket exploded seconds after liftoff from Wallops Island, Virginia, Oct. 28.  
Credit: NASA
