SpaceX Falcon 9 failure investigation focuses on COPV struts

July 20, 2015 by Chris Bergin

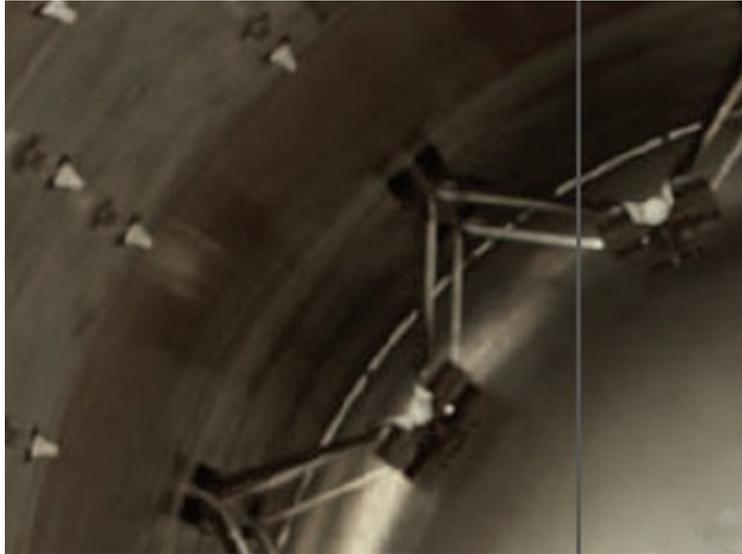
There were also notes (L2) about interest in the rods that support the helium bottles inside the LOX tank in the second stage.

(Image left of a COPV support in the First Stage – which Mr. Musk noted is the same design as those in the Second Stage).

It was suggested that one of these rods – or struts – may have failed during ascent.

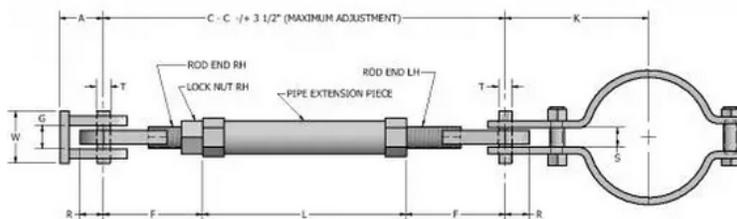
“At (around) 3.2 Gs, the strut holding down one of the helium bottles appears to have snapped.”

(Image left: An example of a strut – not a SpaceX graphic).

With the helium bottle loose – and likely becoming damaged – it is believed a large amount of helium would have been released into the LOX tank, resulting in the overpressure event.

The immediate forward plan to return the Falcon 9 to flight is to change the struts inside all future tanks, independently tested to ensure their quality before being used in the rocket.

“Whatever something is certified to handle, we’re not going to believe that. We’re going to test every single strut. We’re going to switch to a strut that has an even higher margin of safety.”
