# GEMINI PROGRAM MISSION REPORT

# GEMINI X

AUGUST 1966

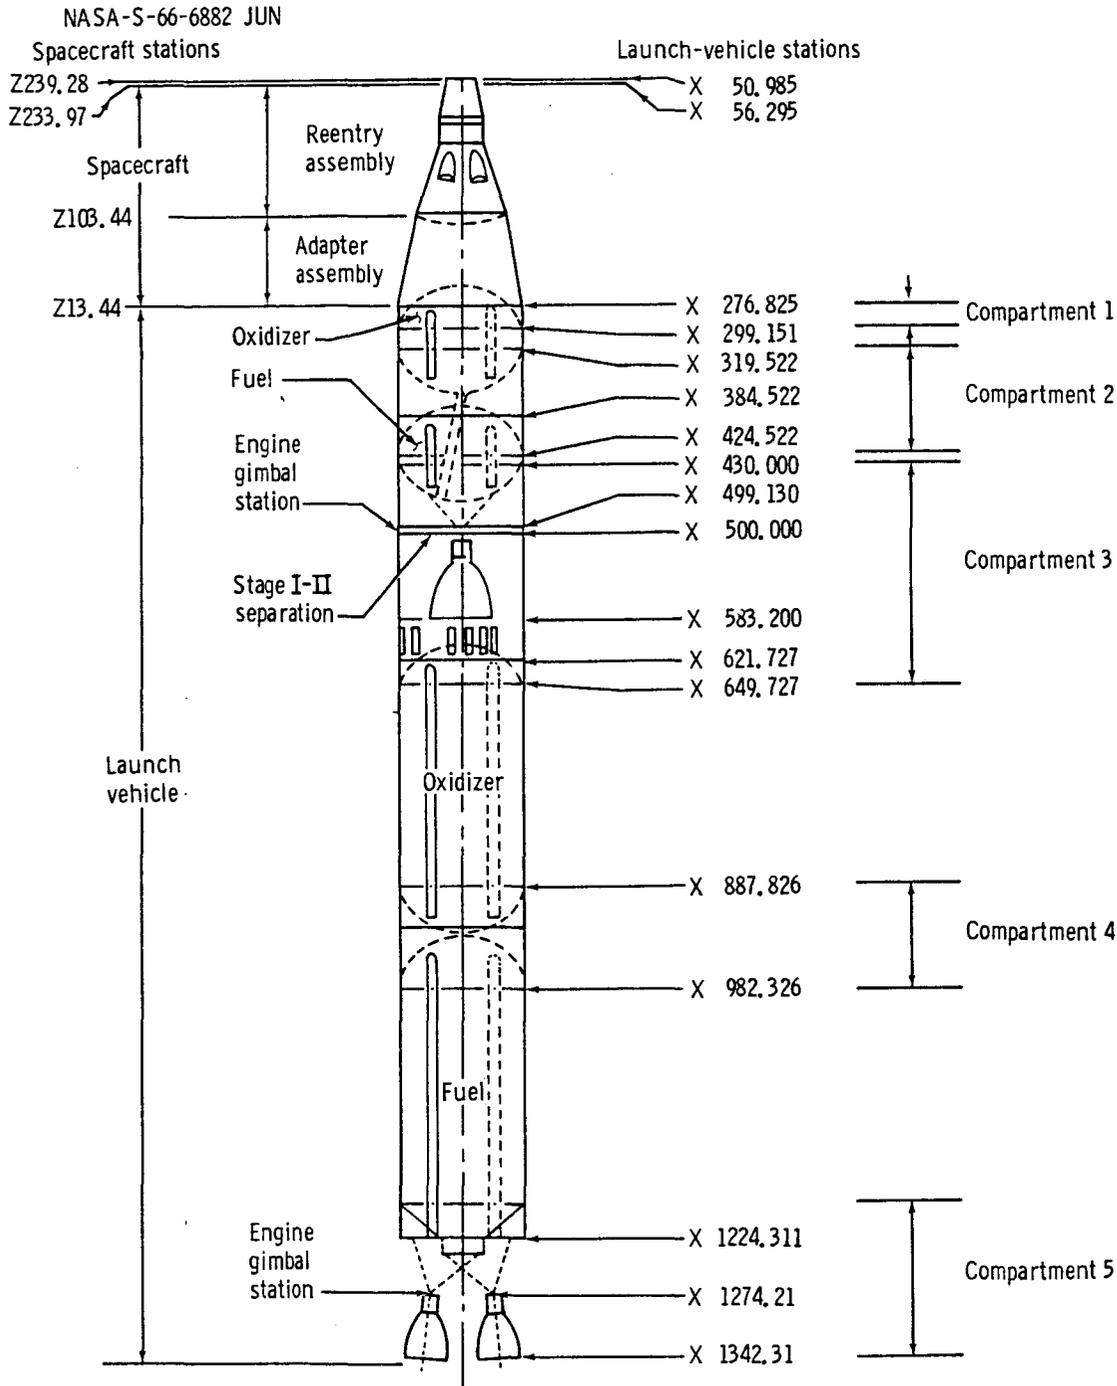
Figure 3.0-1. - GLV/spacecraft relationships.

(a) Launch configuration.

The general arrangement and major reference coordinates of the manned Gemini Space Vehicle are shown in figure 3.0-1. Section 3.1 of this report describes the spacecraft configuration, including the Extravehicular Life Support System (ELSS); section 3.2 describes the GLV configuration; and section 3.3 provides the space vehicle weight and balance data. The general arrangement and major reference coordinates of the GAATV are shown in figure 3.0-2. Section 3.4 describes the GATV configuration, including the Target Docking Adapter (TDA); section 3.5 describes the TLV configuration; and section 3.6 provides the weight and balance data of the GAATV.

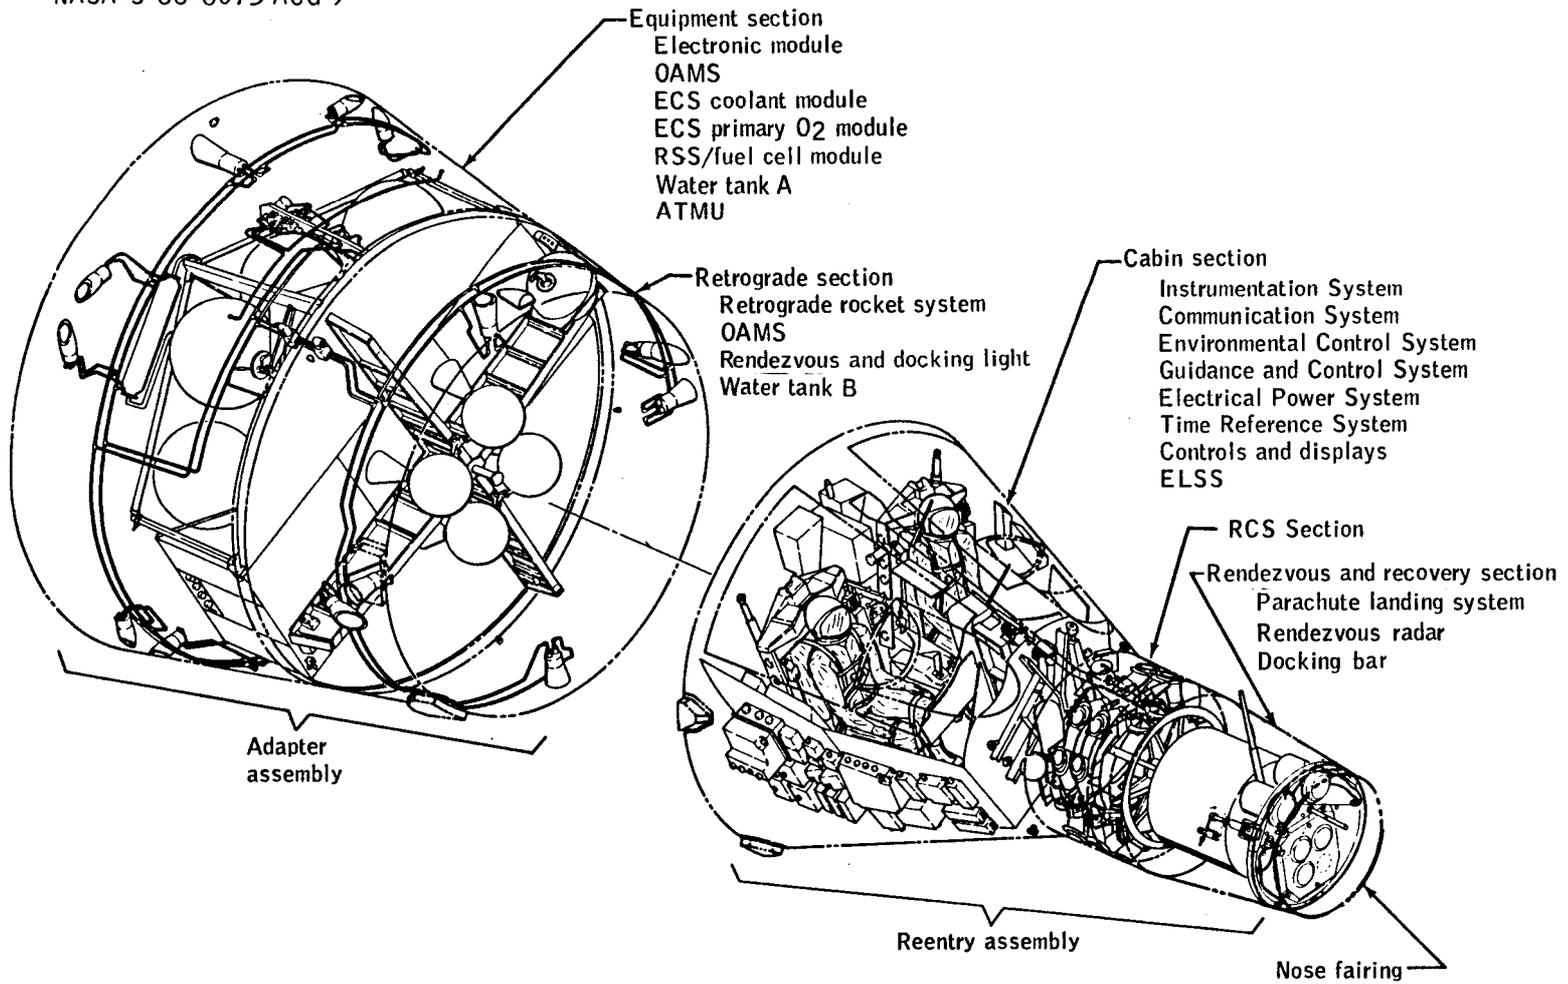
Figure 3.1-1. - Spacecraft arrangement and nomenclature.

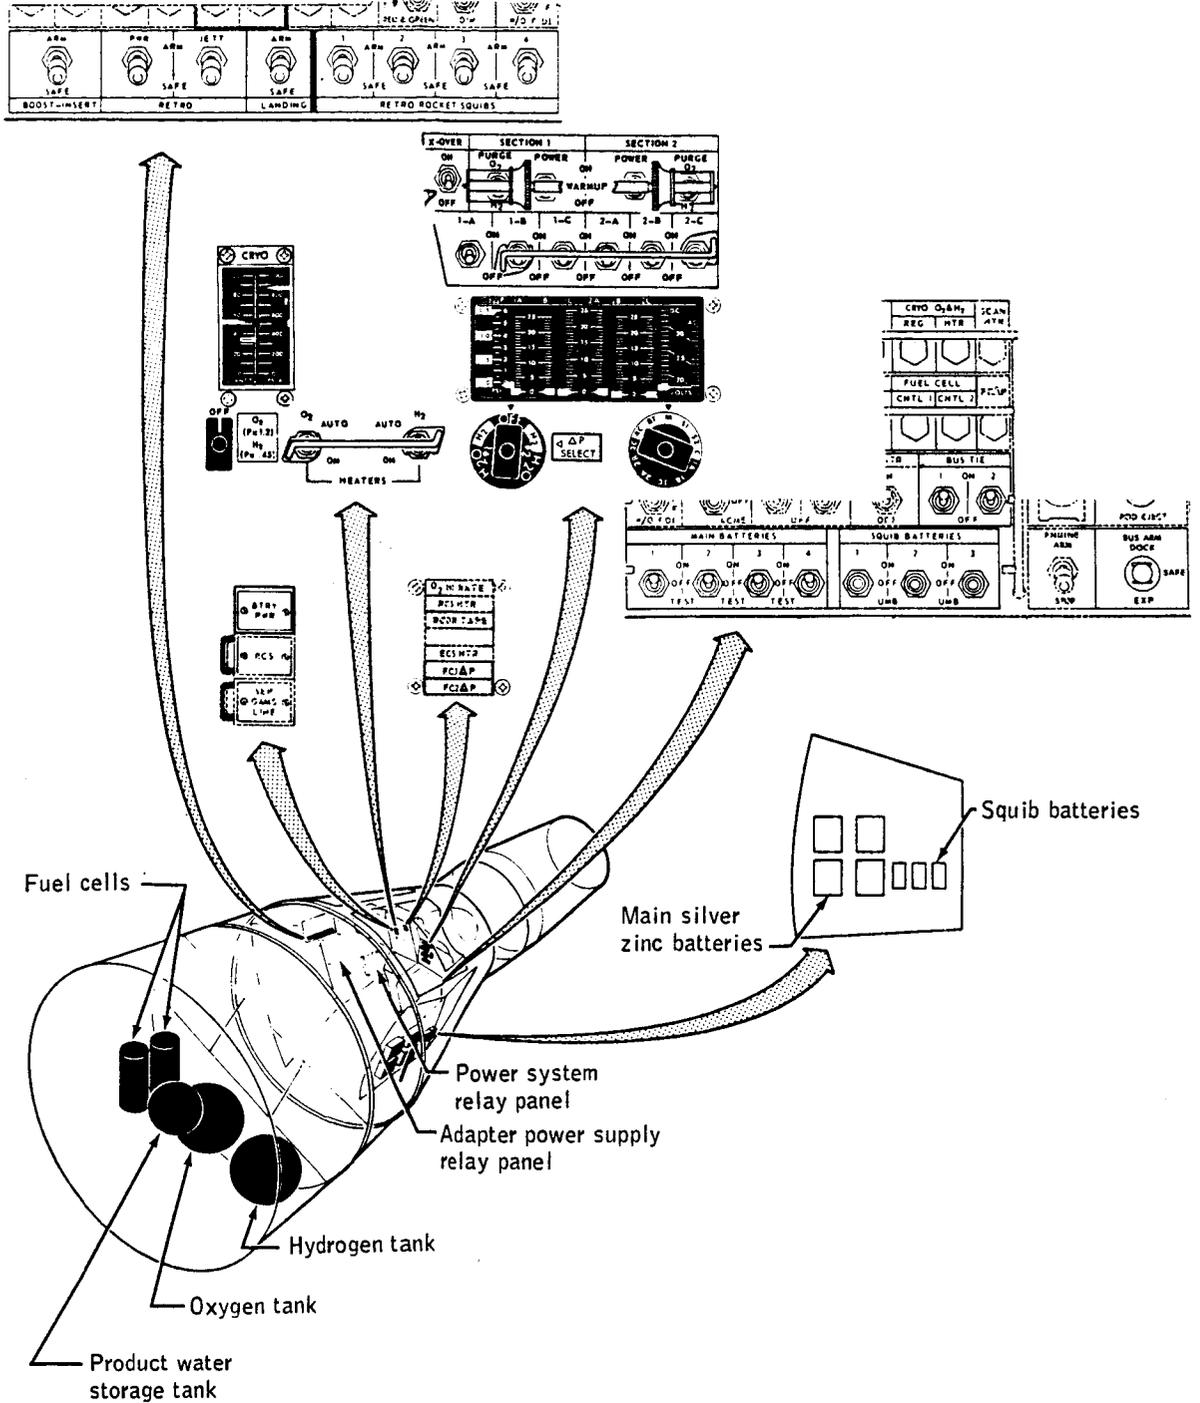
Figure 3.1-2. - Electrical system.

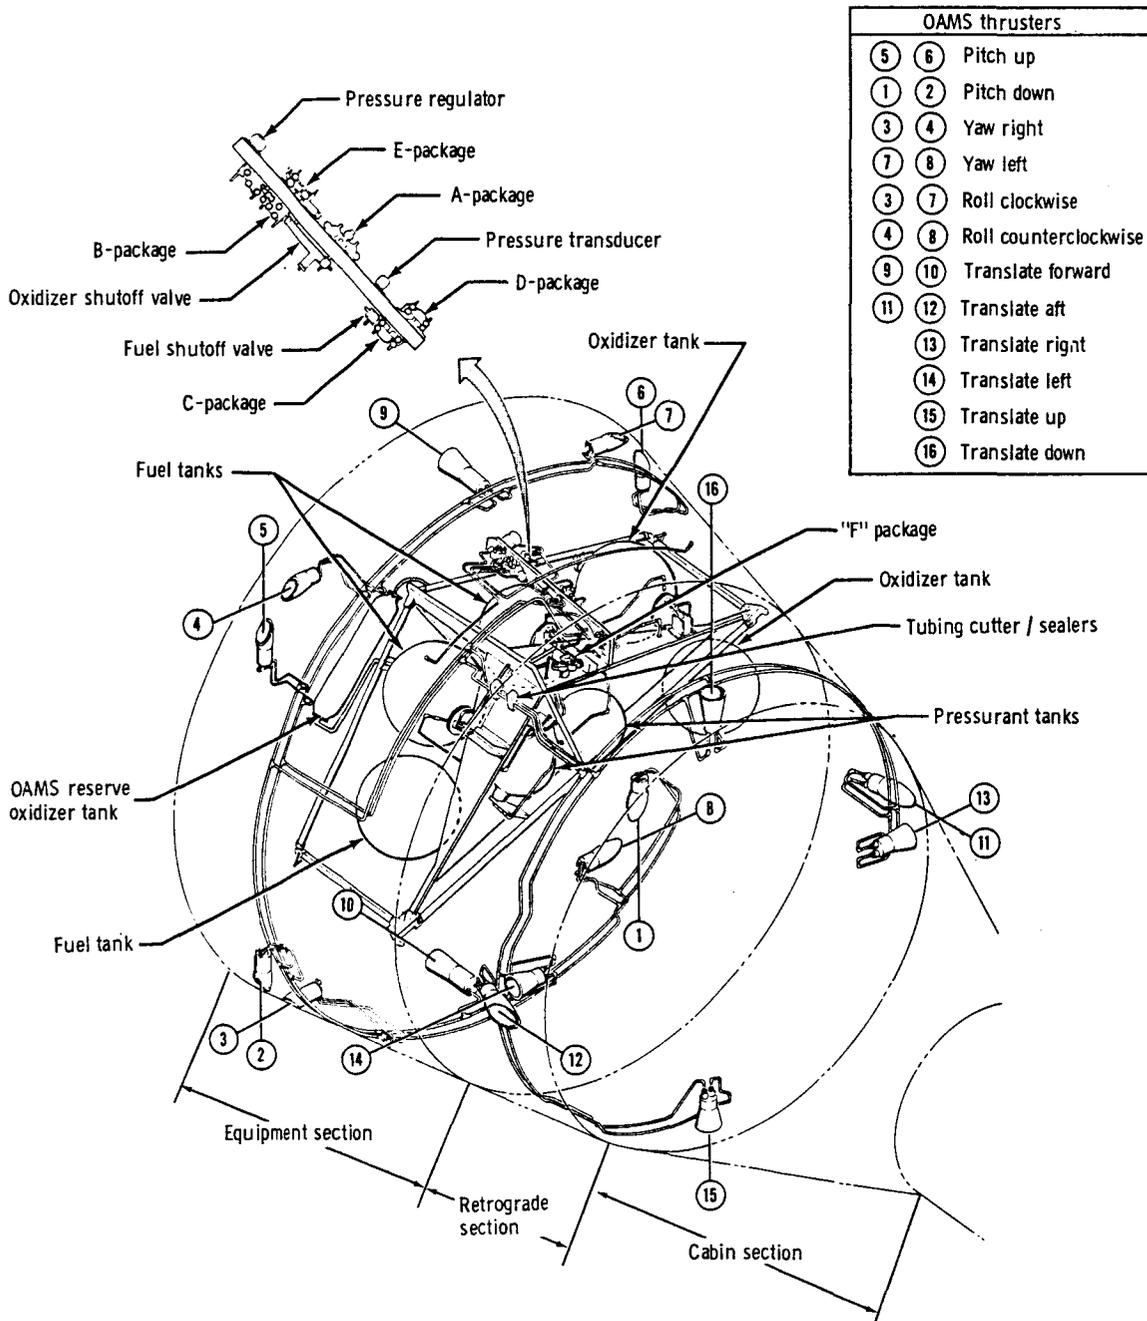
Figure 3.1-3. - Orbital Attitude and Maneuver System.

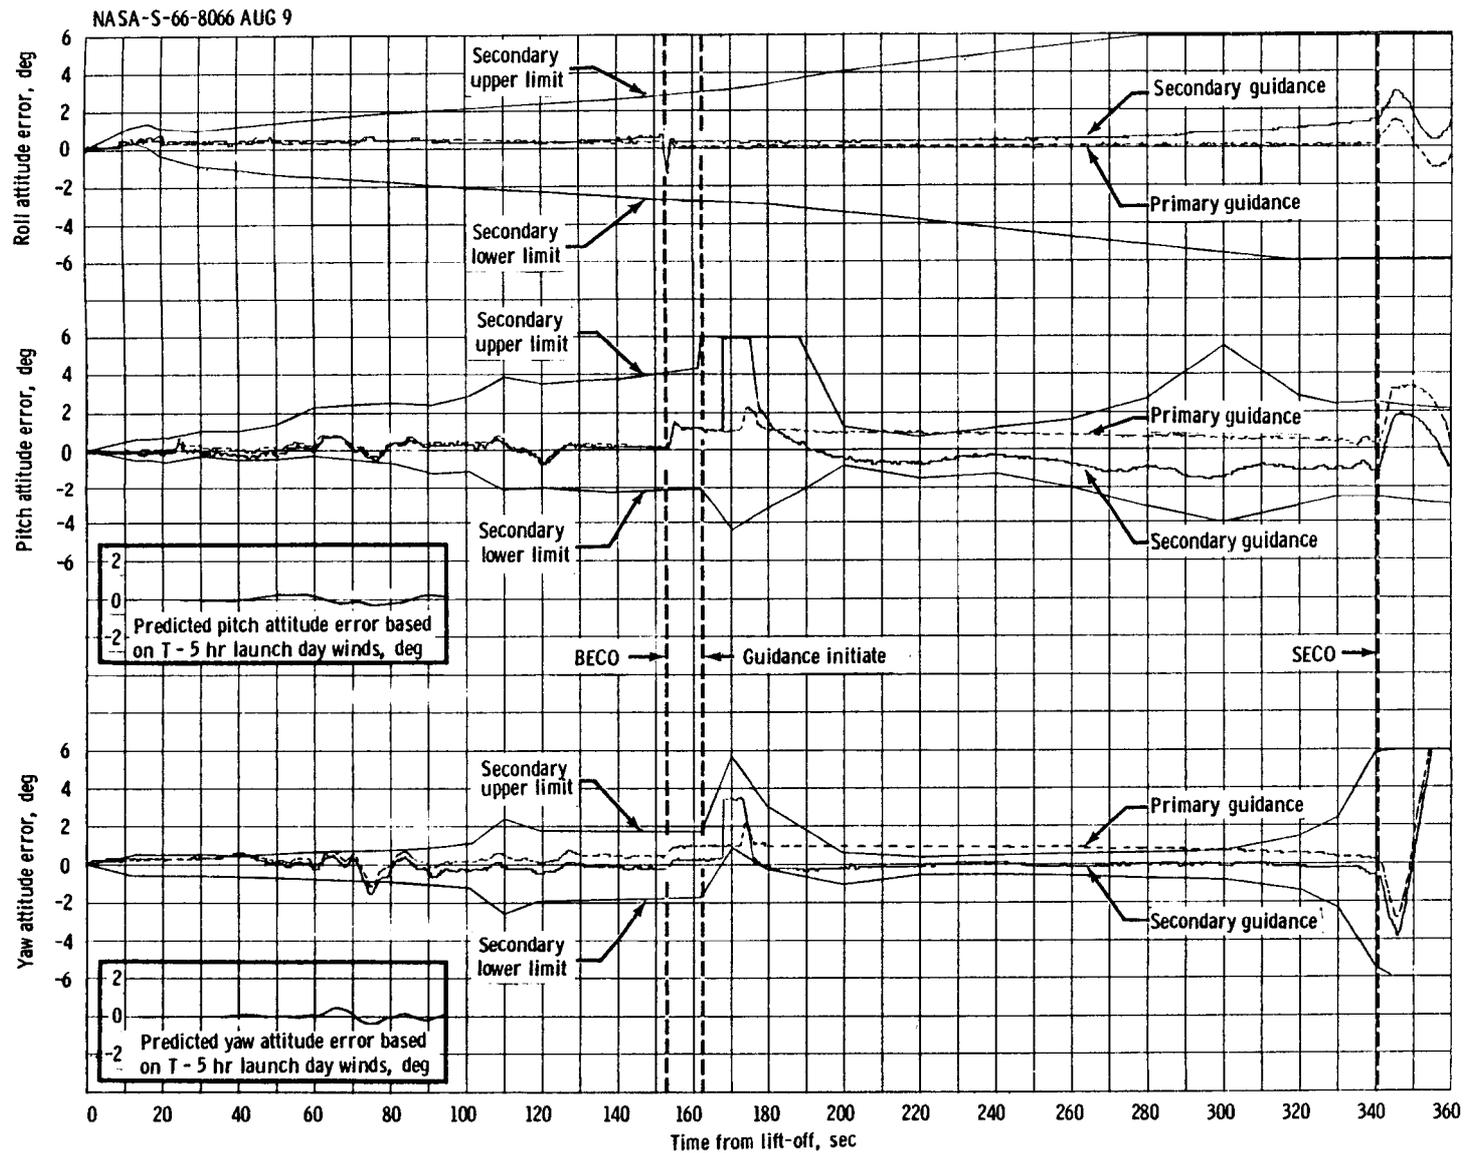
Figure 5.1.5-1. - Comparisons of launch vehicle and spacecraft steering errors.

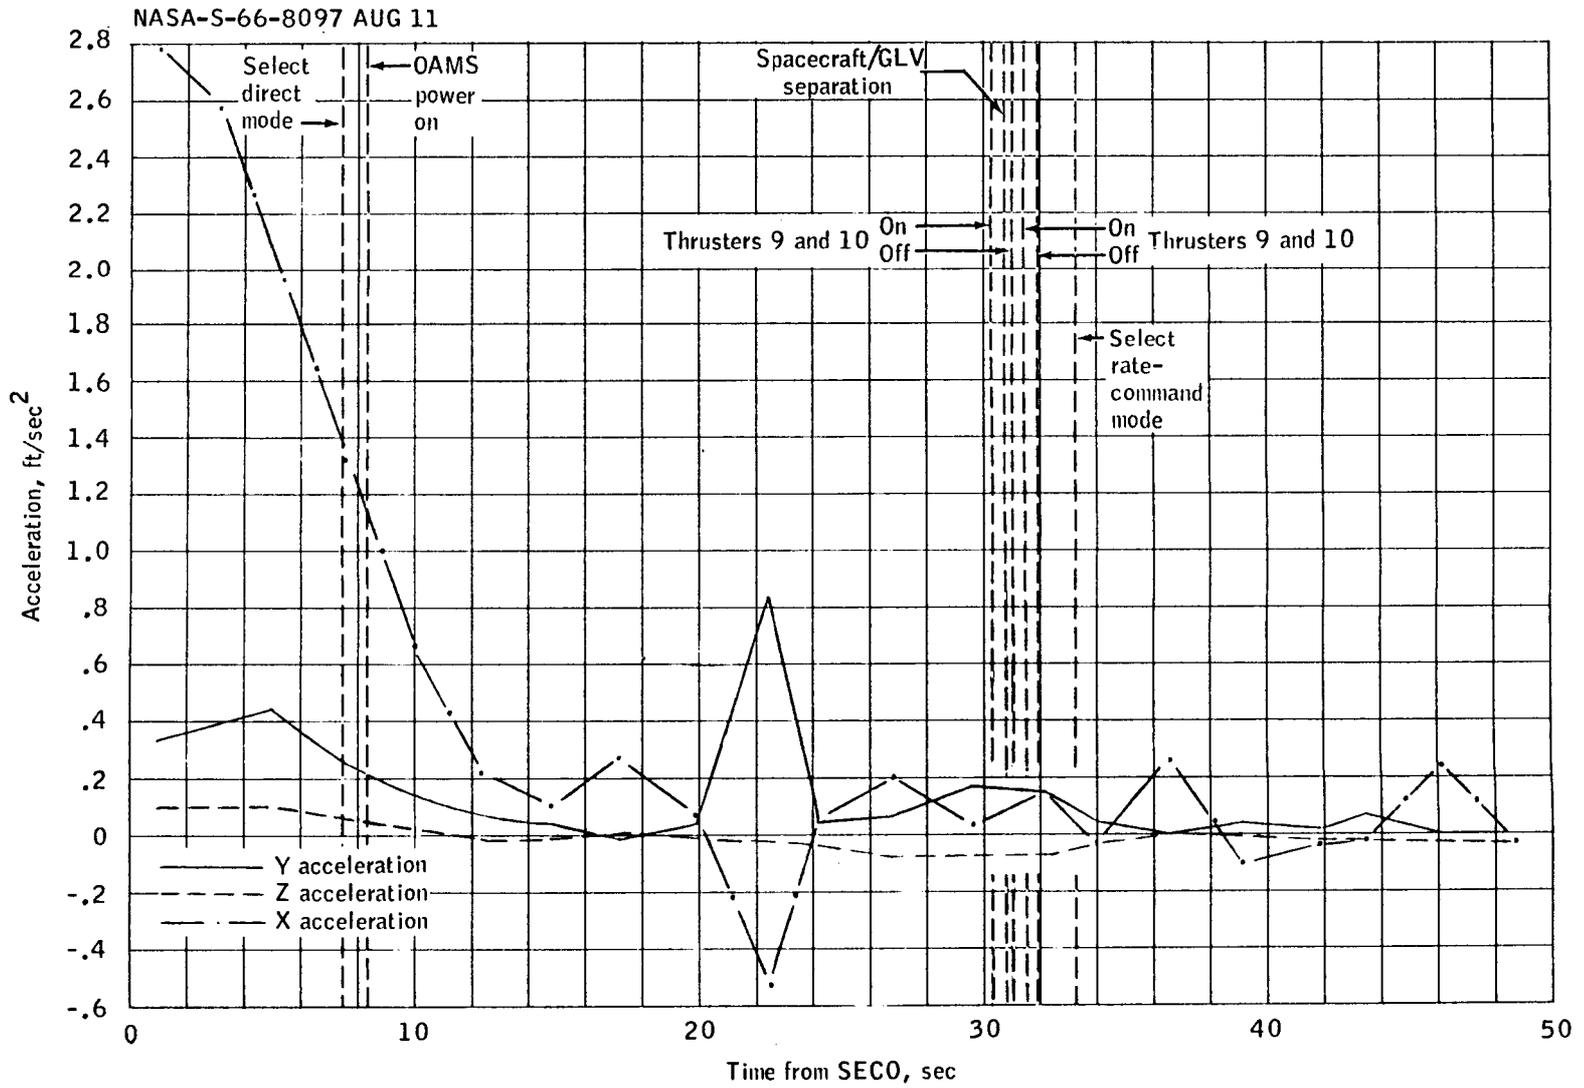
Figure 5.1.5-2. - Spacecraft acceleration measured after SECO.

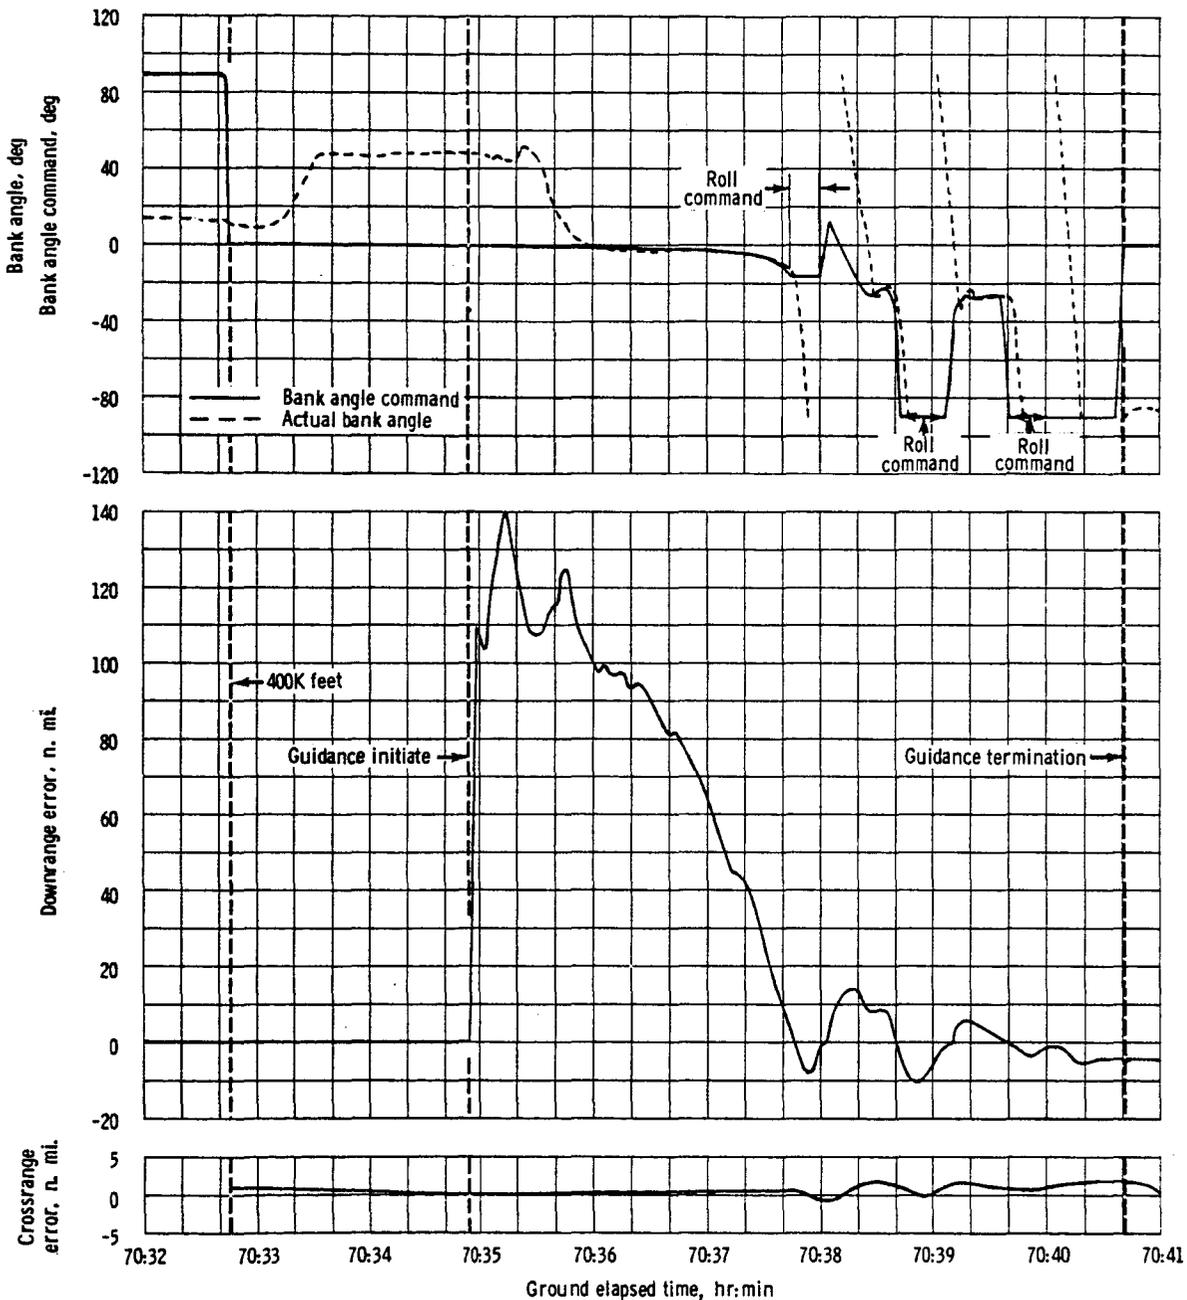
Figure 5.15-24. - Reentry guidance parameters.

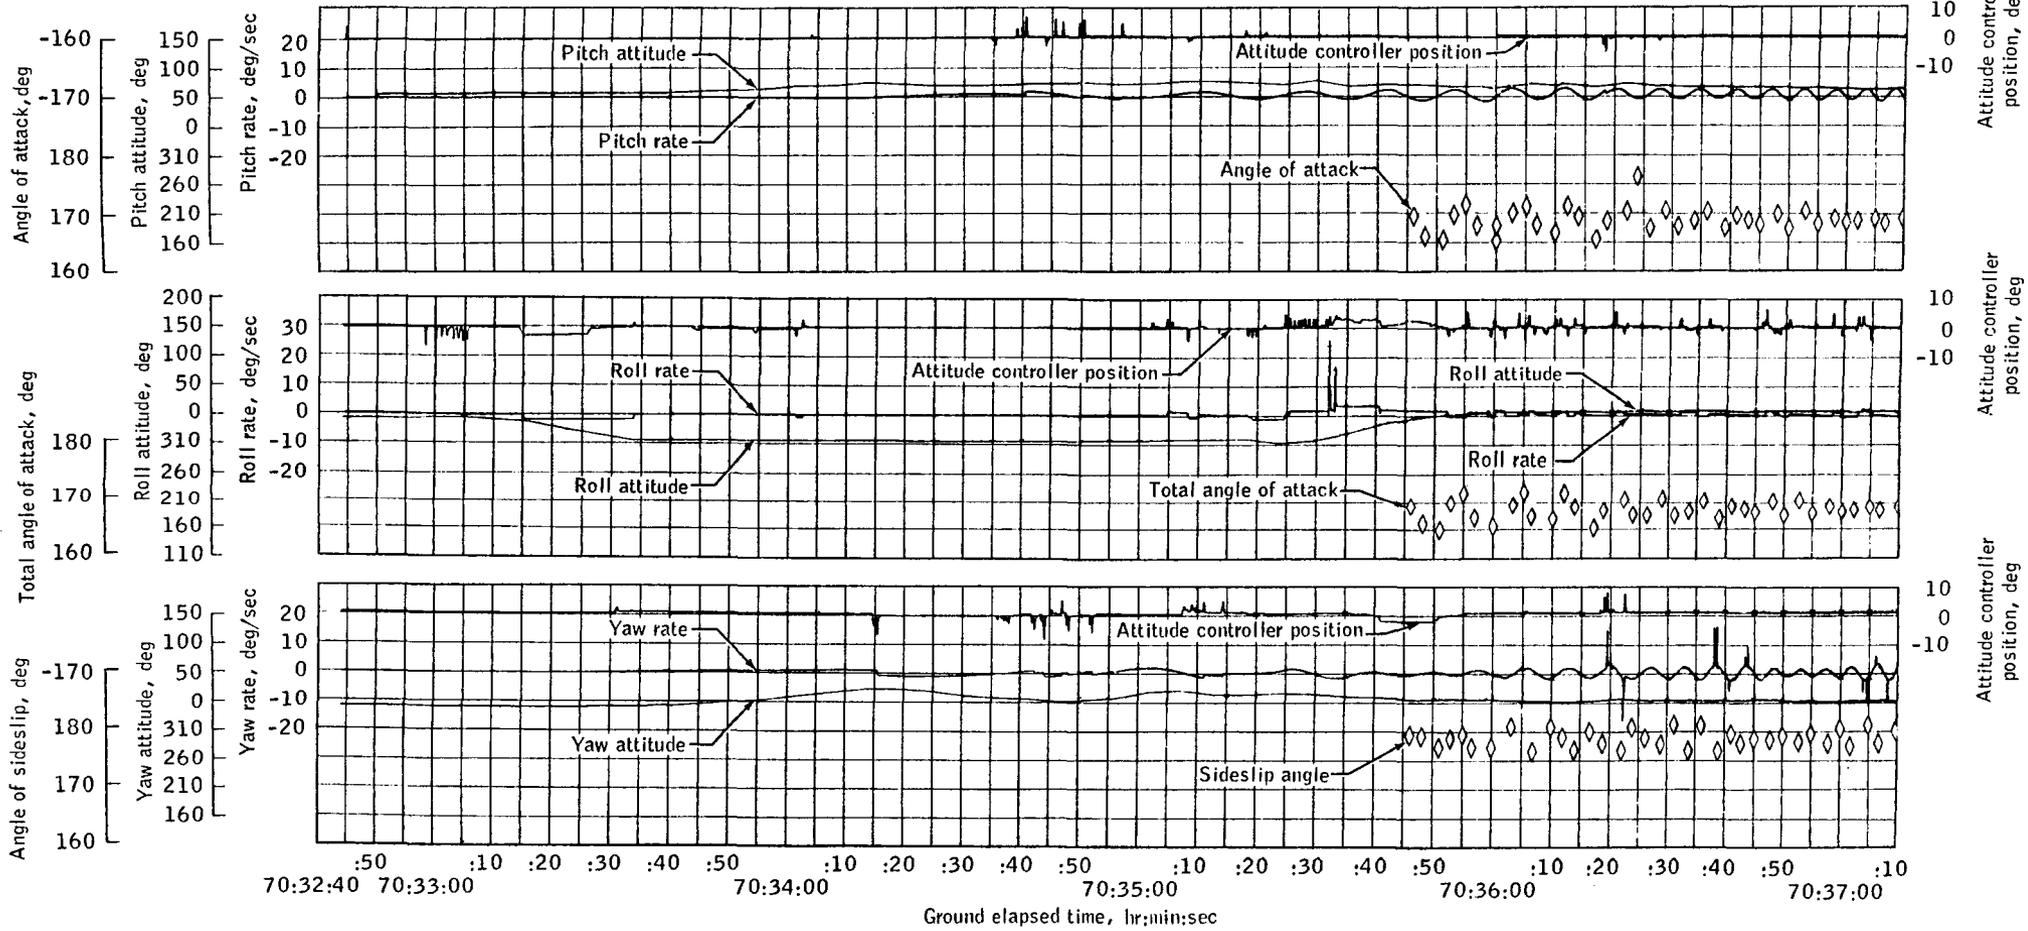
(a) 70:32:40 to 70:37:10 g.e.t.

Figure 5.1.5-25. - Reentry Control System performance.

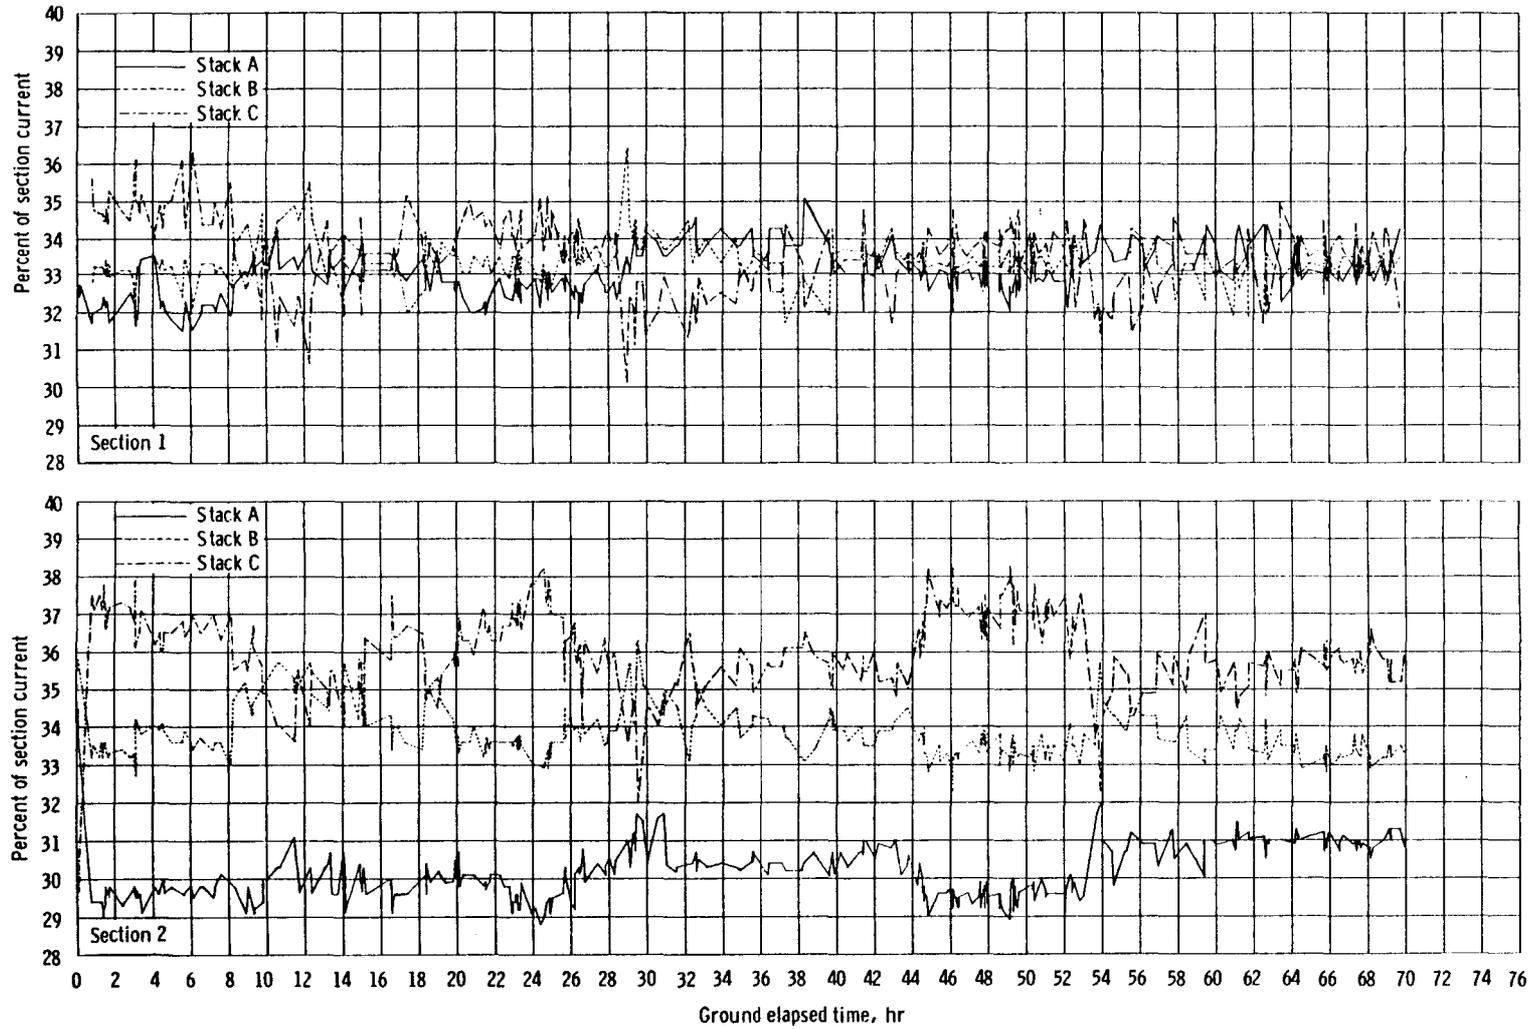
Figure 5. 1, 7-4. - Load sharing between fuel-cell stacks.

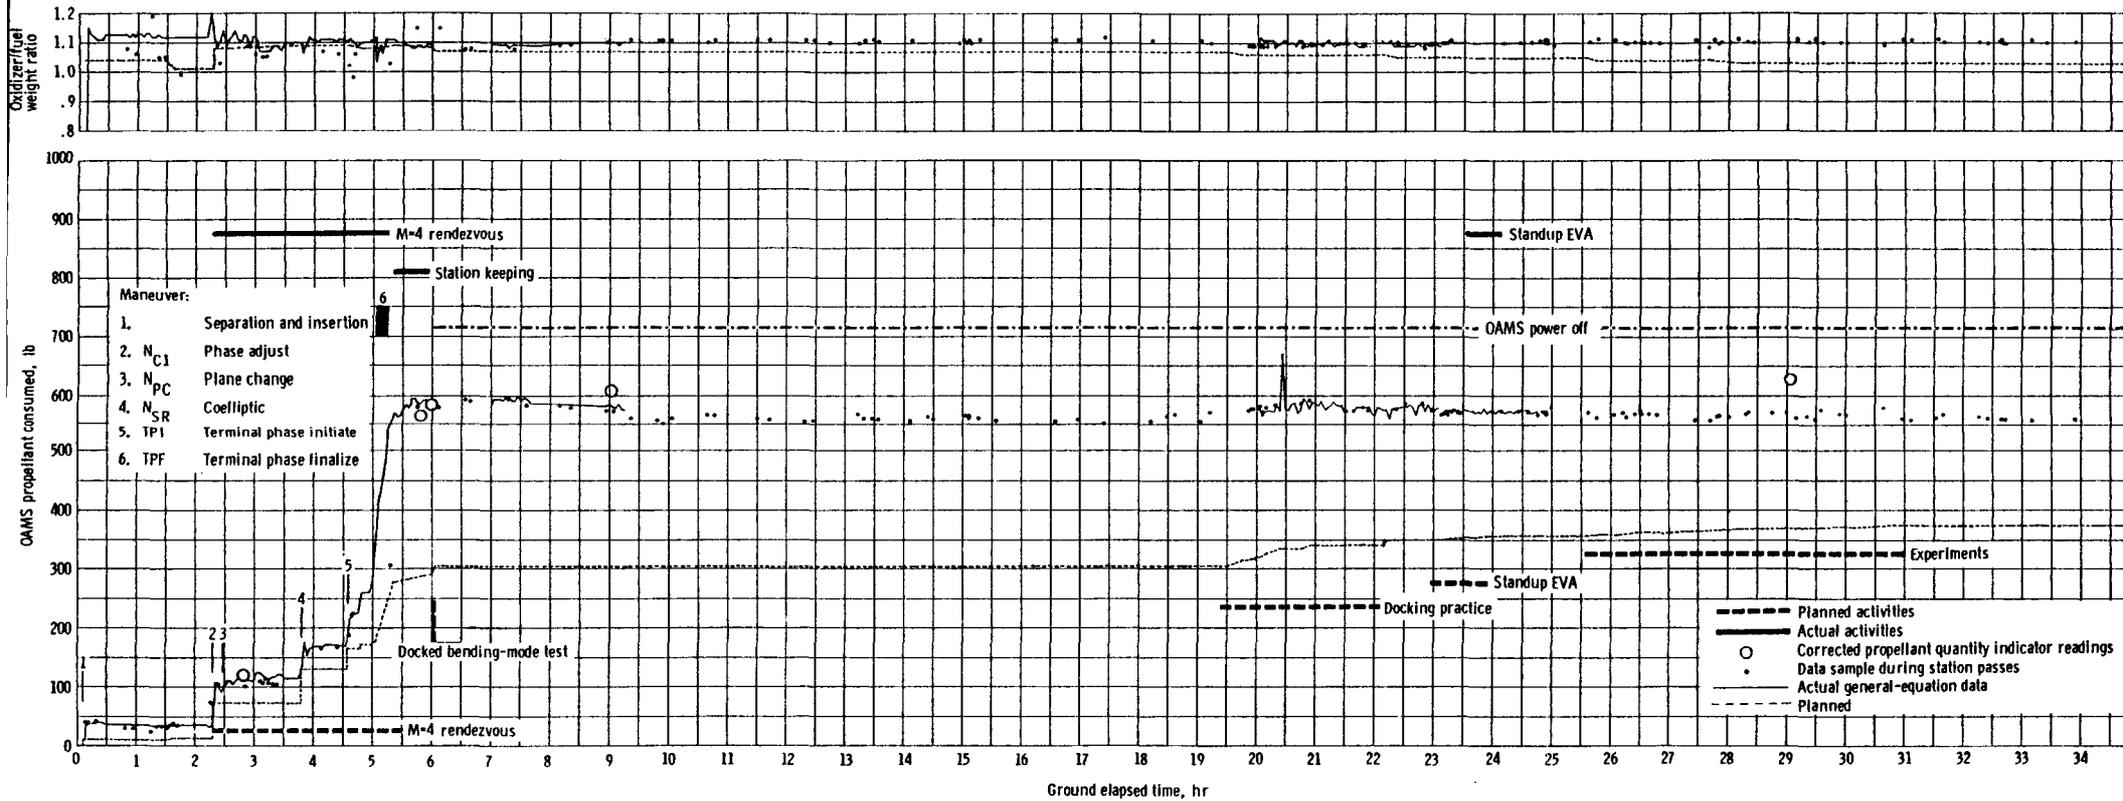
(a) 0 to 35 hours g.e.t.

Figure 5.1.8-1. - OAMS propellant consumption. 5-74-a

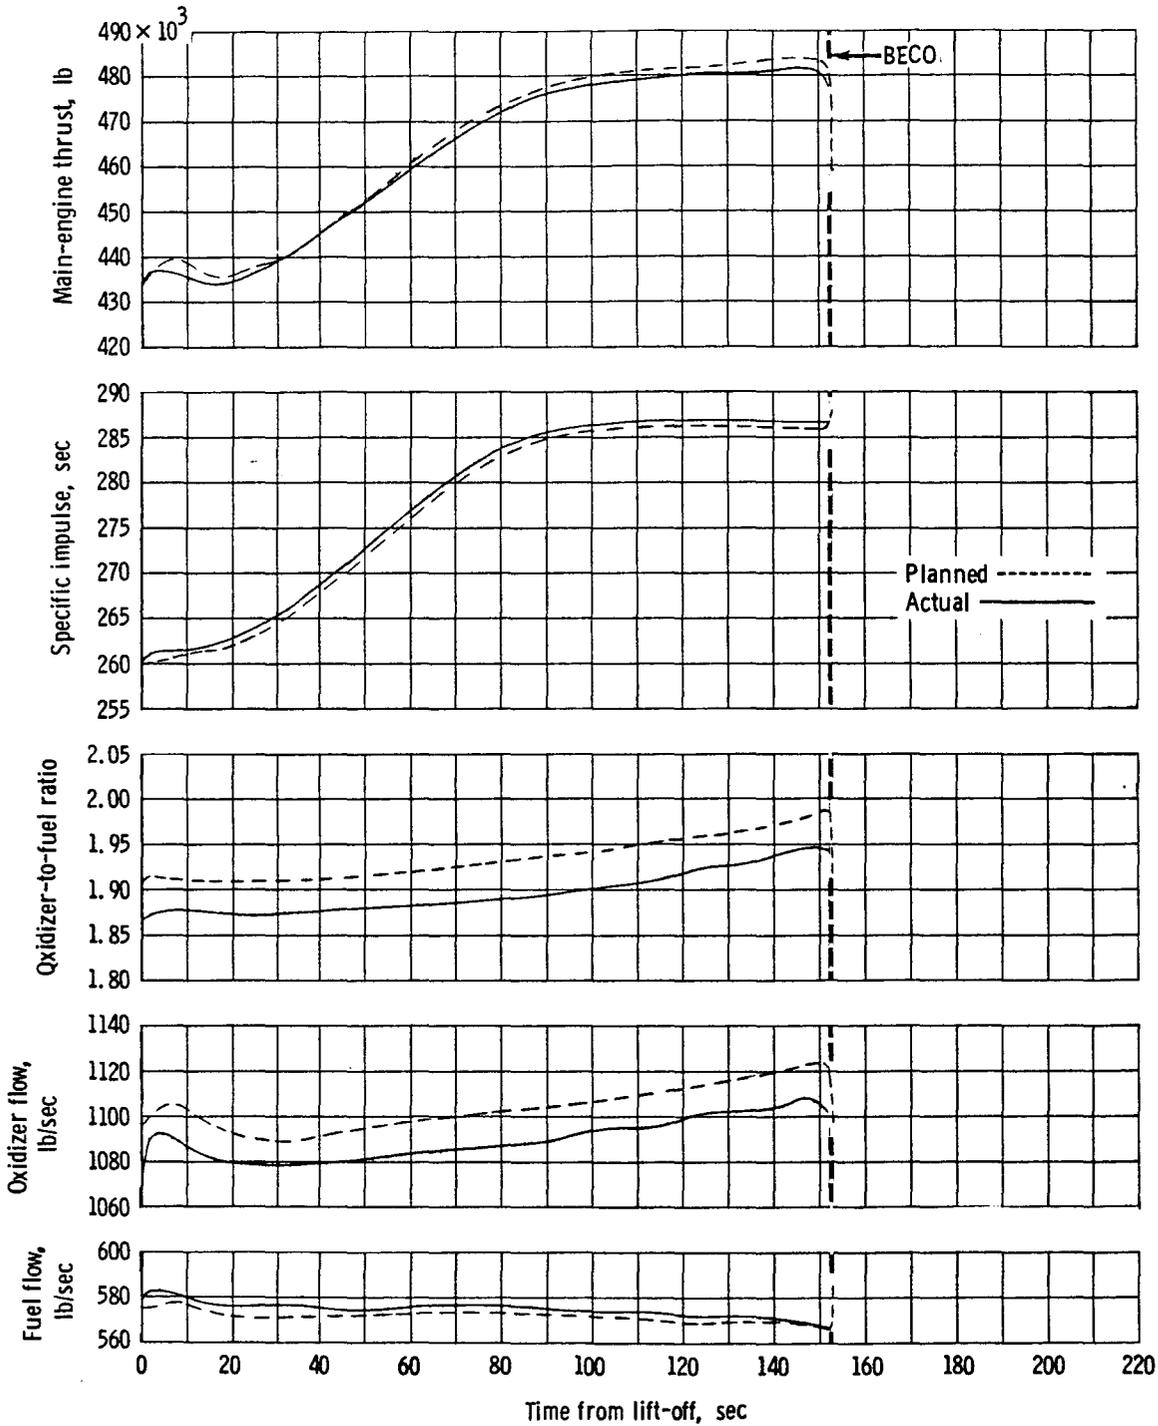
Figure 5.2-1. - Stage I engine performance.

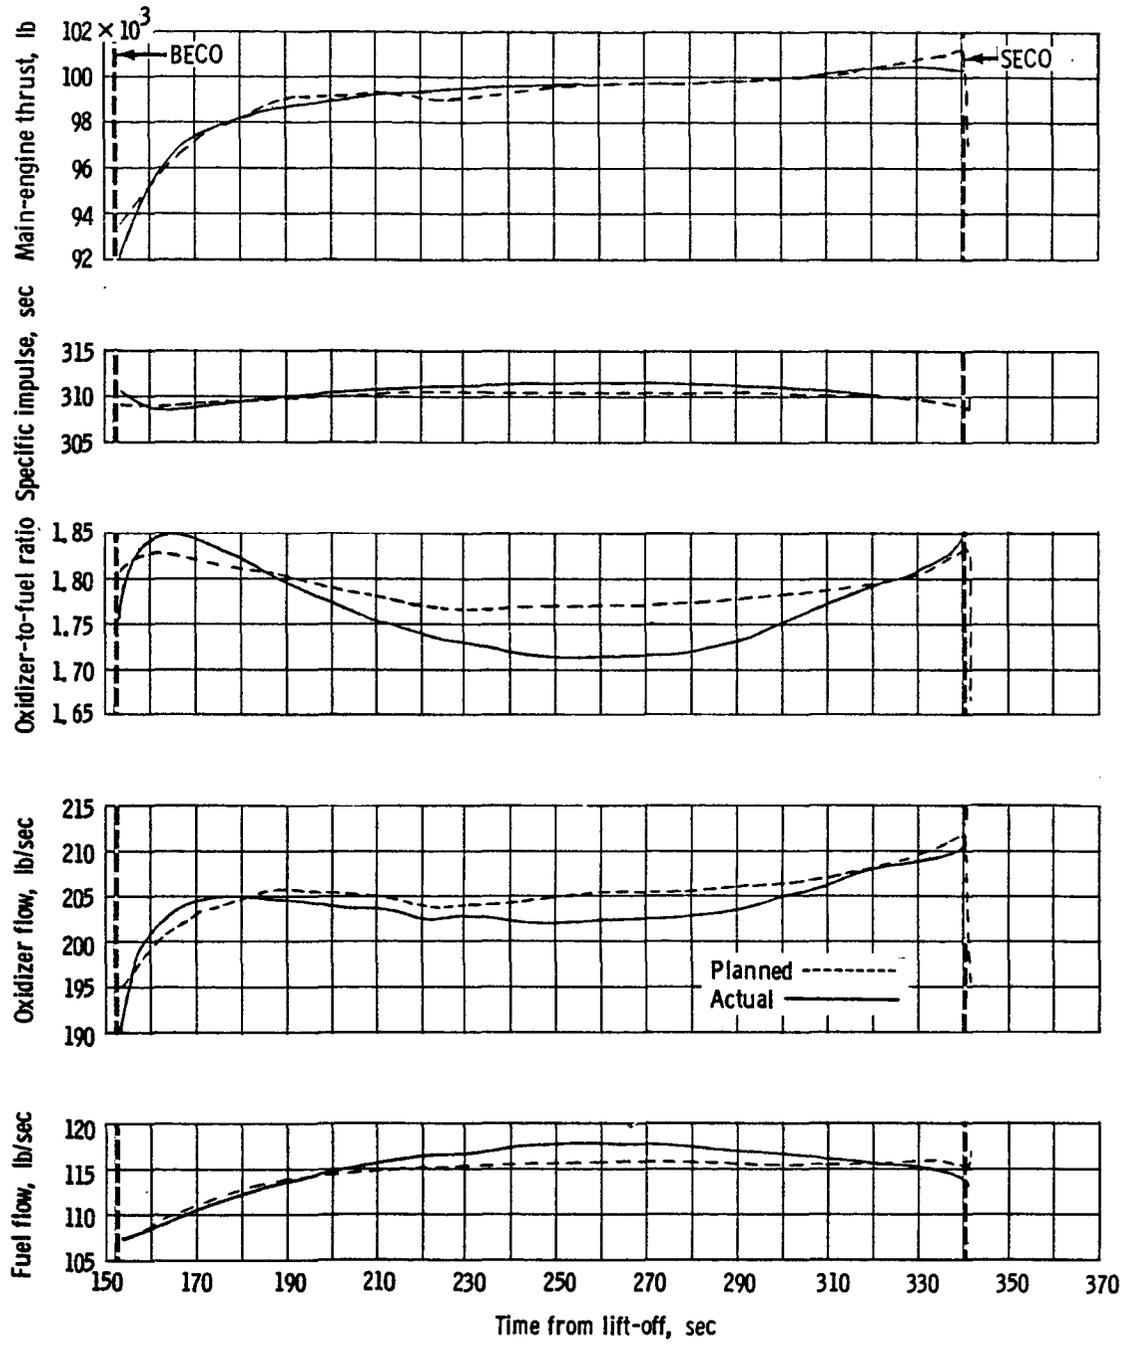
Figure 5.2-2 - Stage II engine performance.

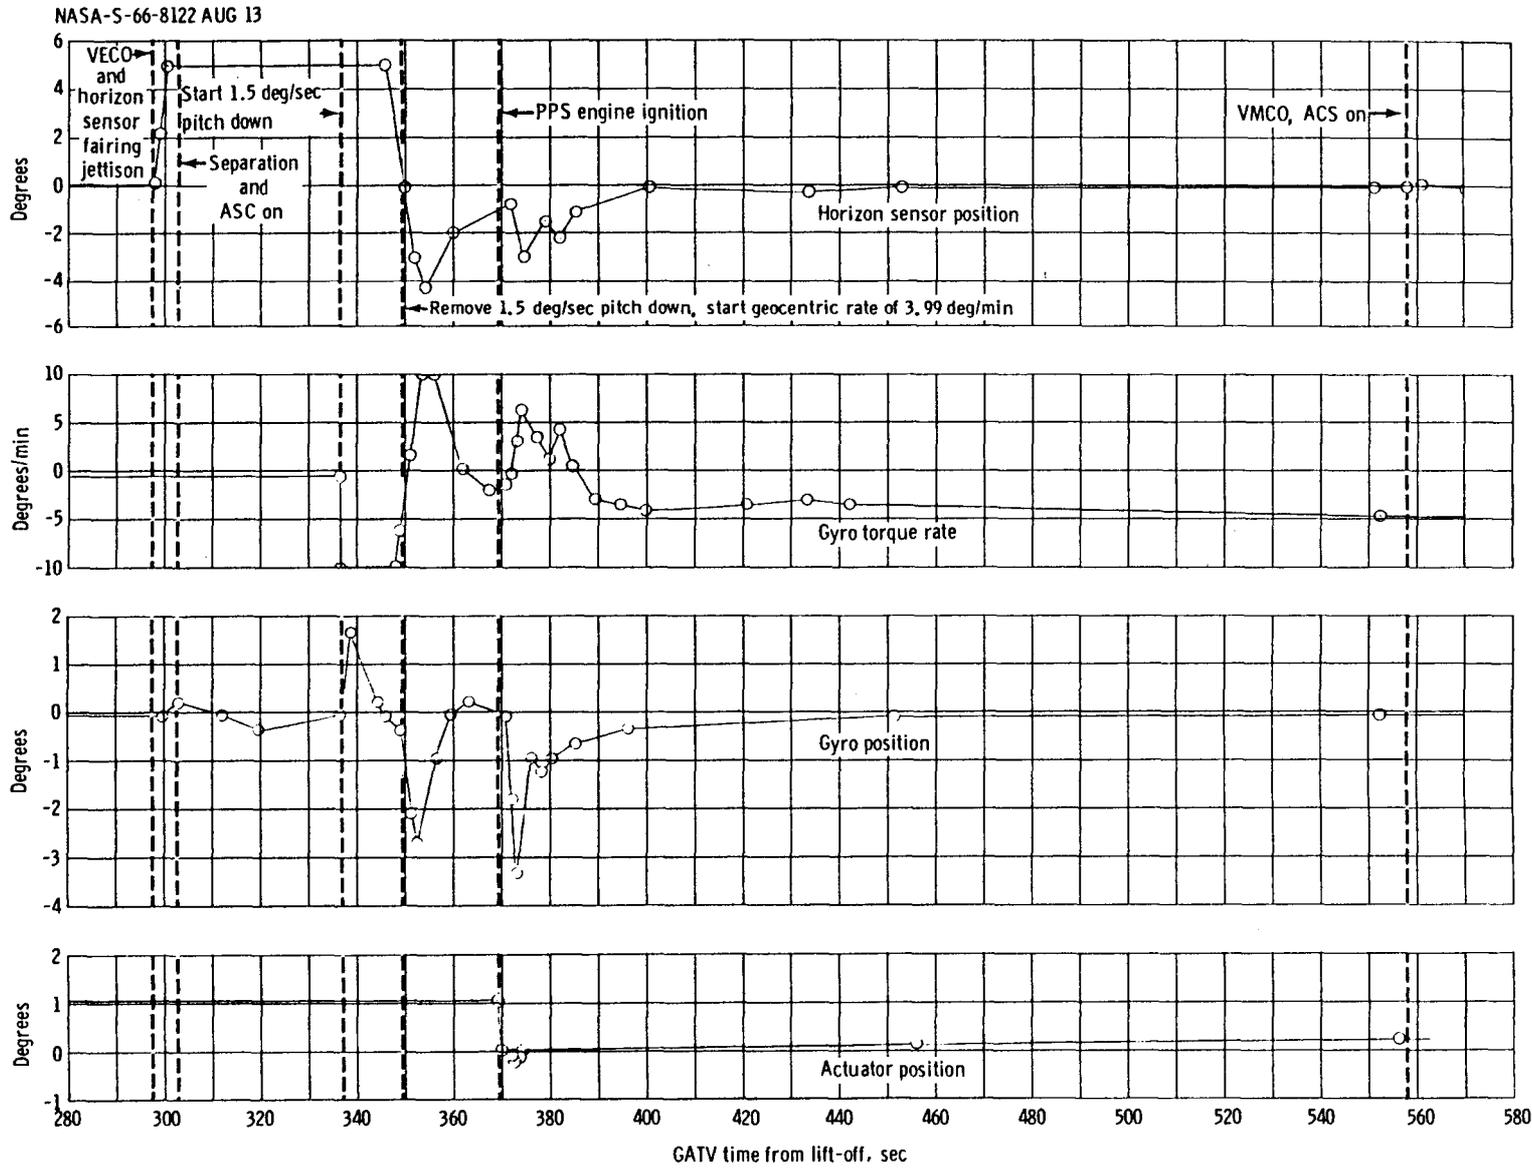
(a) Pitch axis.  
Figure 5.4-3. - Ascent guidance performance.
