# GEMINI PROGRAM MISSION REPORT

# GEMINI X

AUGUST 1966

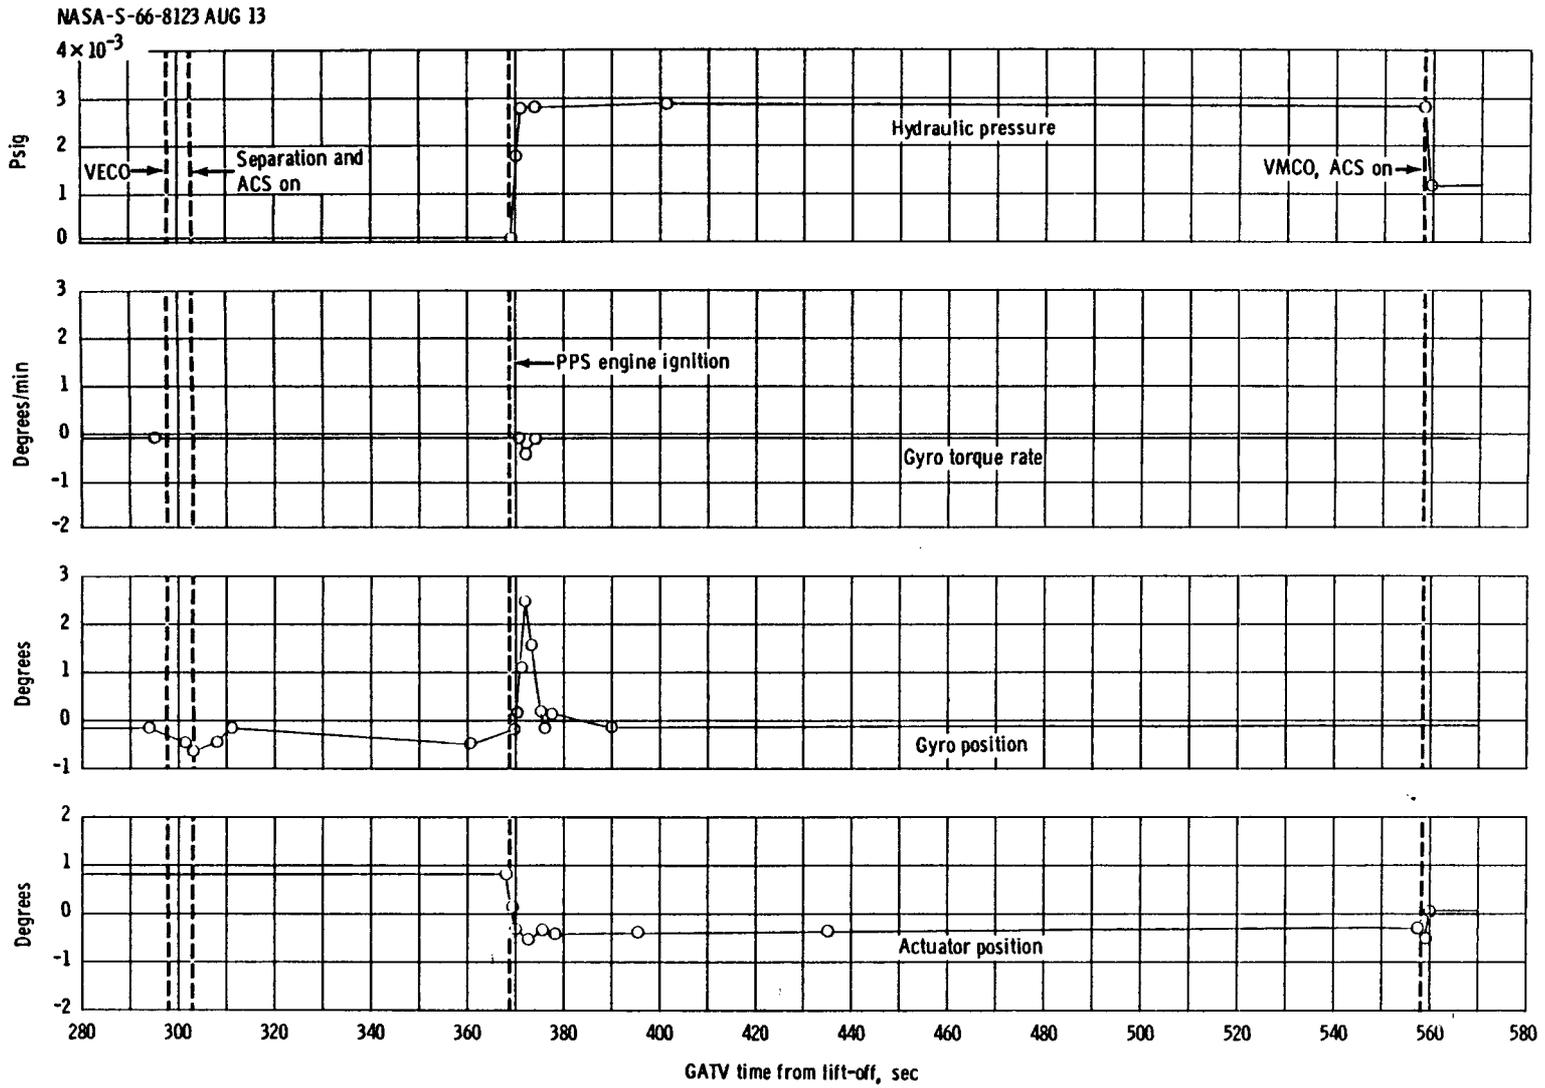
(b) Yaw axis.

Figure 5.4-3. - Continued.

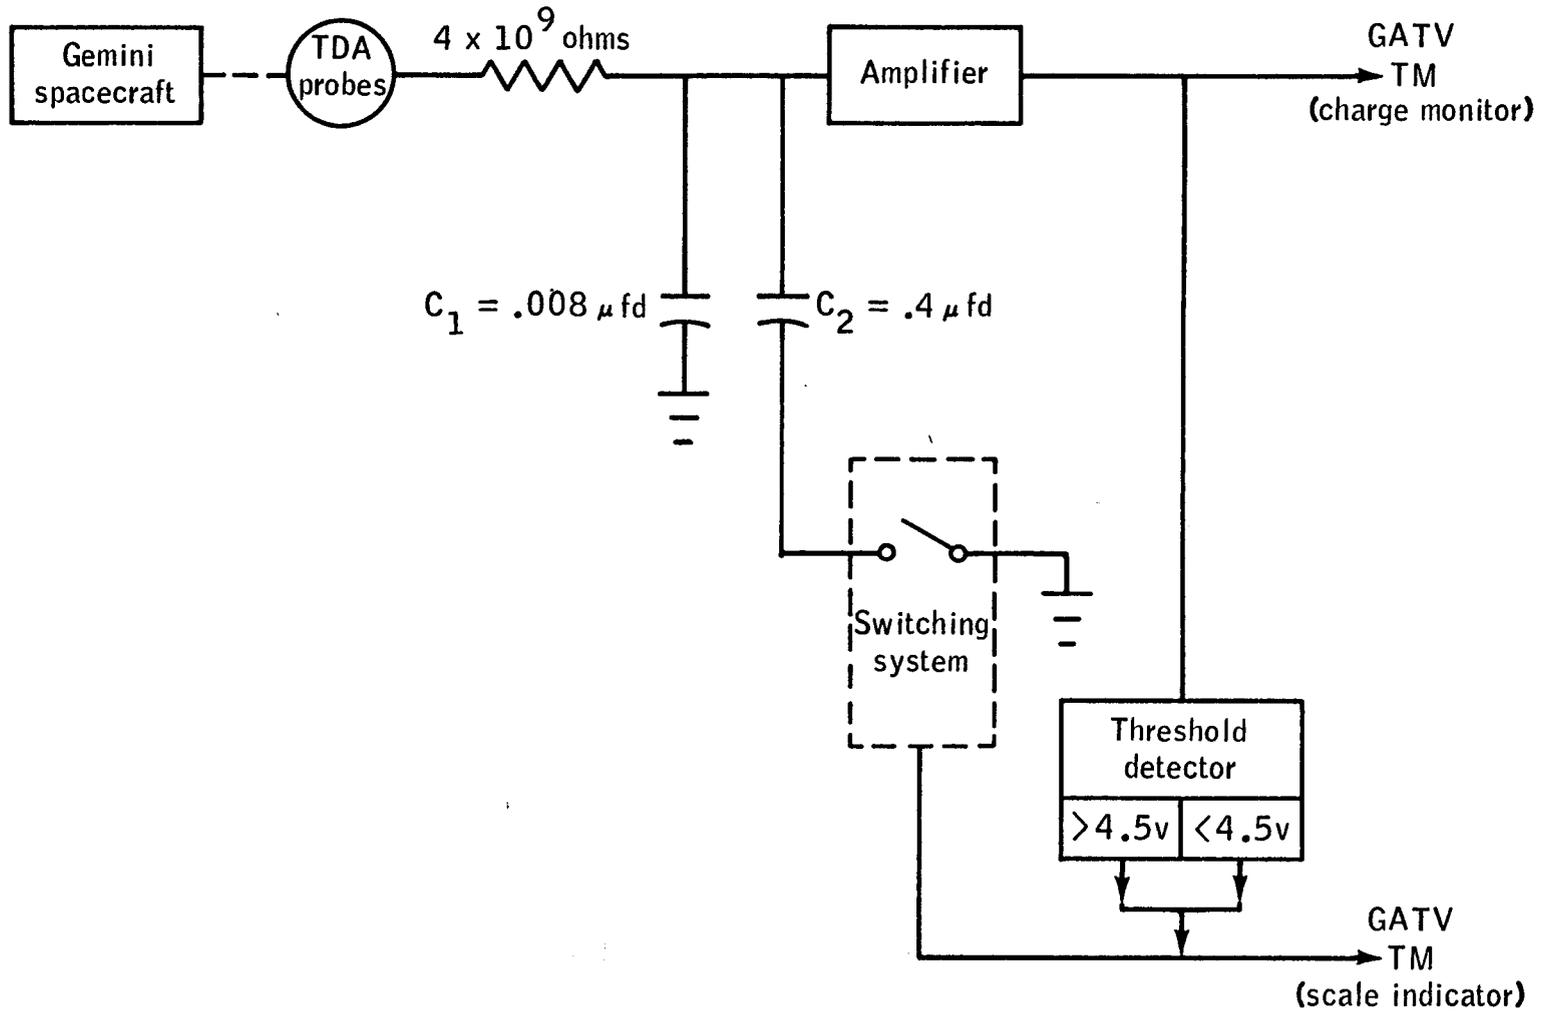
Figure 5.7-1. - Electrostatic charge monitor functional diagram.

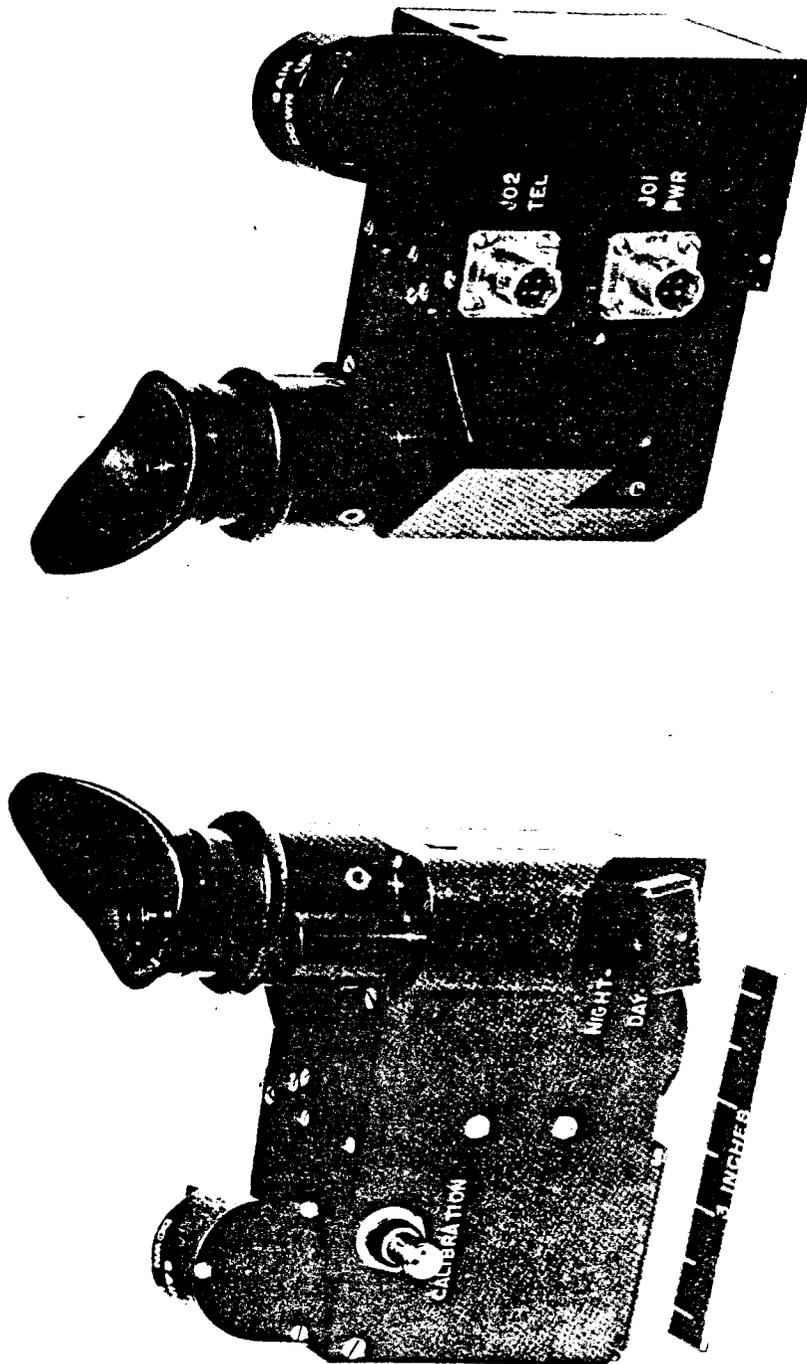
Figure 8.1-1. - Experiment D005, star occultation photometer.

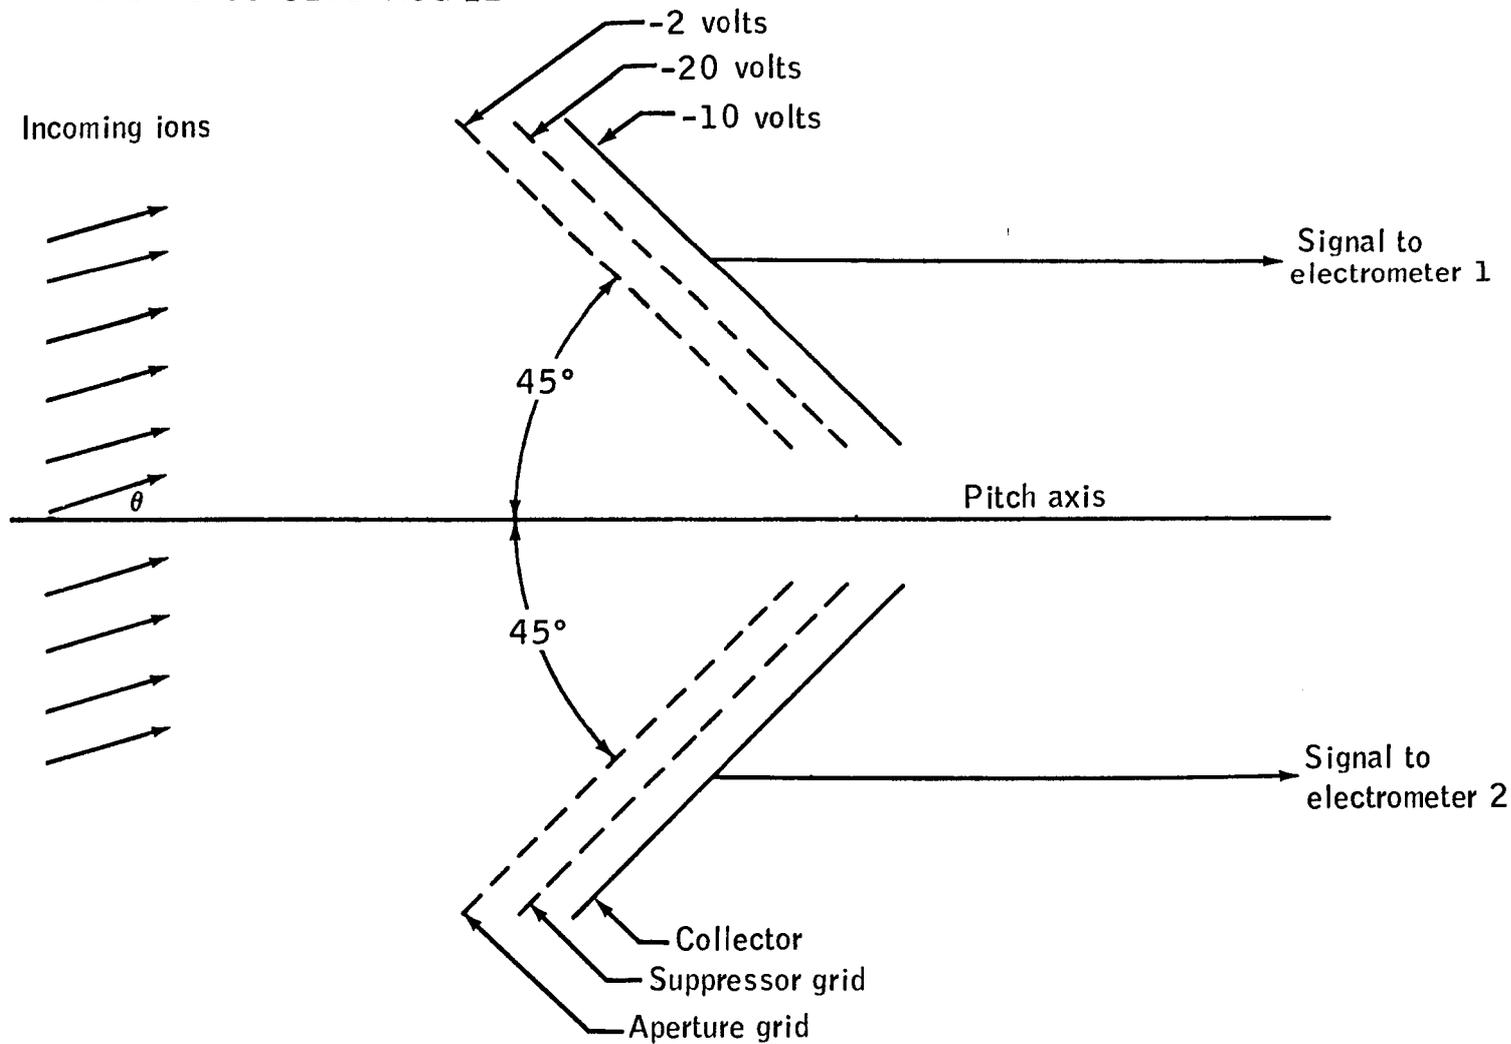
Figure 8.2-2. - Experiment D010, ion-sensing configuration.

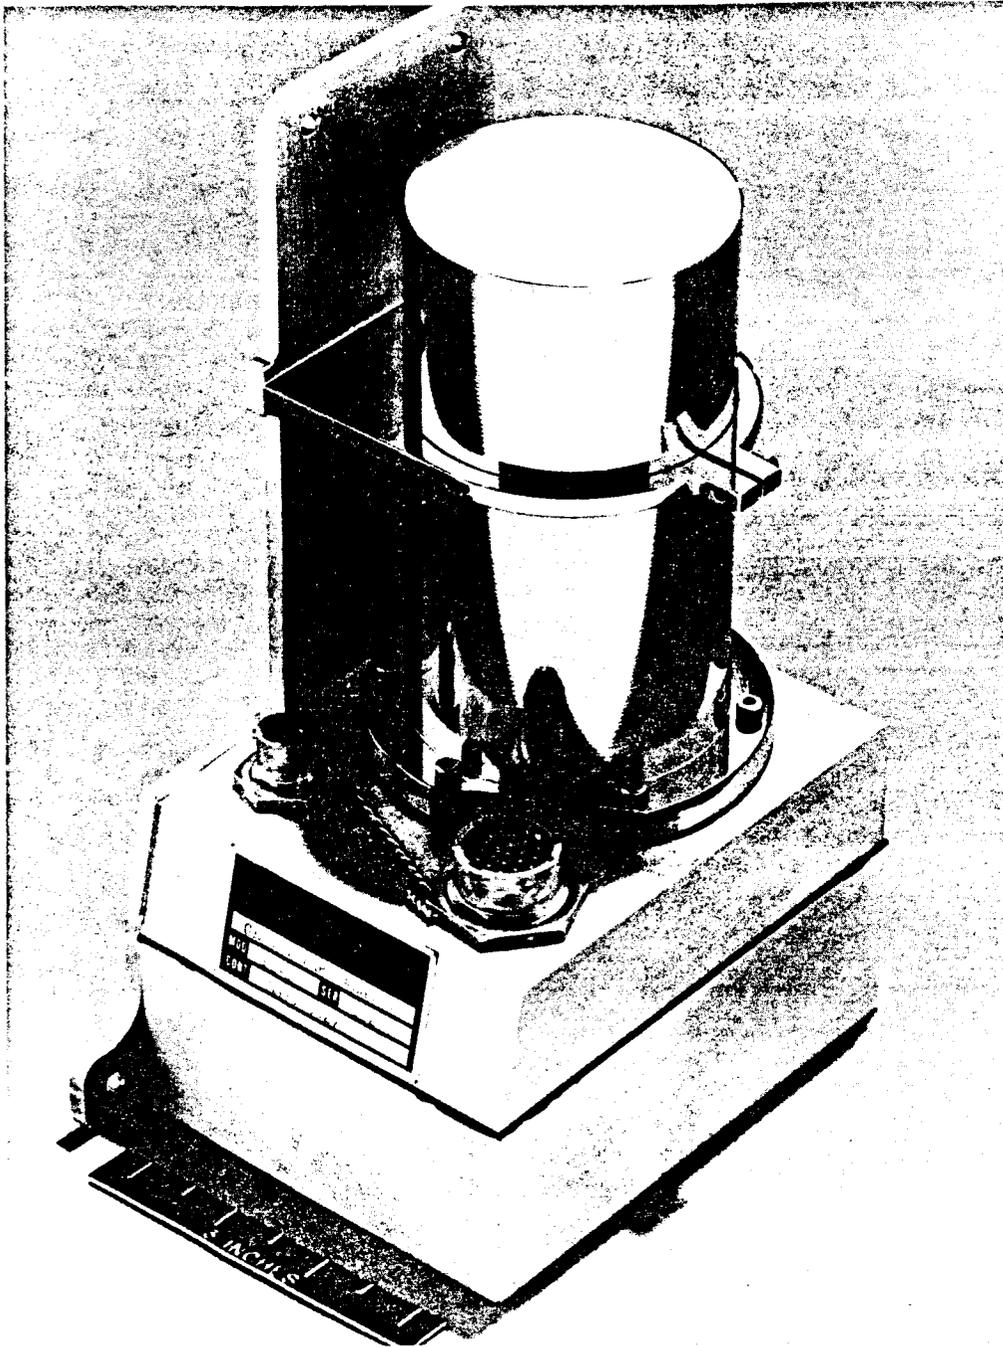
Figure 8.5-1. - Experiment M409, bremsstrahlung spectrometer.

A few spectra were observed during post-pass telemetry dumps at the Hawaii ground station. These spectra indicated that the spectrometer functioned as expected. The computer data processing will consist of reconstruction of spectra as a function of spacecraft time and path. The reconstruction will involve decompressing transmitted numbers, adding sensor efficiency, dead time, and calibration factors, and correlating spacecraft attitude and position. The final results of the experiment will be determined after data from several complete revolutions are processed and analyzed.

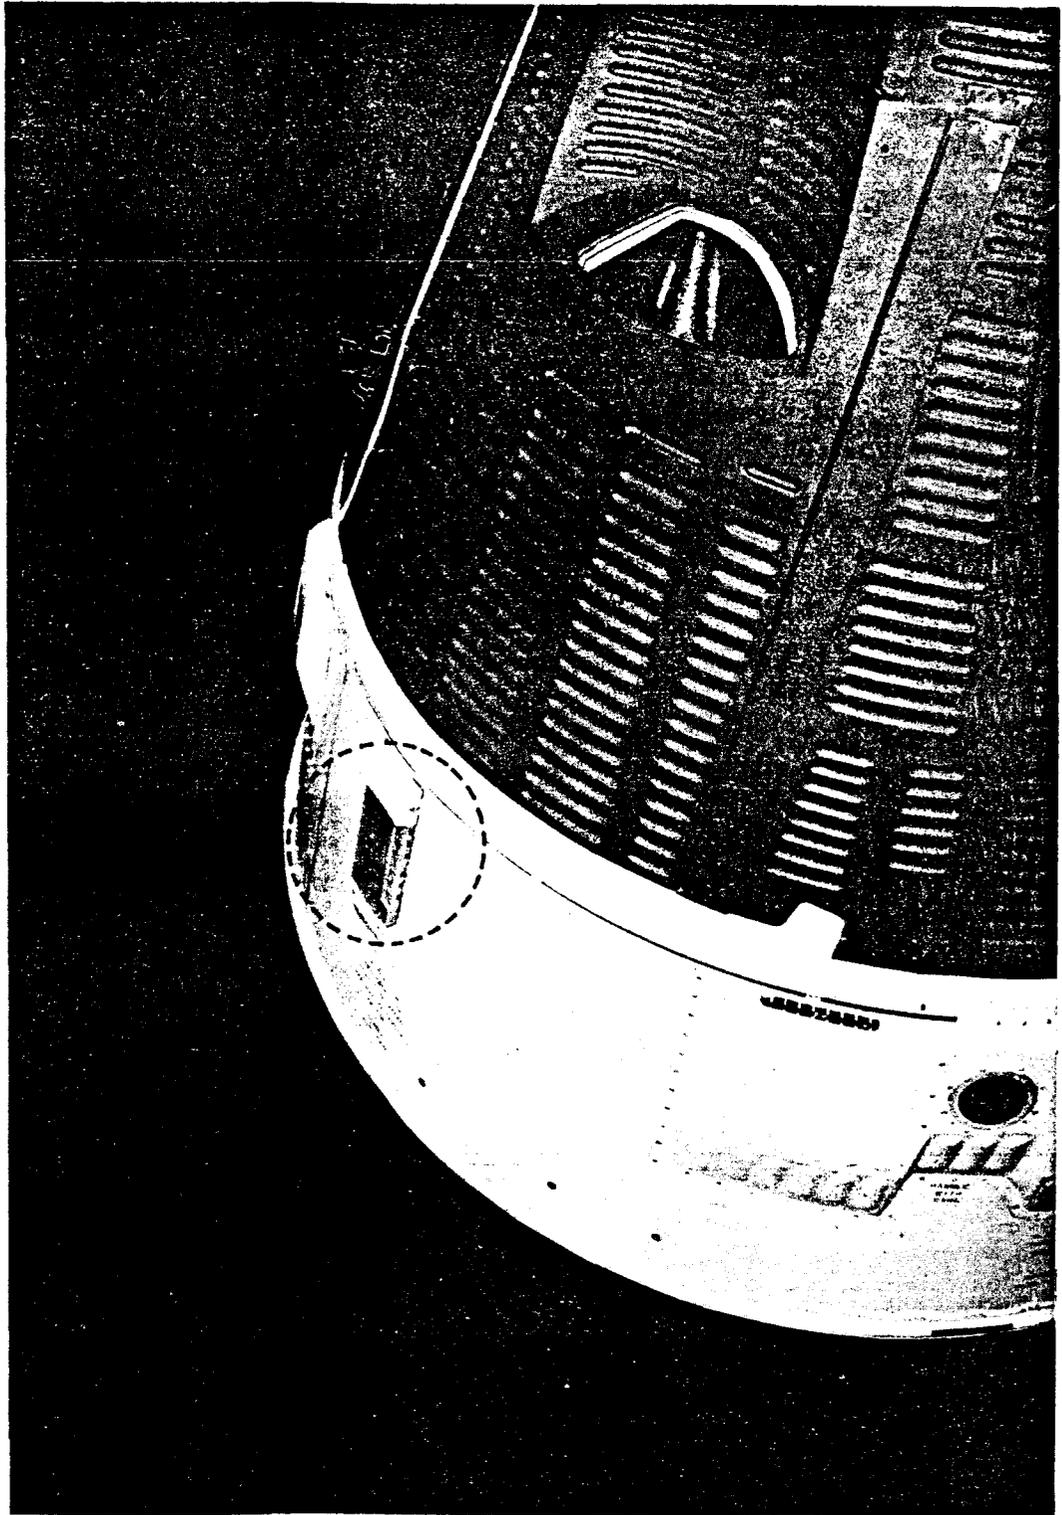
Figure 8.12-1. - Experiment S012, hardware location.

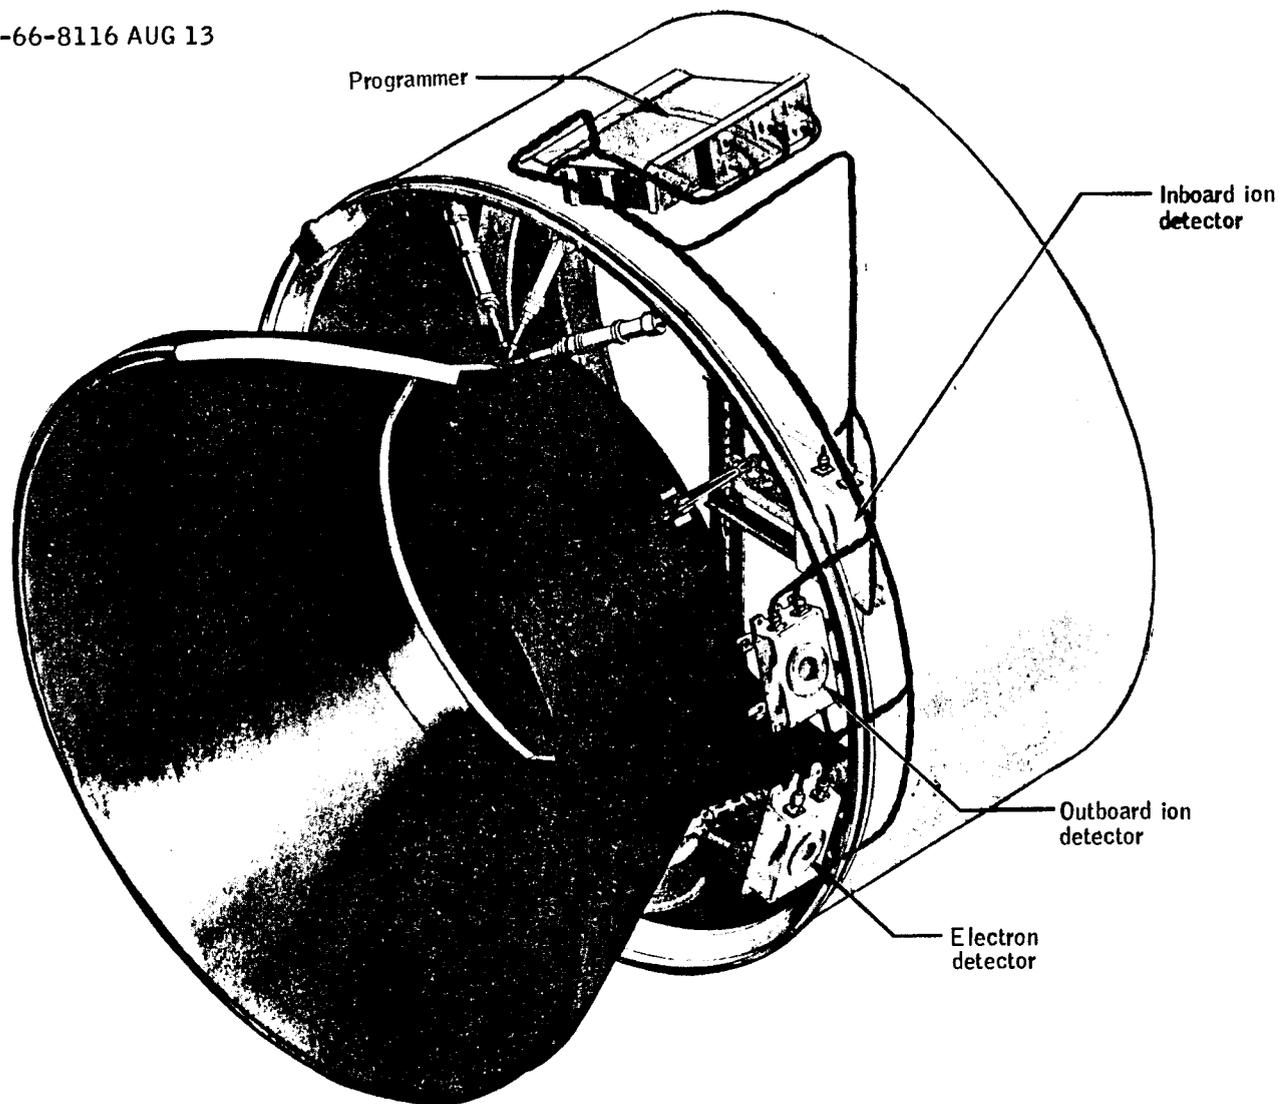
Figure 8.14-1. - Experiment S026, configuration on Target Docking Adapter.

Spacecraft wake structure has been observed out to a distance of 100 feet from the vehicle. Some oscillatory behavior in the wake structure was observed. The theory of Gurevich and other Soviet scientists predicted an oscillatory wake structure. It is not clear at this point whether these S026 observations are the result of spacecraft motion in and out of the wake or represent a confirmation of the Gurevich theory.

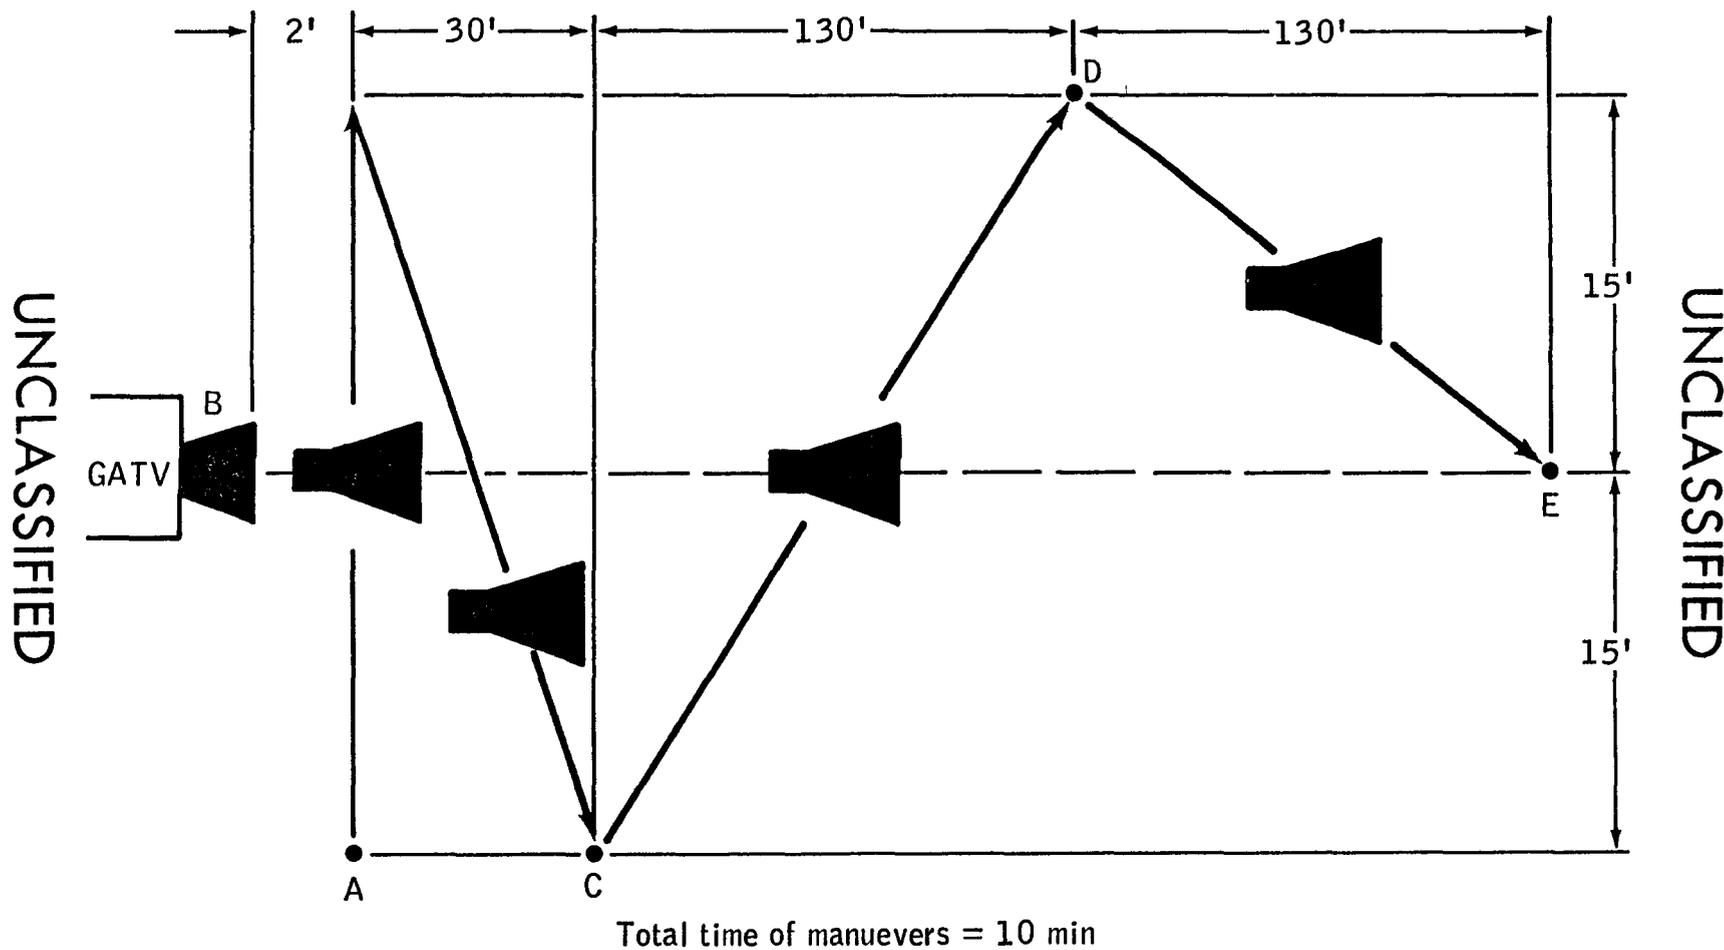
Figure 8.14-3. - Experiment S026, Gemini undocking maneuvers for ion-wake measurements.
