# Human Spaceflights

International Flight No. 68

## Soyuz 33

## USSR

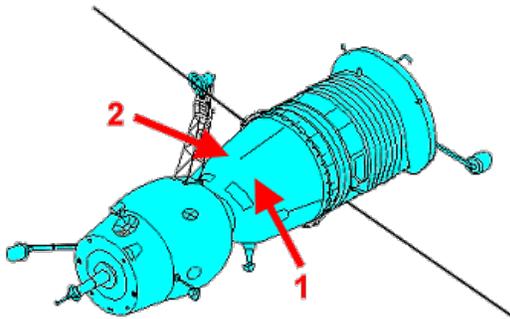
## Crew seating arrangement

Launch	
1	Rukavishnikov
2	Ivanov

Landing	
1	Rukavishnikov
2	Ivanov
