August 2016–May 2017 • Volume 9, Issue 1 (Published since 2009), June 16, 2017 Second Special Edition on Electrostatic Discharge (ESD)

ESD, the Silent Killer—

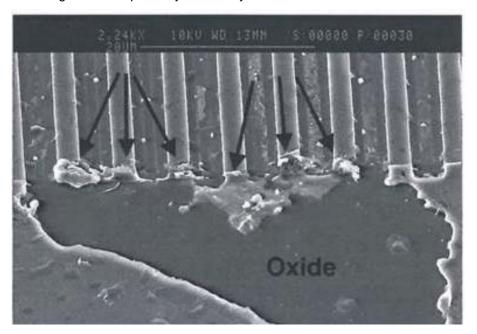
Figure 1 is an example of damage that was probably caused by ESD.

Fig. 1. Detailed view of a damaged site on a metal oxide semiconductor field-effect transistor (MOSFET) probably caused by ESD.

Below are a few examples of some metallic oxide semiconductor field-effect transistor (MOSFET) devices that were damaged during the assembly of a recent space flight International Space Station (ISS) support instrument box. The parts were received, in ESD protective packaging and not removed until board-level assembly soldering took place. The failed board-assembly-level verification and the ensuing troubleshooting ruled out design or operational issues. The suspect parts were removed, tested, and shipped off for failure analysis. Figure 2 shows the PCB assembly with two noted nonfunctional parts circled in red. Although not conclusive, the corner location of damaged parts on the board was thought to be important to the forensics analysis. One theory implied that handling of the board (by the perimeter) allowed for the ESD event to contact these parts directly. During transport, the board is handled only inside an ESD-approved materials bag. There were questions as to the integrity of these transport bags. Due to bag traceability and reuse issues, there was no definite conclusion on this concern.

Figures 3 thru Figure 7 Show the die and damage areas from various photographic and radiographic perspectives. During upper-level assembly circuit troubleshooting, the potential for design or operational damaging voltages to the MOSFET gates were conclusively ruled out. The circuit was incapable of generating the necessary damaging voltages that would have the effect observed.

The conclusion of this ESD failure investigation was that failure was attributed to user error but review of all ESD compliance logs showed that all precautions were taken during operator handling. Due to lack of further evidence, the OCM and the PCB assembly operation were not ruled out as possible culprits, but neither could be confirmed.

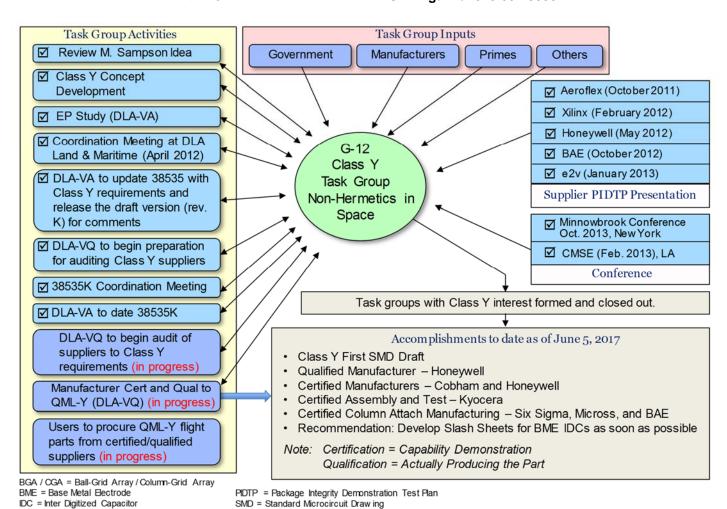
But, it didn't fit any of the existing categories. Therefore, NASA worked with the space community to develop a new Class Y. The processes that finally accomplished this infusion of new technology into the QML system are summarized in Figure 12.

Fig. 12. Infusion of the New Class (Y) Technology into the QML System for Space.
