MMS Transporter Fire

Importance of IRT Training

Senior Management VITS Meeting

May 2, 2016

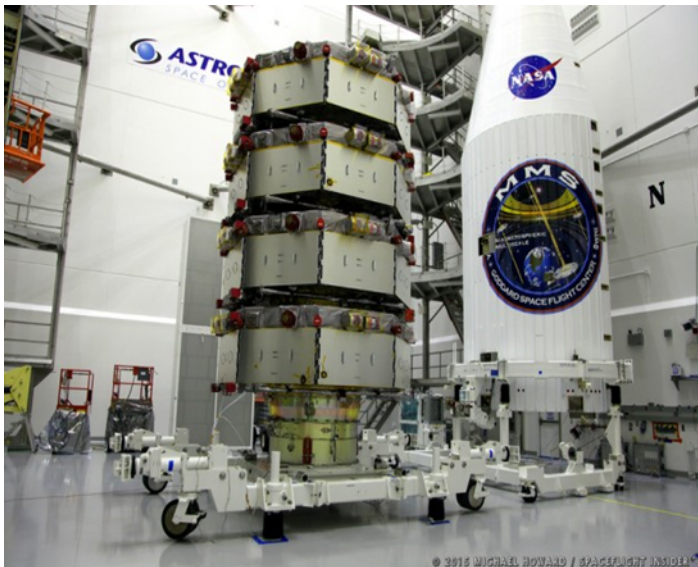
MMS Spacecraft

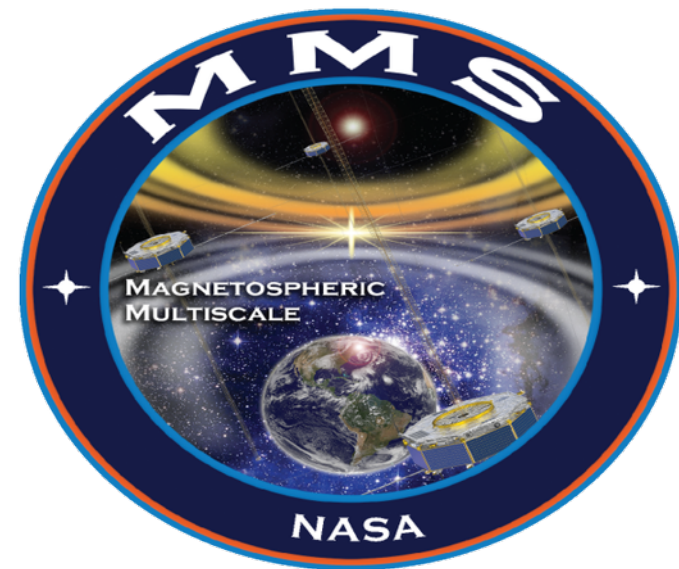
MMS Transport Container and Vehicle

← Simplified movement of contaminants and smoke from fire in ECU

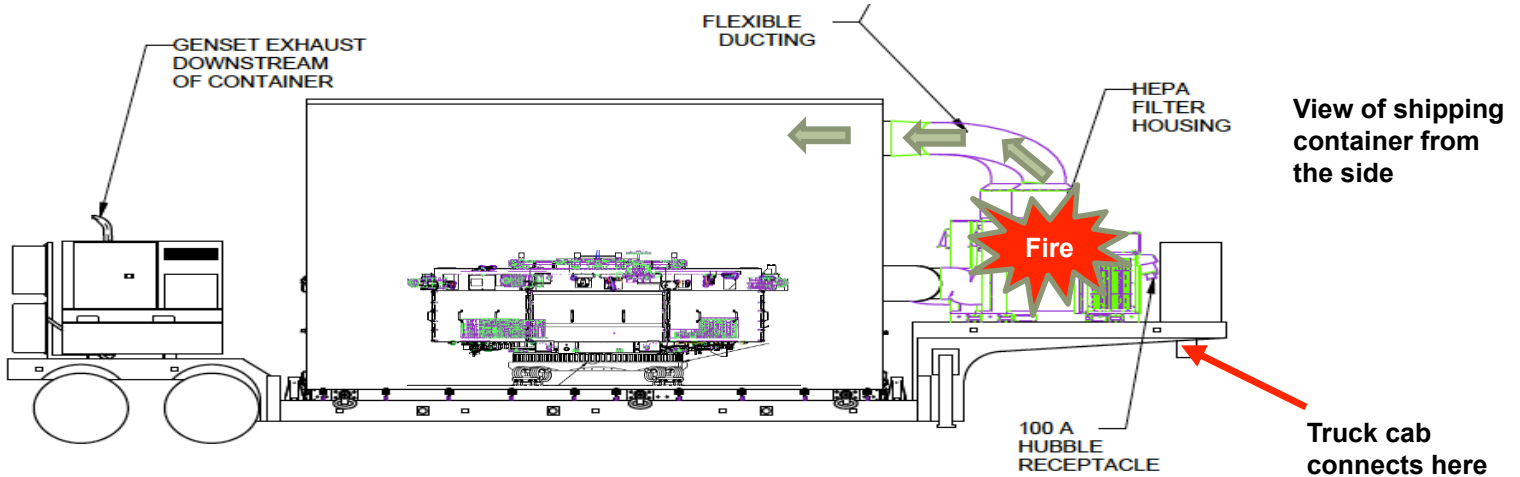
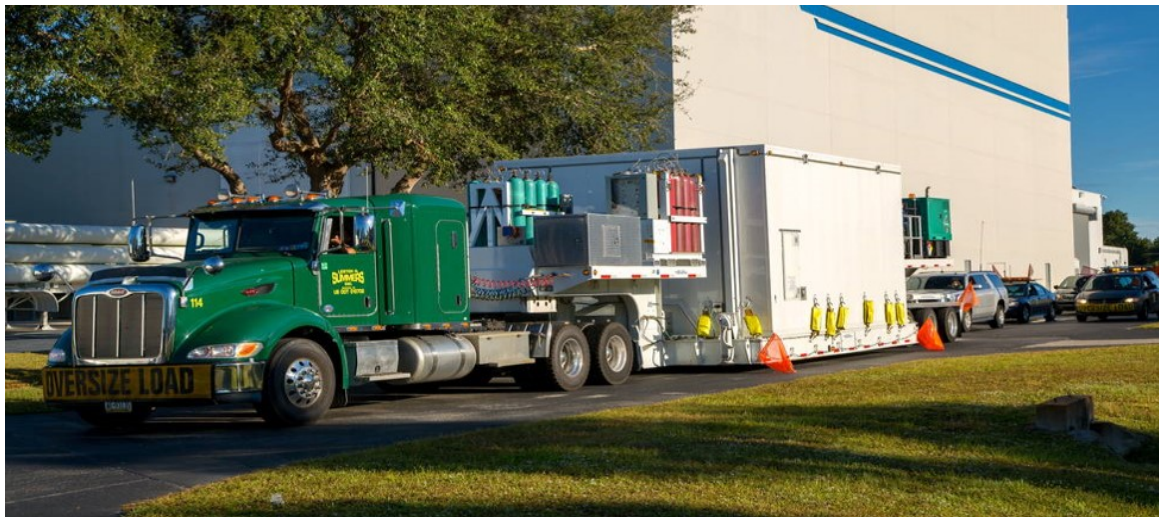
Actual picture of transport vehicle and MMS shipping container

- MMS Spacecraft 1 was transported to NRL (approximately 30 miles) for testing in a shipping container with two Environmental Control Units (ECUs).
 - Once on site at NRL, smoke was observed coming from one of the ECUs.
 - Project personnel already on site at NRL attempted to extinguish the fire with a fire extinguisher.
 - A forklift was then used to remove the ECU from the transporter and place it on the ground away from the shipping container which contained the flight hardware.
 - The NRL Fire Department then proceeded to completely extinguish the fire.
- Interim Response Team (IRT) responders were subject to minor smoke inhalation.
- Investigation revealed that one of the filters in the ECU caught fire during the transport.
 - The filter was not properly supported and fell directly onto the heating element in the ECU causing the fire.

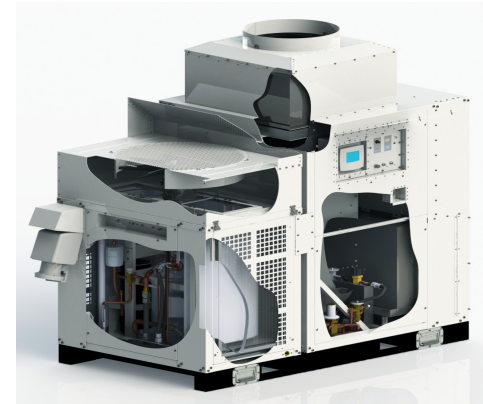
Environmental
Control Unit

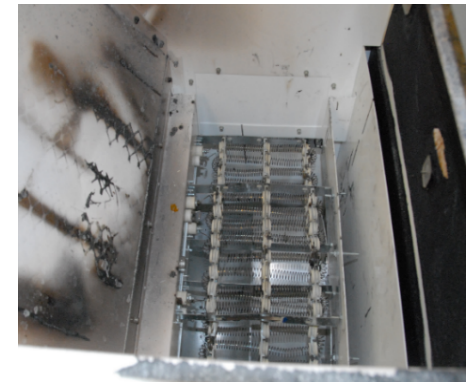
Heating element of the ECU where the filter fell and subsequently caught fire

- The Project Safety Manager (PSM) acted as the Incident Commander and IRT Lead in accordance with the Mishap Preparedness and Contingency Action Plan (MPCP). The MMS Go-Kit that was on site at NRL was retrieved and contents were utilized by the IRT Lead.
 - Flight hardware was secured.
 - Pictures of the incident were taken.
 - Witness statements were recorded.
 - Data was impounded.
 - Worked with the safety organizations and protective services personnel on site.
 - Contacted the Goddard Safety Division to request health assessment for personnel working around the incident due to potentially toxic fumes.
- After the IRT Lead released the scene, the spacecraft was examined to ensure that there was no residual damage to the spacecraft.

- IRT-trained personnel should accompany high-value hardware, spacecraft, instruments, etc., during transport.
- Fully stocked IRT Go-Kits should be available at all locations and on transporters. In this case, the IRT Go-Kit was on site at NRL. There was not one on the transporter.
- Project personnel should know emergency reporting procedures for all facilities and off-site locations.
- IRTs should be prepared to interface and work with multiple safety officers and organizations if an incident occurs at an off-site facility.
- IRTs should understand and be able to comply with any special site restrictions while still coordinating an appropriate mishap response (e.g., restrictions on photo documentation).
- Mishap practice exercises prepare personnel to appropriately respond to an incident. Practice exercises should be conducted prior to each phase of operations.
