# **Fatal Mishap Resulting from a Pressure System Operation in Government Laboratory**

**Leadership ViTS Meeting  
April 3, 2006**

**Jim Lloyd  
Deputy Chief, Safety and Mission Assurance**

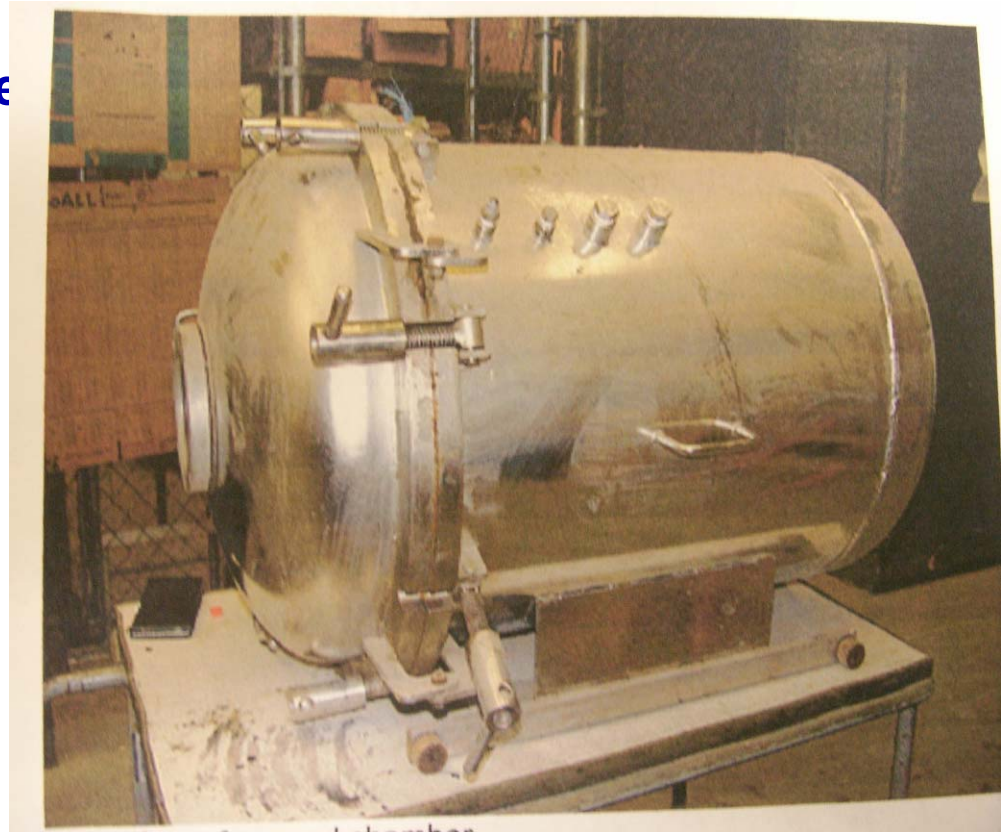
This is a vessel that is similar in construction/size to the one involved in the accident -- stainless steel and approximately 20 inches in diameter

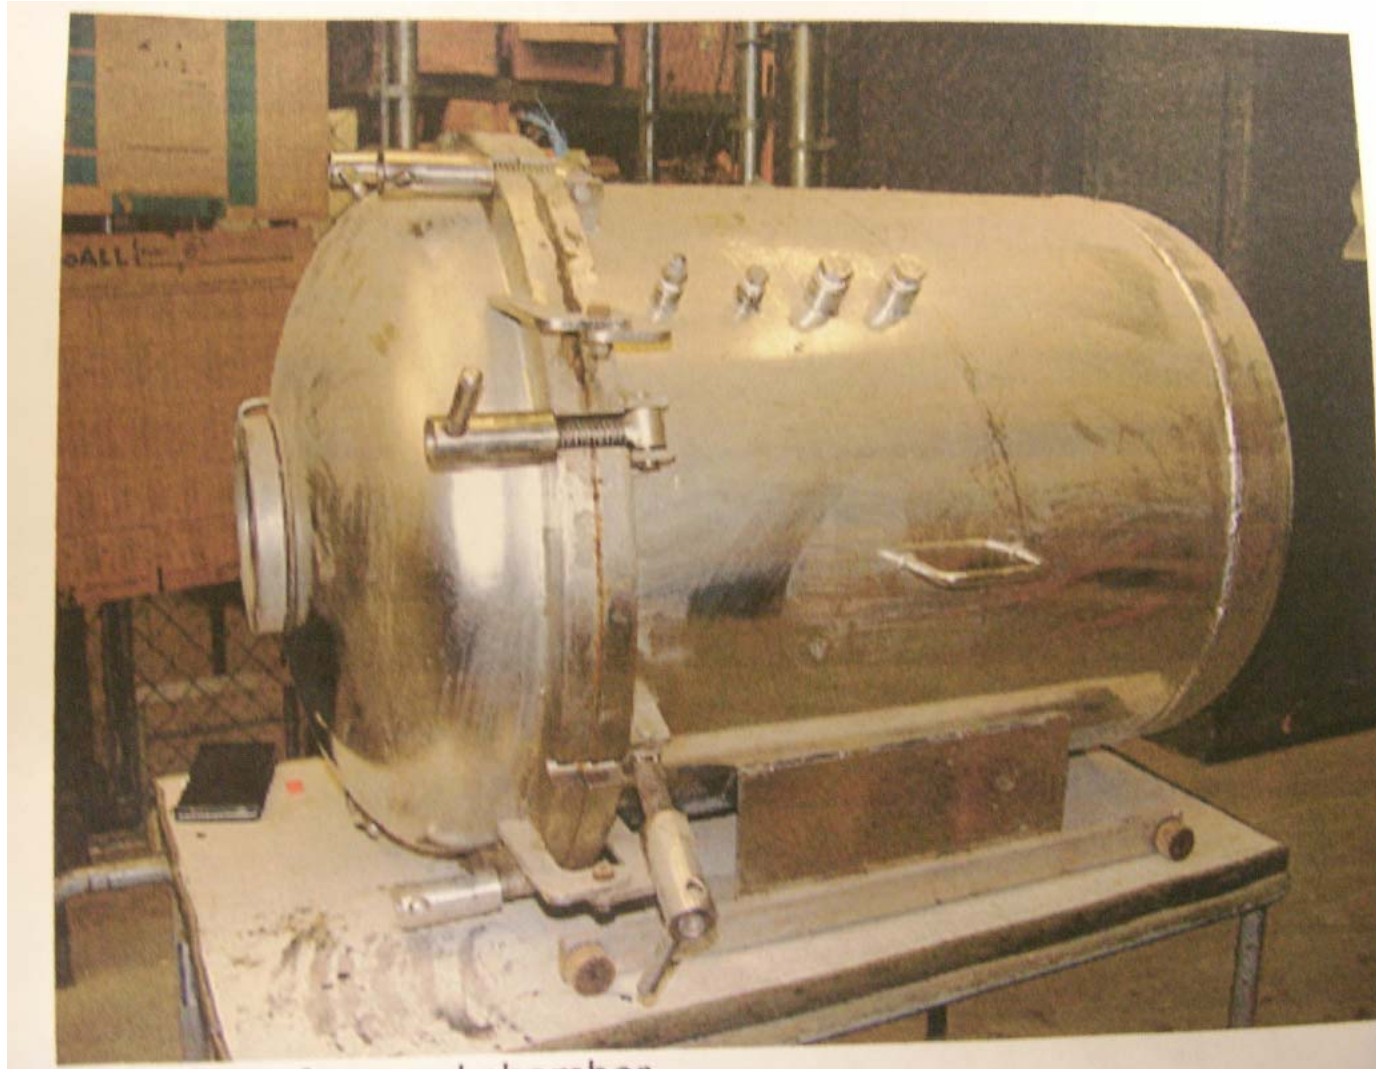
# The Pressure Vessel

- **Vessel at least 33 years old**
- **Unknown prior service, no nameplate, no drawings**
- **No pressure or temperature rating information**
- **Most welds on hold down bolts were cracked before being put into this service.**
- **A query near-completion of the mishap review by the government investigation board chairman identified the vessel as a vacuum chamber, and never intended for positive pressure**

- **Vessel design inappropriate for intended service**
  - Vacuum vessel put into service as a pressure vessel
- **Vessel not pressure checked prior to full use**
  - And no restricted access during initial pressurization
- **Critical welds on hold down bolts not inspected after 33+ years of existence**
  - Were not considered critical for a negative pressure (vacuum) application
- **Bolt welds were cracked and cracks exhibited corrosion prior to this use**
- **Vessel failed (chamber lid separated from chamber body) when all hold down bolt welds broke simultaneously.**

- Only re-use equipment within known capabilities.
- Beware of fabricated systems bypassing the normal review process.
- Seek expert technical counsel when dealing with hazards resulting from potential energies like pressure.
- Inadequate (or non-existent) safety and engineering review procedures can lead to accidents, particularly in systems with significant stored energy.
