SYSTEM FAILURE CASE STUDIES

APRIL 2009 VOLUME 3 ISSUE 03

Red Light

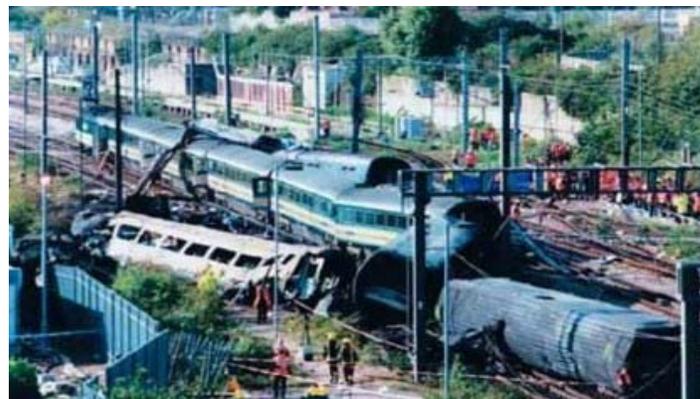
Figure 1: The collision at Ladbroke Grove Junction

Meanwhile, the slower Thames Train 3-car Turbo Class 165 (henceforth the “165”) was bringing commuters “down” from Paddington. The ARS routed the 165 from Line 4 to Line 3 and then scheduled a stop at SN109 so the train would not collide with the HST (Figure 1). Prior to moving from Line 4 to Line 3, the 165 passed a double yellow at SN63, then a single yellow at SN87, which indicated that the next signal (SN109) would probably be red. Data recorders recovered from the train after the collision show that the driver correctly reduced power at the double yellow (SN63) and coasted through the single yellow at SN87. Instead of continuing to brake for the upcoming red at SN109, he increased power 239 meters before the signal. He then cancelled the AWS warning and passed SN109 at danger.

The 165 was traveling at just under fifty miles per hour when it collided with the HST, which had been traveling at approximately eighty miles per hour. The steel HST pushed through the first coaches of the aluminum 165, which disintegrated on impact. As the HST penetrated the 165, it ruptured a fuel tank in the 165’s leading coach. A cloud of diesel fuel ignited and started fires in several cars.

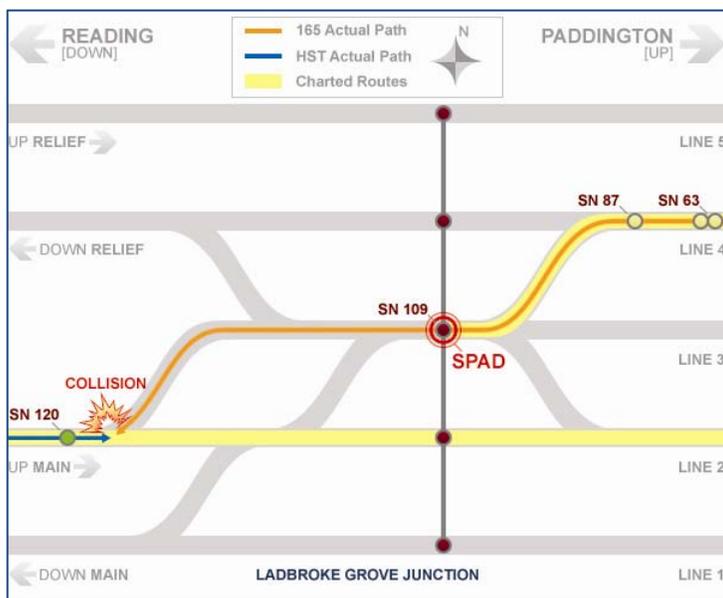
Figure 2: Diagram of the collision site

On October 5, 1999, the High Speed Train (HST) 1A09 was carrying eight passenger cars eastbound towards Paddington on the main “up” line from Reading (Figure 2). The Automatic Route Setting gave the HST green signals along its route, giving it the right of way and a “full speed ahead” status.

A diesel commuter train (the 165) passed a red signal at Ladbroke Grove crossing. It continued approximately 700 meters into the path of the approaching high speed train before the two trains collided with a closing speed of approximately 130 mph.

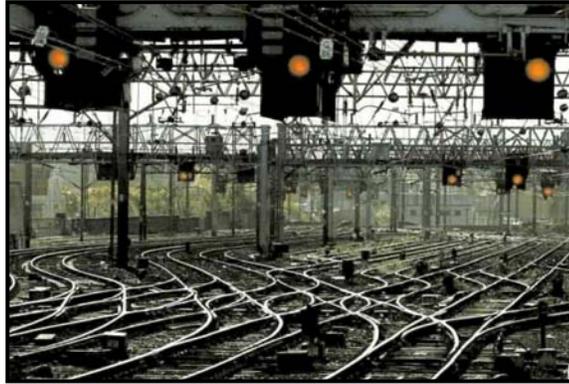
Figure 3: A complex railway junction (not SN109).

SN109 was one of several signals on the gantry, but it only became fully visible approximately 60 meters after the other signals. The investigation concluded that drivers were faced with “an exceptionally difficult signal reading task” at SN109. On approach, the gantry was frequently obscured by transverse girders and overhead line equipment, making it difficult to get a clear view of the signal. The complexity of the gantry layout further added to the challenge of discerning SN109 from the other signals.
