Lost In Translation: The Mars Climate Orbiter Mishap

Leadership ViTS Meeting

August 2009

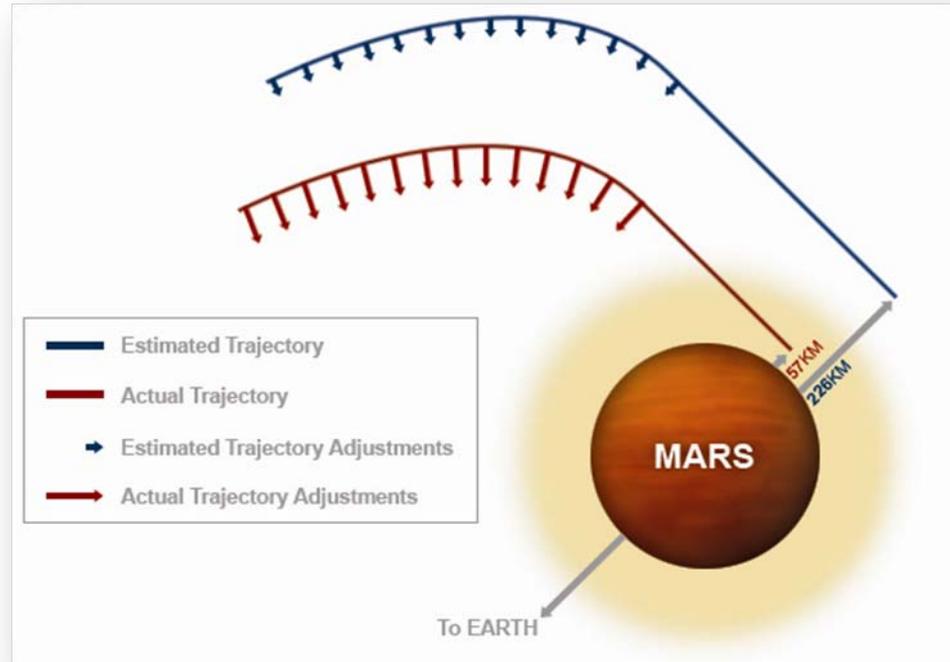
The MCO entered the Martian atmosphere at approximately 57km, not at its estimated 110km.

The MCO made minor trajectory changes along its journey to stay on target. The team later discovered that each minor trajectory adjustment along the way had been 4.45 times greater than they realized, because the software tracking the spacecraft was operating in English units rather than the required Metric units. All other calculations were in metric. The discrepancy sent the spacecraft closer to the planet than its calculated trajectory indicated.

Increased atmospheric stress destroyed the spacecraft.
