SYSTEM FAILURE CASE STUDIES

MARCH 2010 VOLUME 4 ISSUE 3

Island Fever

Mechanical failures spark nuclear melt-down in Three Mile Island power plant.

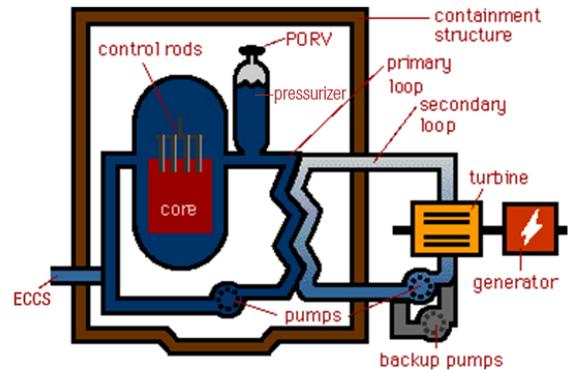
Figure 1 shows a brief overview of how nuclear reactors work. First, heat is generated as atoms split inside a nuclear **core**. The core in TMI-2 is 12 feet tall and weighs 100 tons. To control the rate at which atoms split and the resulting heat, **control rods** are raised and lowered into the core. More heat is generated when the control rods are raised, and less when they're lowered.

Figure 1: The nuclear reactor uses nuclear power to turn water into steam, generating electricity.

The **primary loop** pumps water through the core, absorbing heat generated by the nuclear fission process. In addition to being radioactive, water in the primary loop stays at very high temperatures, and must be pressurized to keep from turning into steam. The primary system has a pressurizer to control the pressures in the primary loop. The pressurizer has a pilot operated relief valve (**PORV**) that opens to release excess pressure from the primary loop. In the case of "loss of coolant" from the primary loop, an emergency core coolant system (**ECCS**) injects water into the system to cool down the primary loop. To contain the radioactive material, all of these components are surrounded by a **containment structure**, which is a four-foot-thick concrete encasement.

The **secondary loop** carries water that is heated by primary loop through a heat exchanger. Though the two loops are next to each other, the water in the two loops never comes in direct contact. This prevents water in the secondary loop from becoming radioactive. As water moves through the

secondary loop, heat from the primary loop turns secondary loop water into steam. This steam goes into a **turbine** and expands, turning a **generator**. This generator then produces electricity. After moving through the turbine, the steam condenses back into water and continues its cycle through the secondary loop.

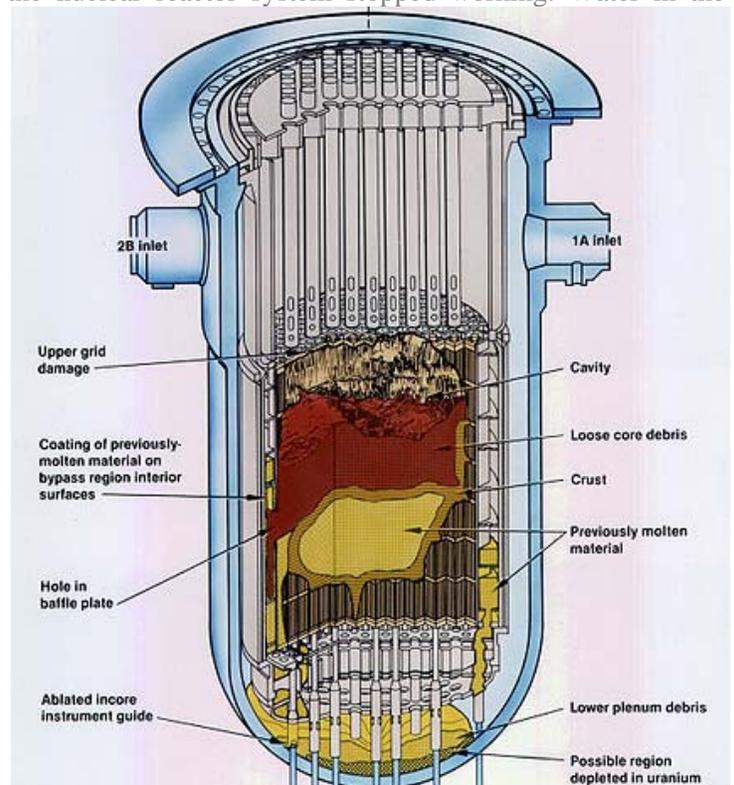
Around 6:00 a.m., the core became exposed to the intense heat and steam building up in the primary loop. The fuel rods reacted with the steam, melting exposed portions of the core (Figure 2). As the core melted, more radioactive material was released to the coolant, producing hydrogen gas bubbles in the core. This hydrogen bubble was discovered later, and became a serious concern because it prevented water from flowing through the core. At 6:00 a.m., there was also a shift change in the control room. The new shift noticed that the temperatures in the PORV pipe and the holding tanks were too high. They correctly realized the system was experienc-

Figure 2: Illustration of the end-state of the core. Half of the core had been melted from the loss of coolant.

secondary loop could no longer remove heat from the radioactive primary loop. As heat and pressure built up in the primary loop, the PORV opened to relieve the pressure. A mechanical failure left the PORV open. Radioactive water flowed out of this open valve into a tank, which burst, leaking water into the containment unit.

Meanwhile, unpressurized water in the core turned to steam, severely reacting with the core and further raising primary loop radioactivity levels. Leakages into the containment building posed a contamination problem to the facility and the surrounding areas.

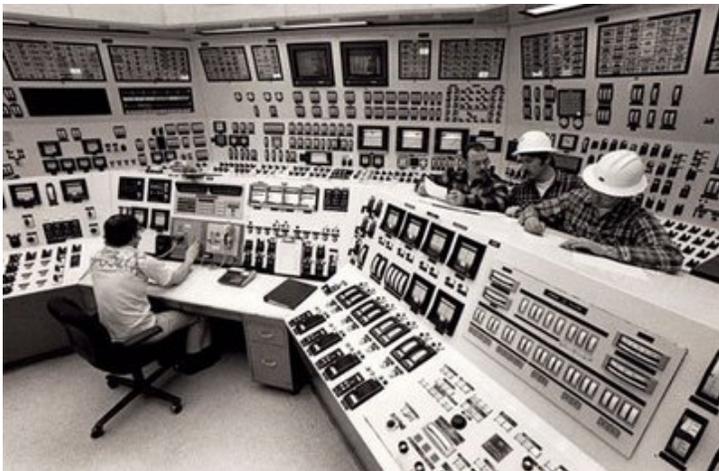
Figure 3: A typical nuclear power plant control room. Note the numerous arrays of dials, controls, and indicators.

The operators were not trained to look for other clues that could have indicated that the valve hadn't closed; they were used to the assumption that, if the light is off, the valve was closed. As Figure 3 shows, the control boards offered no easy answers to the problem, and the operators received seemingly conflicting signals from the gauges. It was not until a fresh shift came in at 6:00 a.m. that a new set of eyes put the pieces together to pinpoint the problem.

The dials showed that pressure inside the reactor was falling, while pressure inside the primary loop was rising, two seemingly conflicting facts since the two are connected. Because the series of malfunctions that had occurred were very unlikely and were not part of normal plant operation, the operators didn't think to check the PORV or the valves, and naturally assumed that one of the dials was just wrong.

The key to this incident was the unclear nature of the PORV indicator. The indicator light was linked to the power line that powered the PORV, not the PORV itself. This light did not give direct indication about whether the PORV itself was open or closed; it only told whether the power source to the PORV was on or off. Even though the power source had shut off and the PORV should have closed, it actually remained stuck open, without indication.

Finally, subsequent to the TMI incident, all valves had to have physical limit switches that showed an actual valve status, as opposed to showing the "commanded" or "inferred" position. Similarly, thermocouples were added to piping downstream of the PORV exhaust, so that plant operators could determine, with a redundant measure, what was really happening within the system.
