Hit the Bricks:

LC-39 Pad A Flame Trench Damage

Leadership ViTS Meeting

August 2010

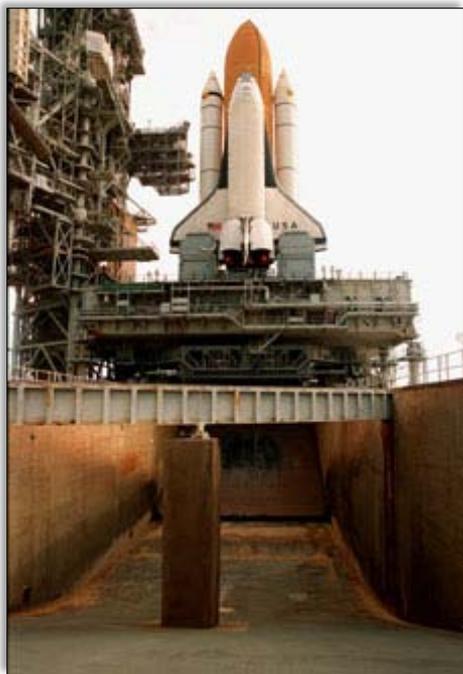
The flame trench of Pad 39A

- Channels exhaust away from the orbiter and supporting structures.
- Rests on an 11-foot-deep concrete floor and is contained by 3-foot-thick concrete walls.
- Trench is inspected before and after each space shuttle launch for foreign object debris or visual damage.

- Protects walls of flame trench against extreme temperatures and pressures imposed by the launch.
- Built using an interlocking tongue and groove design.
- Glued together with epoxy and anchored to concrete-embedded steel rails.

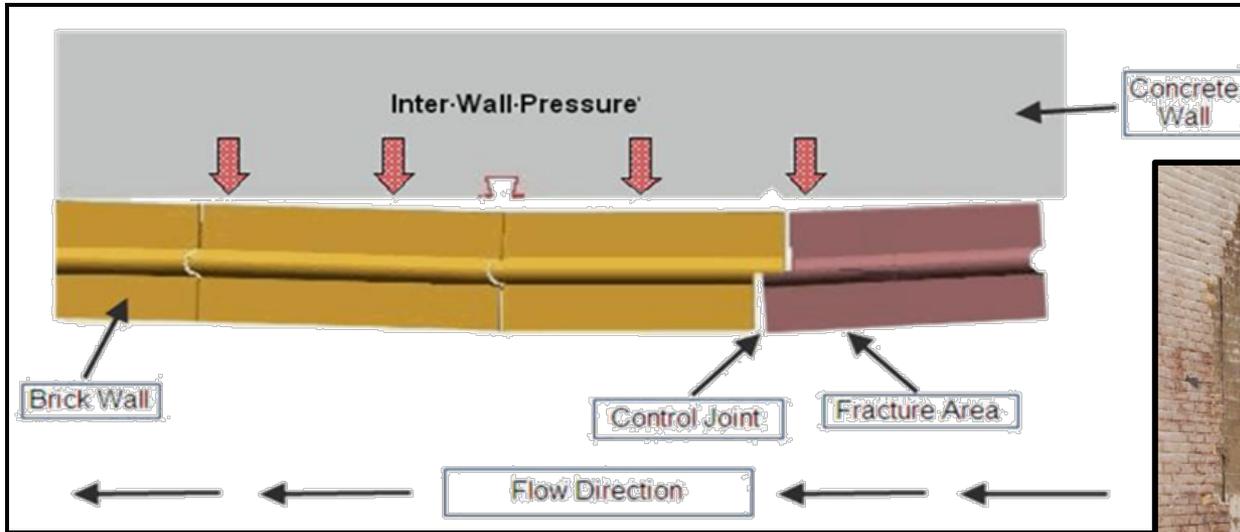
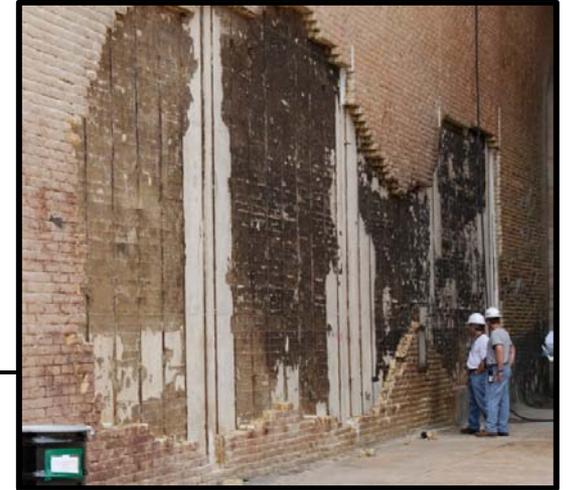
- Forces from SRB ignition caused a section of the wall that had been repaired with Fondu Fyre to tear away, creating a fracture in the brick lining.
- Hot gas seeped through the fracture and built up between the concrete wall and the refractory bricks.
- The bricks gave way to the pressure of the hot gas and burst away from the concrete at the control joint.
- The interlocking design propagated a cascading effect that blasted the bricks varying distances, some exceeding 1,800 feet.
- The flying bricks, shown by radar to travel up to 680 miles per hour, damaged the opposite wall and a nearby security fence.

Inspection teams were unable to detect severe carbonation of the epoxy and extensive corrosion in the steel anchors hidden beneath the brick lining. Operators were unaware of the imminent failure in the flame trench wall and cleared the pad for launch. When Space Shuttle Discovery blasted off, dynamic loads from the exhaust liberated thousands of refractory bricks.

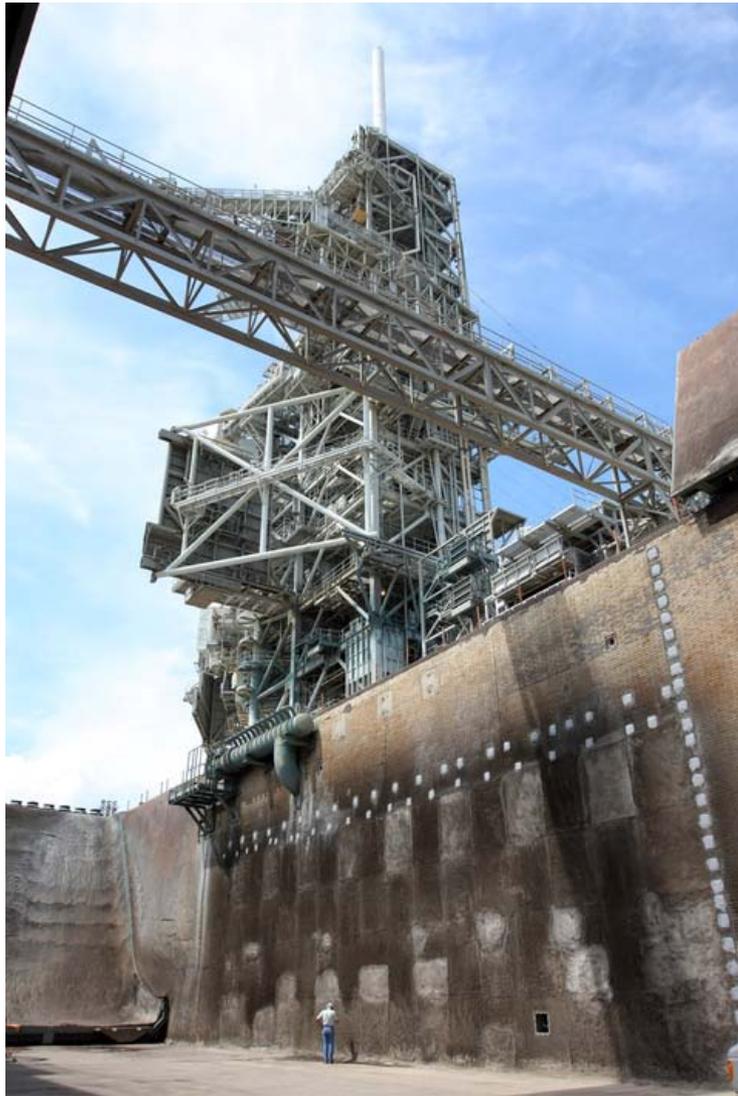
An inspector examines the repaired section of the flame trench wall.

- Comprehensive inspection, maintenance, and repair processes are critical to properly identifying hazards, even in systems that are apparently reliable.
