## SYSTEM FAILURE CASE STUDIES

MARCH 2011 VOLUME 5 ISSUE 3

# Vicious Cycle

## Pilot loses control of X-15; Aircraft Suffers In-Flight Breakup

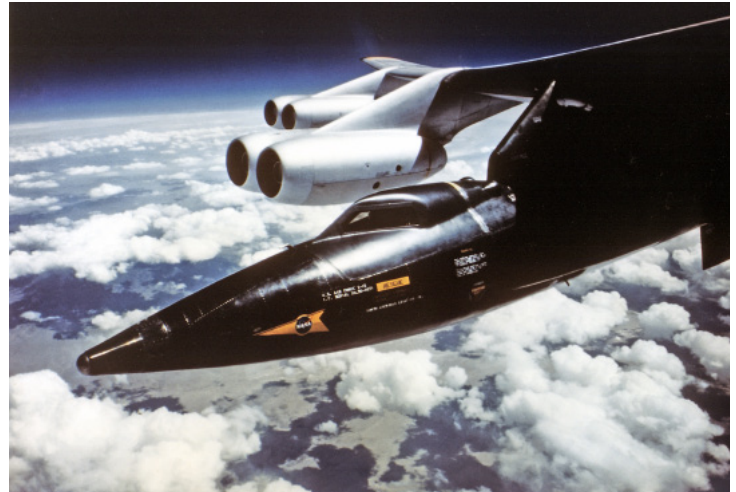
**Figure 1: The North American X-15 rides beneath the starboard wing of a specially modified B-52A to launch altitude.**

A typical flight began with the aircraft shackled under a wing of a specially modified B-52A (Figure 1). The X-15 rode the bomber to an altitude of approximately 45,000 feet before dropping away and allowing its rocket engine to propel it to an ascent of over 350,000 feet – more than 66 miles above the surface of the earth. Approximately 84 seconds later, the pilot would shut down the engine, and the remainder of the flight would continue unpowered. An X-15 flight usually lasted for 10 minutes from launch to touchdown on Rogers Dry Lakebed.

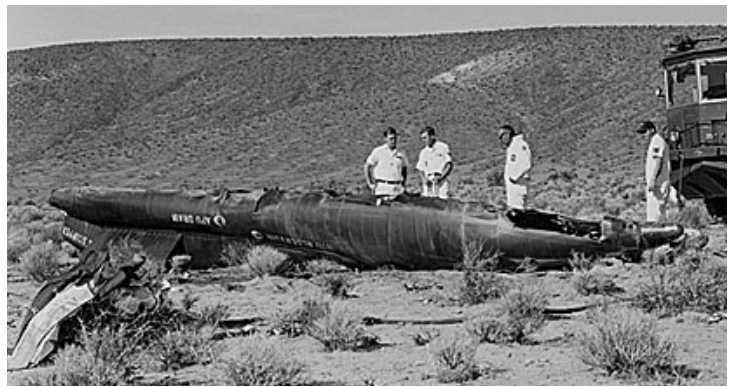
After the aircraft had completed three revolutions, Major Adams' effort to hold anti-spin control inputs and the X-15's flight control system stopped the rotation, resulting in a 45 degree inverted dive. Major Adams still had 130,000 feet of altitude to recover from the dive, but the MH-96 began forcing the horizontal stabilizers into rapid, cyclic oscillation to their limit of travel. In response, the X-15 pitched violently (plus and minus 15 g's) and yawed almost as violently (plus and minus 8 g's). No procedure existed for this condition either; post-mishap simulations found the only way to break the cycle would have been to shut down the MH-96's gain changer. But the severe buffeting Major Adams encountered during the spin and dive likely resulted in him being incapacitated during the approximately 15 seconds that the airframe withstood such massive g forces. Major Adams was unable to eject before the X-15-3 broke apart (Figure 4).

NASA and the USAF convened an accident board that concluded that Major Adams had inadvertently initiated, then increased right drift off his required aircraft heading because of distraction, misinterpretation of the attitude indicator, and possible vertigo. If the RCS had been operative, it would have resisted Major Adams' heading change, but the electric disturbance caused the MH-96 to disarm the automatic controls. The yaw became so severe that the aircraft reentered at right angles to the flight path, and increasing dynamic pressure pushed the X-15 into a hypersonic spin. By the time Major Adams recovered from the spin, pitch gains in the MH-96 had reached a maximum. The gains, in conjunction with system oscillations, sent commands to the horizontal stabilizers that exceeded their rate limits. These commands saturated the system, causing the external stabilizers to cycle up-and-down at 26 degrees per second. Since the stabilizers were already being driven at their rate limits, no capability to respond to pilot maneuvers or system augmentation remained. This prevented Major Adams from pulling out of the dive and righting the aircraft. At 62,000 feet, forces from this limit-cycle oscillation broke the aircraft into many pieces and Major Adams, unconscious, died in the crash.

**Figure 4: Responders survey the wreckage of the X-15-3 near Johannesburg, California.**
