SYSTEM FAILURE CASE STUDIES

APRIL 2011 VOLUME 5 ISSUE 4

Got Any Ideas?

Pilots Ditch Passenger Jet in Hudson River; All Occupants Survive.

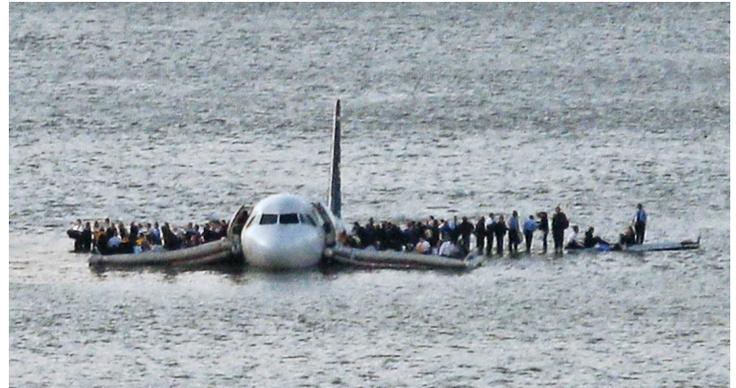
Figure 1: Passengers and crew members of U.S. Airways Flight 1549 stand on the aircraft wings and slide/rafts as they wait to be rescued.

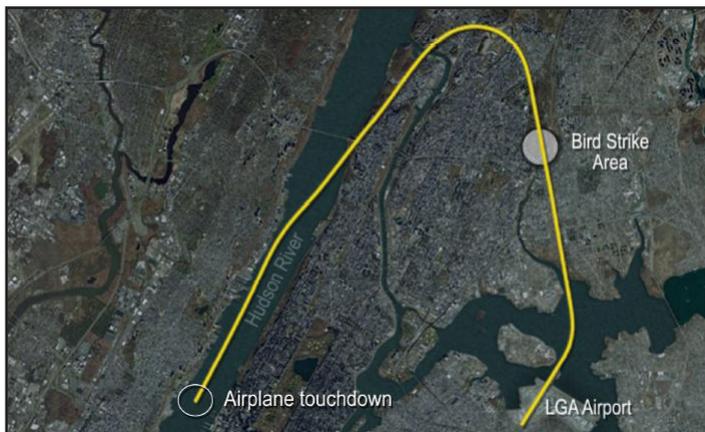
As the aircraft descended, its speed hovered near V_{LS} , and at 150 feet, it entered alpha-protection mode. Three minutes after the bird strike, the airplane skidded onto the water at a descent rate of 12.5 feet per second (Figure 4). External pressure from the impact collapsed the aft fuselage frame, cracking the aft fuselage skin. Water poured through the breach and into the cabin, rendering the rear exits and slide/rafts useless. The flood forced passengers to evacuate onto the wings and into the forward slide/rafts. The first ferry arrived within five minutes of the ditching, and the last passengers were rescued approximately 20 minutes later. Some individuals had been submerged to the chin when water flooded the cabin, and a few were later hospitalized for hypothermia. The aircraft endured significant damage, five people suffered critical injuries, but all of the passengers and crew members survived.

Figure 4: Flight path of U.S. Airways Flight 1549

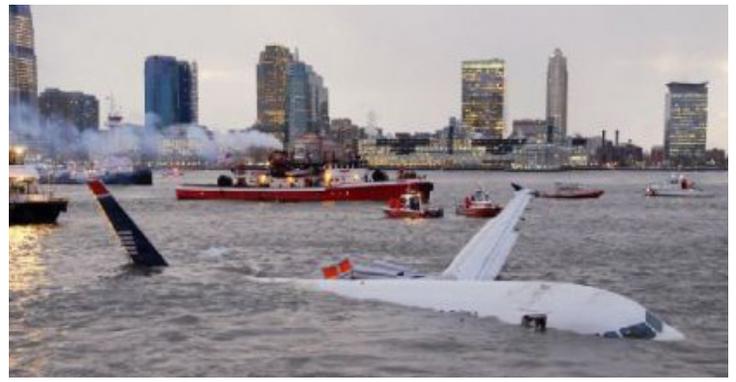
ily have led to “cold-shock,” a phenomenon that can lead to drowning in as little as five minutes. As per NTSB, these slide/rafts, in conjunction with the proximity and swift response of passenger ferries, likely saved dozens of lives (Figure 5).

Figure 5: Commuter Ferries and Coast Guard vessels surround U.S. Airways Flight 1549 as it sinks into the Hudson River minutes after the last passenger was rescued.
