SYSTEM FAILURE CASE STUDIES

Got Any Ideas?

Pilots Ditch Passenger Jet in Hudson River; All Occupants Survive.

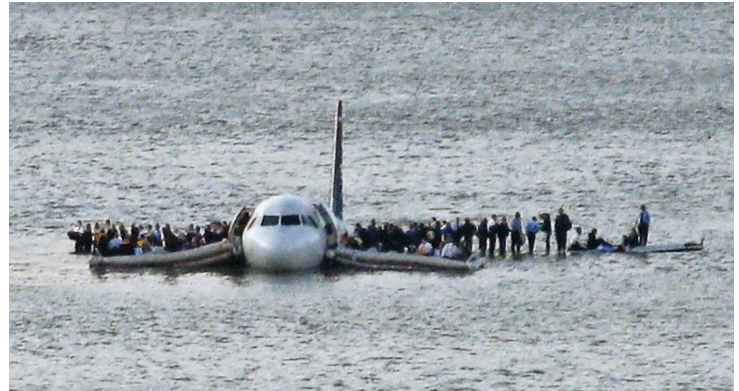
Figure 1: Passengers and crew members of U.S. Airways Flight 1549 stand on the aircraft wings and slide/rafts as they wait to be rescued.
