NASA SAFETY CENTER
SYSTEM FAILURE CASE STUDY

From Rockets to Ruins

The PEPCON Ammonium Perchlorate Plant Explosion

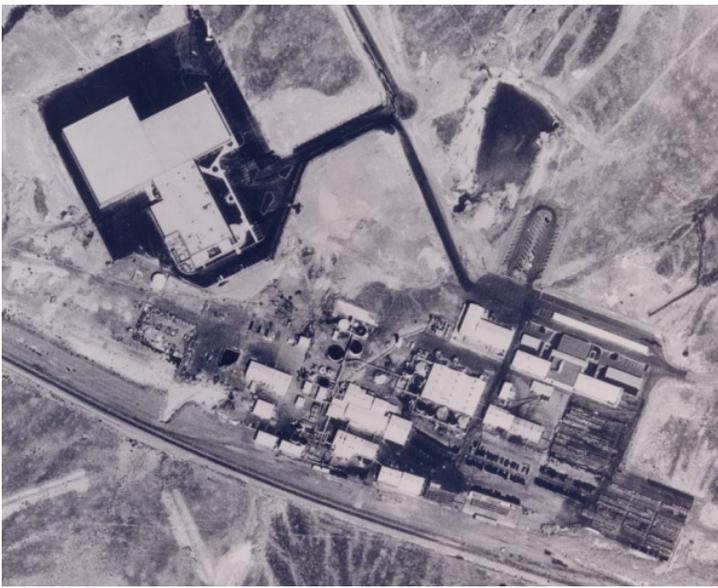
Figure 1. The PEPCON facility before the blasts. Source: Lawrence Livermore National Laboratory.

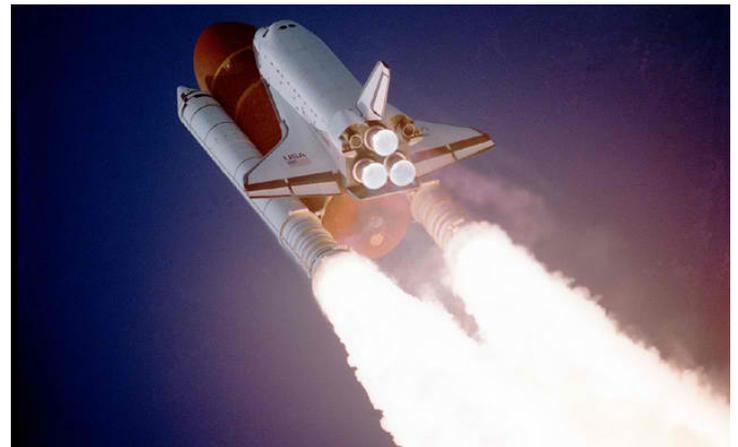
Figure 2. Each Space Shuttle SRB is loaded with approximately 550 tons of propellant. AP makes up 69.6% of the fuel (382.8 tons by weight) commonly referred to as Ammonium Perchlorate Composite Propellant (APCP). The remaining mixture comprises aluminum fuel (16%), iron oxide catalyst (0.4%), a polymer binder and secondary fuel (12.04%), and an epoxy curing agent (1.96%). NASA.

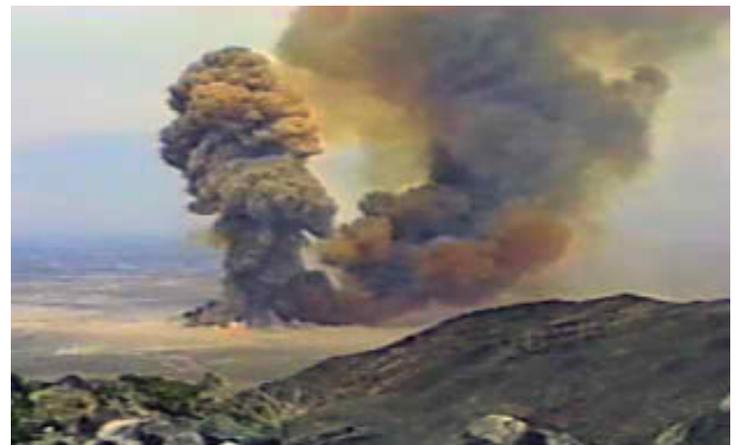
Figure 3. It is estimated that the second major explosion consumed 1,500 tons of AP—almost four times the amount of AP consumed by one Space Shuttle Solid Rocket Booster. Source: Public Domain

Witnesses reported a shockwave visibly travelling across the ground toward them. Many were temporarily blinded by the immediate flash and others lacerated by flying glass. Henderson responders were effectively incapacitated. Of the 4,000 tons of AP stored at the plant, it is estimated that approximately 1,500 tons were consumed in the subsequent explosion.

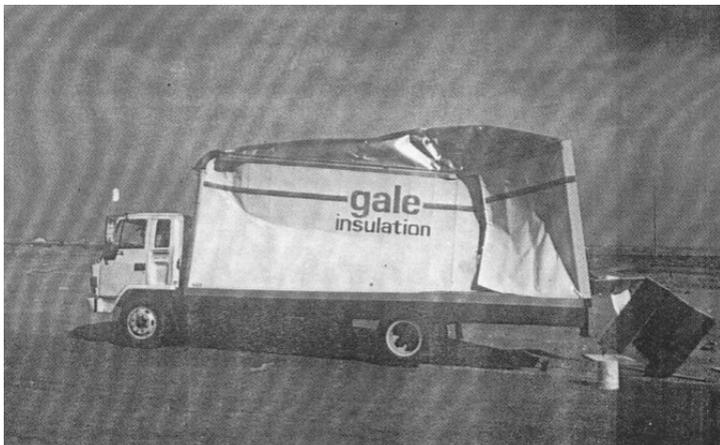
Figure 3. A truck displaying the effects of the shockwave from the second explosion. Source: United States Fire Administration.

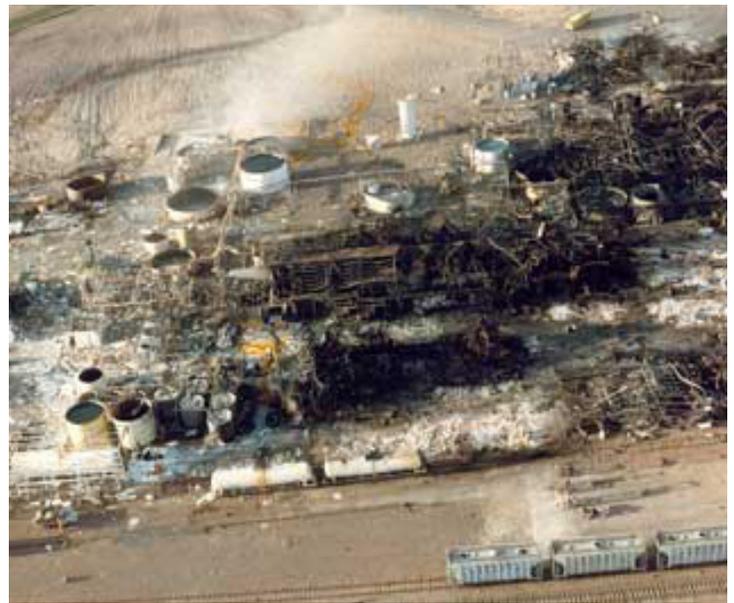
Figure 5. Remnants of the PEPCON facility. Source: Lawrence Livermore National Laboratory.

The PEPCON facility and neighboring Kidd Marshmallow plant were completely obliterated. The shockwaves had damaged buildings in Henderson; shattering windows, cracking walls, and breaking doors. The affected area spanned a 10-mile radius from the PEPCON facility.
