Breathe

Survival and the United States' Most Advanced Fighter Jet

Senior Management ViTS Meeting

March 2013

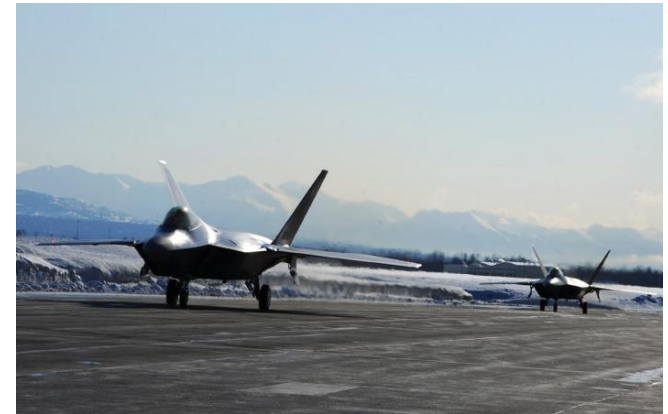
Figure 1.

- The F-22, introduced into United States Air Force (USAF) in December of 2005, is an air-to-air/air-to-ground, fifth-generation, single seat, twin-engine, supermaneuverable, superiority fighter utilizing state-of-the-art avionics, stealth, and supersonic cruise technology (Figure 1.).
- The mishap aircraft (MA) was properly inspected and maintained and had no history of reoccurring maintenance issues.

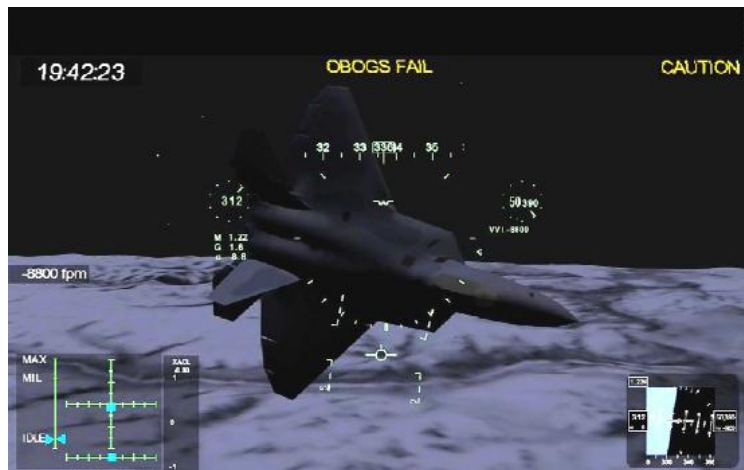
- At 7:39:57 p.m., the flight leader (FL) seeing the MP ahead of formation, directed the MP to return to a trail formation.
- The MP acknowledged in his last radio transmission. He initiated a climbing turn to rejoin, crossed FL's projected flight path, and then began descent into formation from approx. 52,000 ft. mean sea level (MSL) (Figure 2.).

Figure 2. The MA performing a descending right hand turn to rejoin formation.

- The MP would have immediately felt suffocated and would have struggled to breathe. Actual cabin altitude in the F-22A cockpit is unknown.
- The MP set throttles to idle, initiating a descent procedure until 7:42:45 p.m. (Figure 2.). There had been no pressure to the MP's oxygen mask since 7:42:37 p.m. For the next 8 secs, the MP made no control inputs. Passing through 19,000 ft. MSL, cabin pressure rose above nominal as the MA descended rapidly.

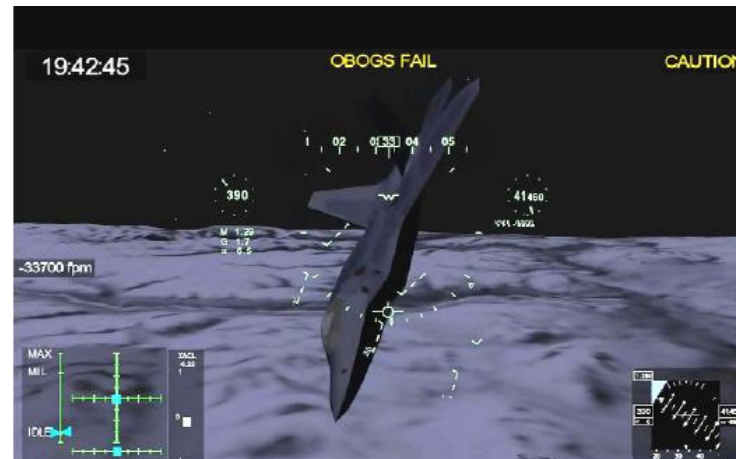
- At 7:42:53, the MP made a combination of stick and pedal inputs, initiating a 240-degree descending right roll at greater than 45 degrees per sec, rolling the MA inverted and plummeting down at a rate of -57,800 fpm (Figure 3.). There were no stick inputs and only very minor pedal inputs for the next 15 secs.

Figure 3. The MA position after MP stopped control inputs (no pressure to mask).

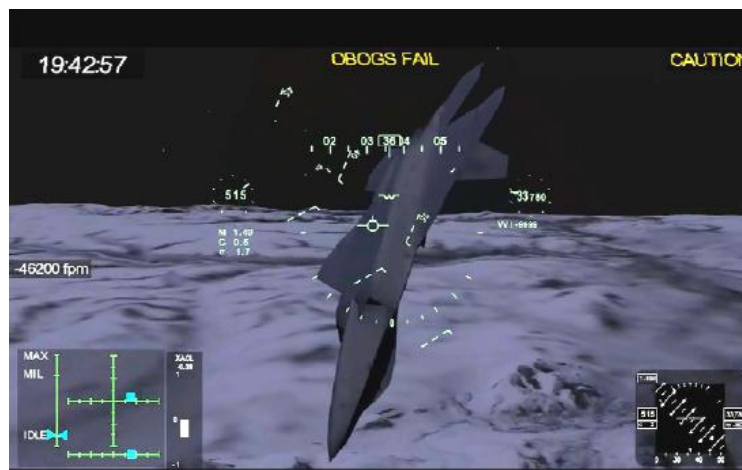
Figure 4. The MA inverted and plummeting with no control input from MP (no pressure to mask).

The MP entered a 240-degree roll through inverted, and the nose down pitch attitude of the MA increased. Although a dive recovery was initiated, the MA impacted the ground, killing the MP.

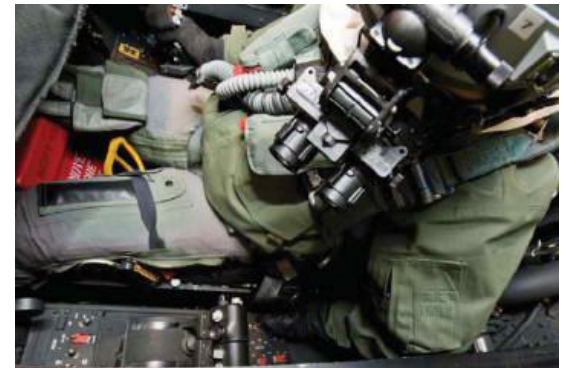
Figure 5.

- A CAT III gear and NVG cockpit maneuverability assessment revealed reduced mobility (Figure 5.). NVGs narrowed line of sight and interfered with visual scanning, requiring wearers to shift their torso while bracing against the cockpit to perform a scan. CAT III gear limited tactile sensation.
- Testers able to activate the small EOS pull-ring in CAT III gear and NVGs stated the 40lb-pull activation would be difficult and it was possible to drop the ring between the seat frame and cushion.

The Pentagon Inspector General investigating the Air Force investigation also deemed human error causal to the mishap. Civil legal action against the manufacturer resulted in changes to the design and location of the EOS activation mechanism.
