Russia's Proton crashes with a trio of navigation satellites

Published: July 1; updated: July 2, 3, 4, 5, 9, 11, 15, 18, 19; 23; Aug. 11

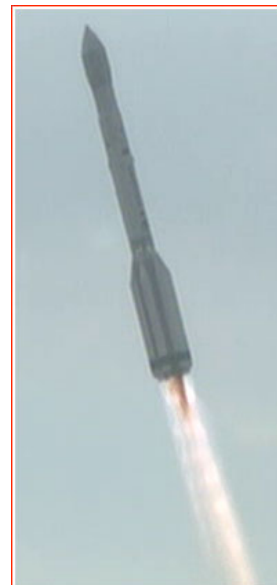
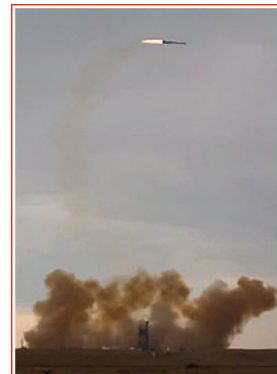
The rocket started veering off course right after leaving the pad, deviating from the vertical path in various directions and then plunged to the ground seconds later nose first. The payload section and the upper stage were sheered off the vehicle moments before it impacted the ground and exploded. The flight lasted no more than 30 seconds.

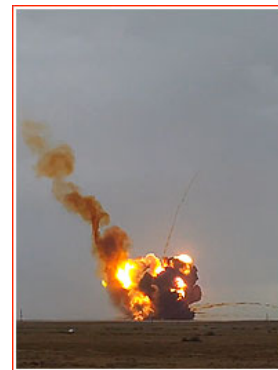
Lopatin reiterated that all pre-launch activities had been proceeding normally until around 0.4 seconds before liftoff, when the emergency flight algorithm was activated. Around 6.8 seconds after the liftoff signal, the
