Soyuz MS-10 abort caused by sensor failure at booster separation

written by Chris Bergin | November 1, 2018

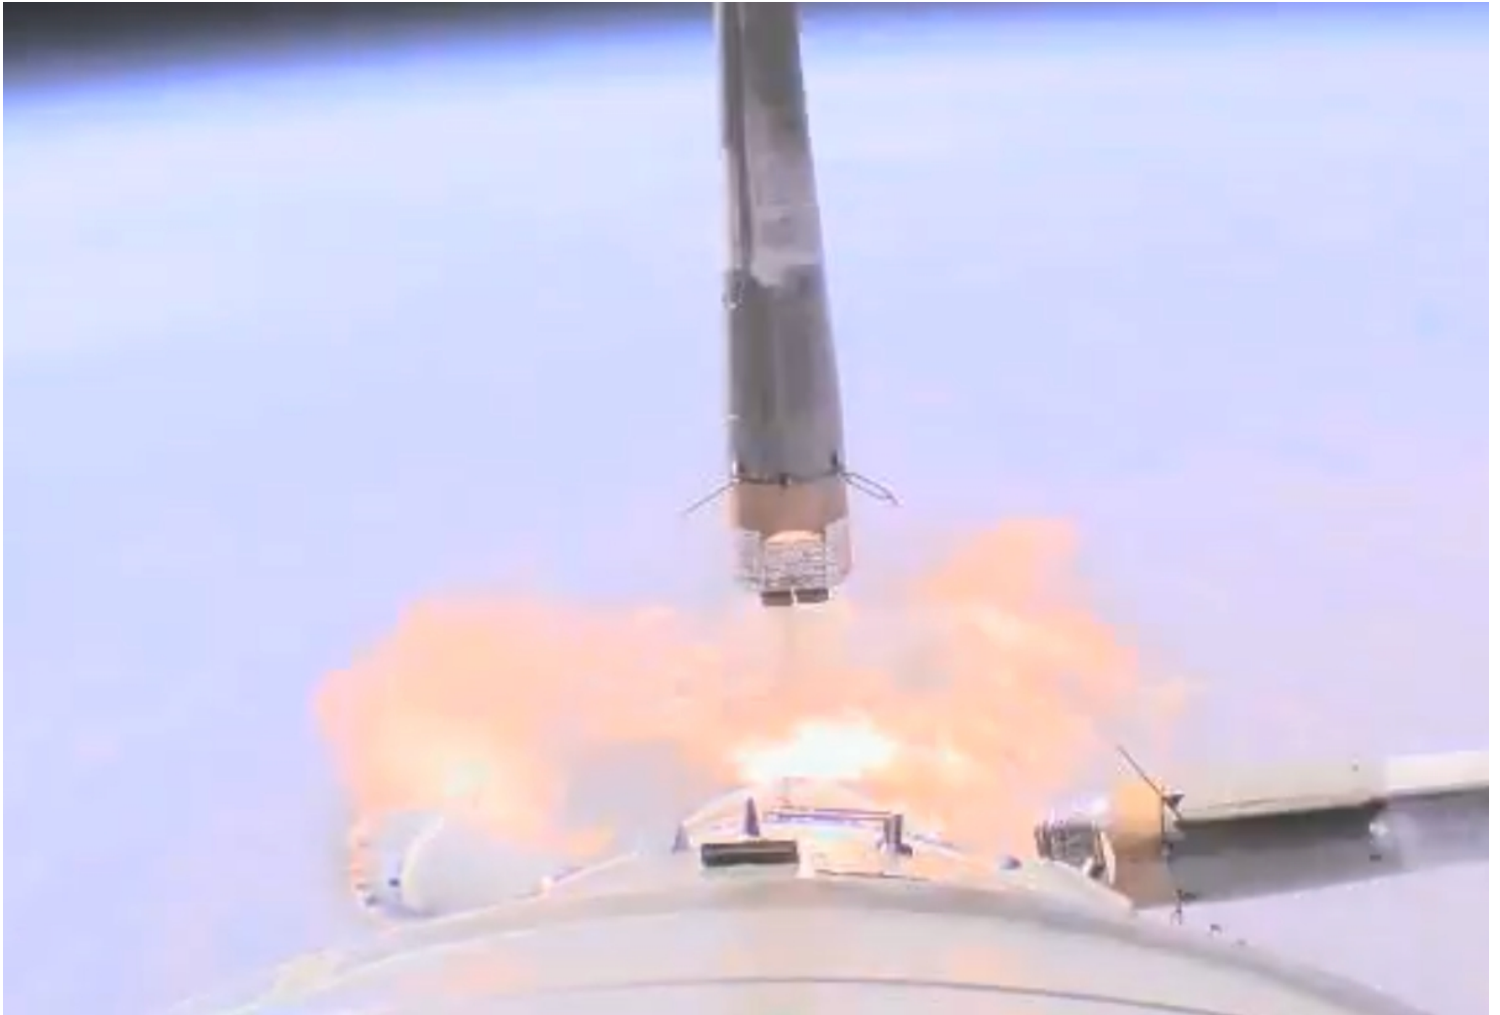
Russian investigators have concluded last month's Soyuz MS-10 abort was caused by a sensor failure on one of the four Soyuz FG boosters. The sensor, which triggers LOX valves to vent on the top of the booster – allowing them to cleanly depart from the core – resulted in the booster sliding down the side of the core and rupturing the tank, causing the Soy to fail and the Soyuz MS-10 to conduct an emergency abort. A press conference blamed an "error during assembly" of t
