RESULTS OF THE SECOND U.S. MANNED ORBITAL SPACE FLIGHT, MAY 24, 1962

1. SPACECRAFT AND LAUNCH-VEHICLE PERFORMANCE

BY JOHN H. Boynton, Mercury Project Office NASA Manned Spacecraft Center; and E. M. Fields, Mercury Project Office NASA Manned Spacecraft Center

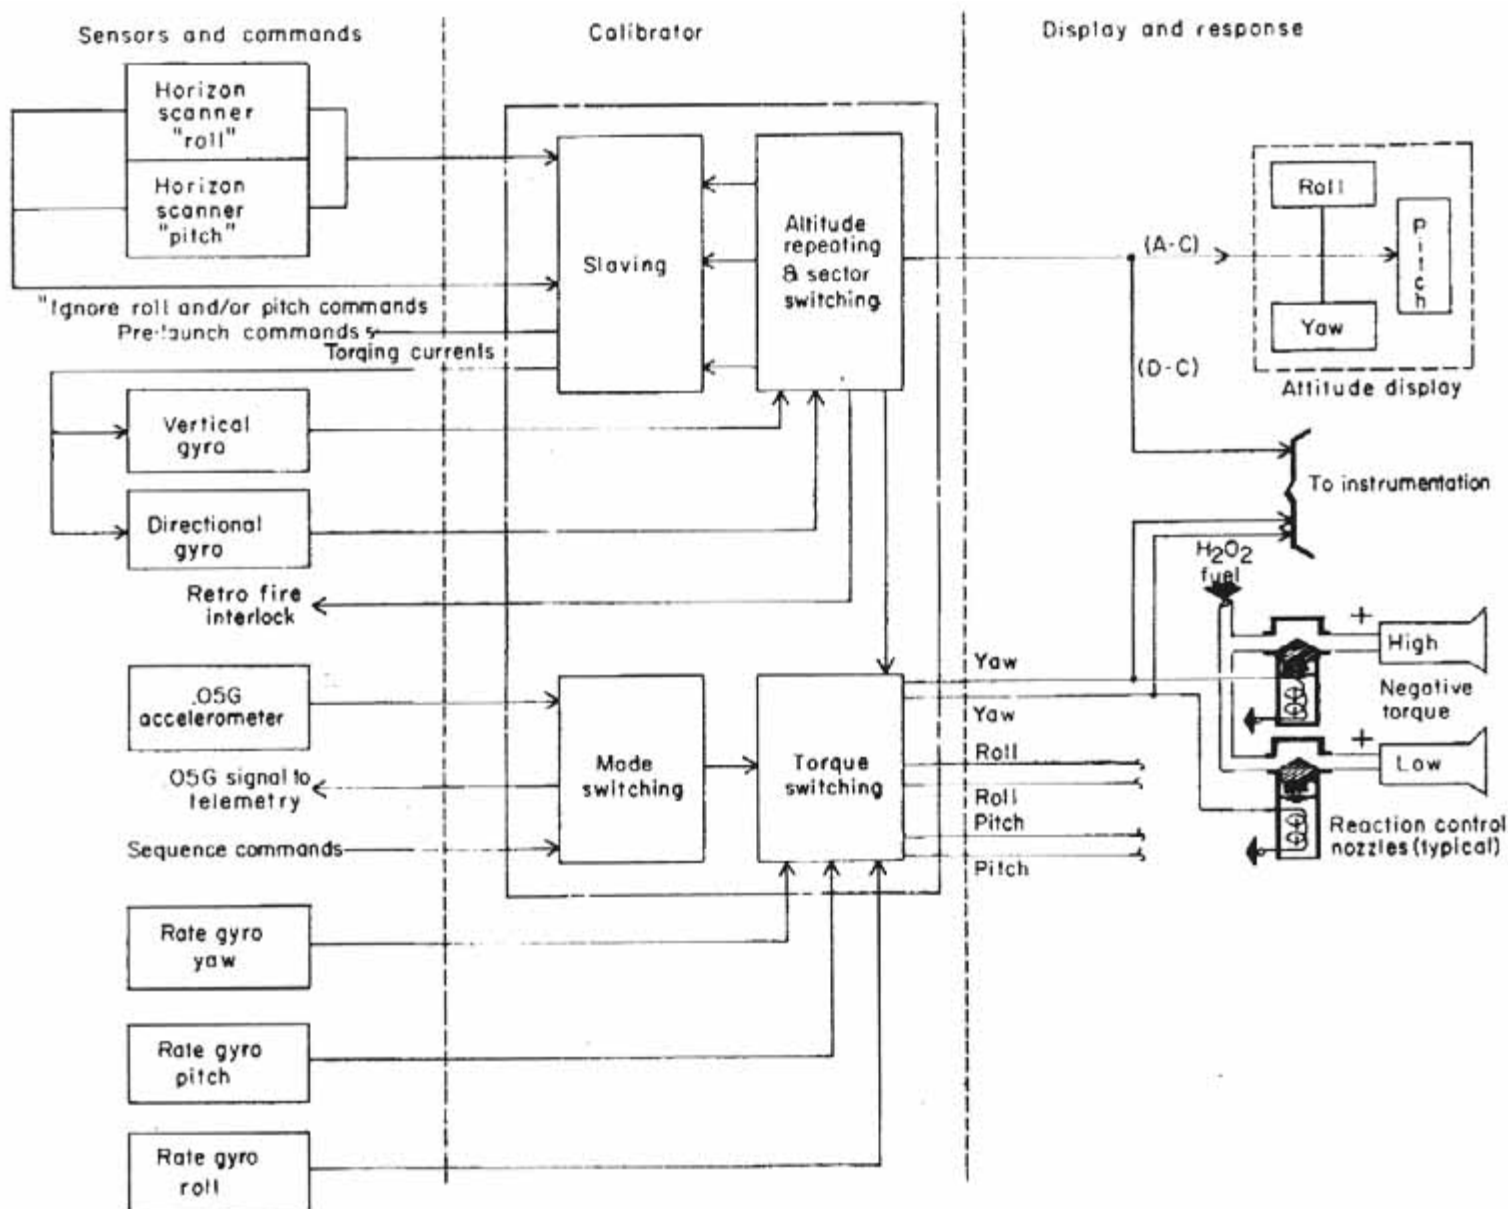
Figure 1-5.-Control system schematic diagram.

The horizon scanners are employed to provide a correction reference for the spacecraft attitude gyros which is indicated in the basic schematic diagram shown in [figure 1-5](#). An error introduced by the pitch horizon scanner circuit was present during launch and apparently remained to some degree throughout the flight. Since the scanners were lost when the antenna canister was jettisoned during the normal landing sequence, postflight inspection and analysis of these units were impossible; however the failure is believed to have been in the scanner circuit and was apparently of a random nature in view of the fact that the scanner system has been fully qualified on previous flights.
