APOLLO 11 MISSION REPORT

MANNED SPACECRAFT CENTER  
HOUSTON, TEXAS  
NOVEMBER 1969

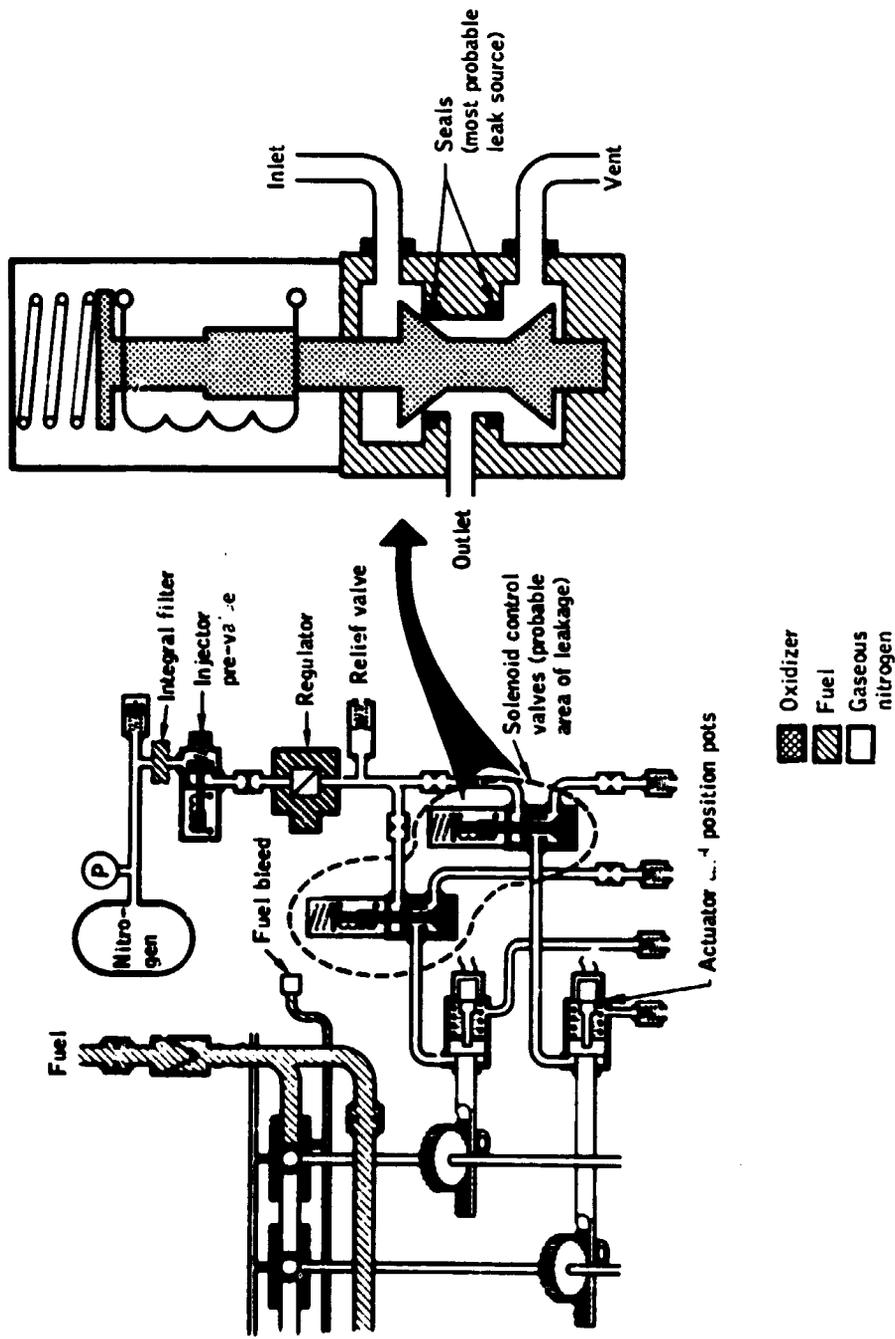
The fuel and oxidizer valves are controlled by actuators driven by nitrogen pressure. Figure 16-2 is representative of both nitrogen control systems. When power is applied to the service propulsion system in preparation for a maneuver, the injector pre-valve is opened; however, pressure is not applied to the actuators because the solenoid control valves are closed. When the engine is commanded on, the solenoid control valves are opened, pressure is applied to the actuator, and the rack on the actuator shaft drives a pinion gear to open the fuel and oxidizer valves. When the engine is commanded off, the solenoid control valve vents the actuator and closes the fuel and oxidizer valves.

It is concluded that the leakage was due to a contamination-induced failure of a solenoid control valve. The source of contamination is unknown; however, it was apparently removed from the sealing surface during the valve closure for the first lunar orbit insertion maneuver (fig. 16-2). A highly suspect source is a contaminated facility manifold at the vendor's plant. Although an investigation of the prior failure indicated the flight valve was not contaminated, the facility manifold is still considered a possible source of the contaminants.

Figure 16-2.- Control for service propulsion propellants.

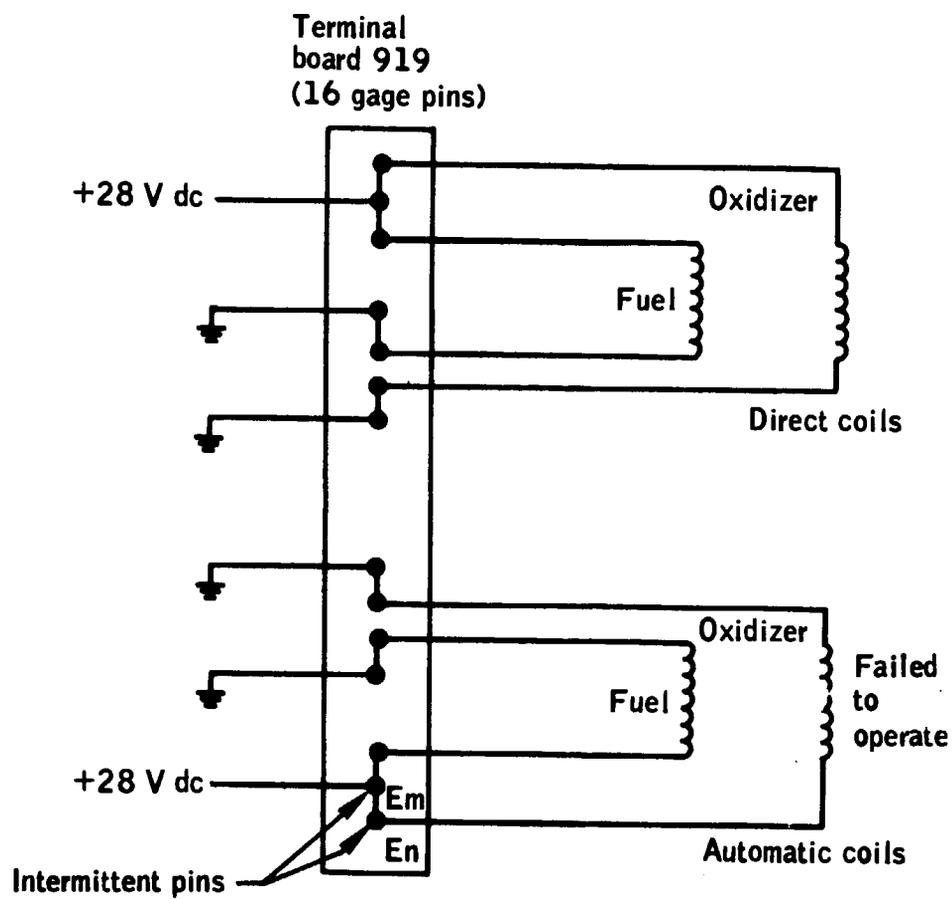
Postflight tests showed that two pins in the terminal board (fig. 16-3) were loose and caused intermittent continuity to the automatic coils of the engine valve. This type failure has previously been noted on terminal boards manufactured prior to November 1967. This board was manufactured in 1966.

Figure 16-3.- Terminal board schematic for minus-yaw engine, command module reaction control system 1.

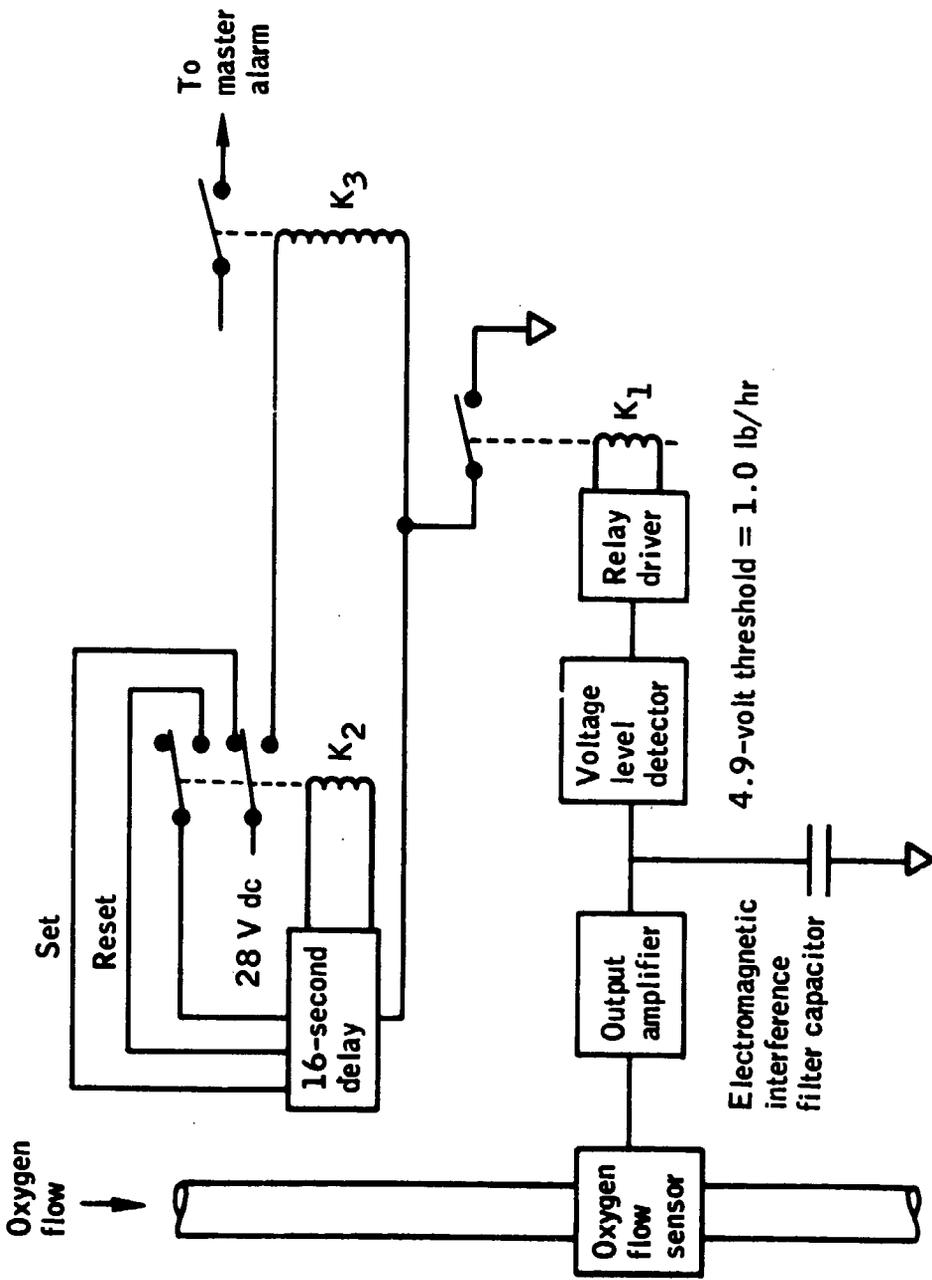
During the initial lunar module pressurization, two master alarms were activated when the oxygen flow rate was decreasing from full-scale. The same condition had been observed several times during altitude-chamber tests and during subsequent troubleshooting. The cause of the problem could not be identified before launch, but the only consequence of the alarms was the nuisance factor. Figure 16-4 shows the basic elements of the oxygen flow sensing circuit.

Note in figure 16-4 that in order for a master alarm to occur, relay K1 must hold in for 16 seconds, after which time relays K2 and K3 will close, activating a master alarm.

Figure 16-4.- Oxygen flow sensing circuit.

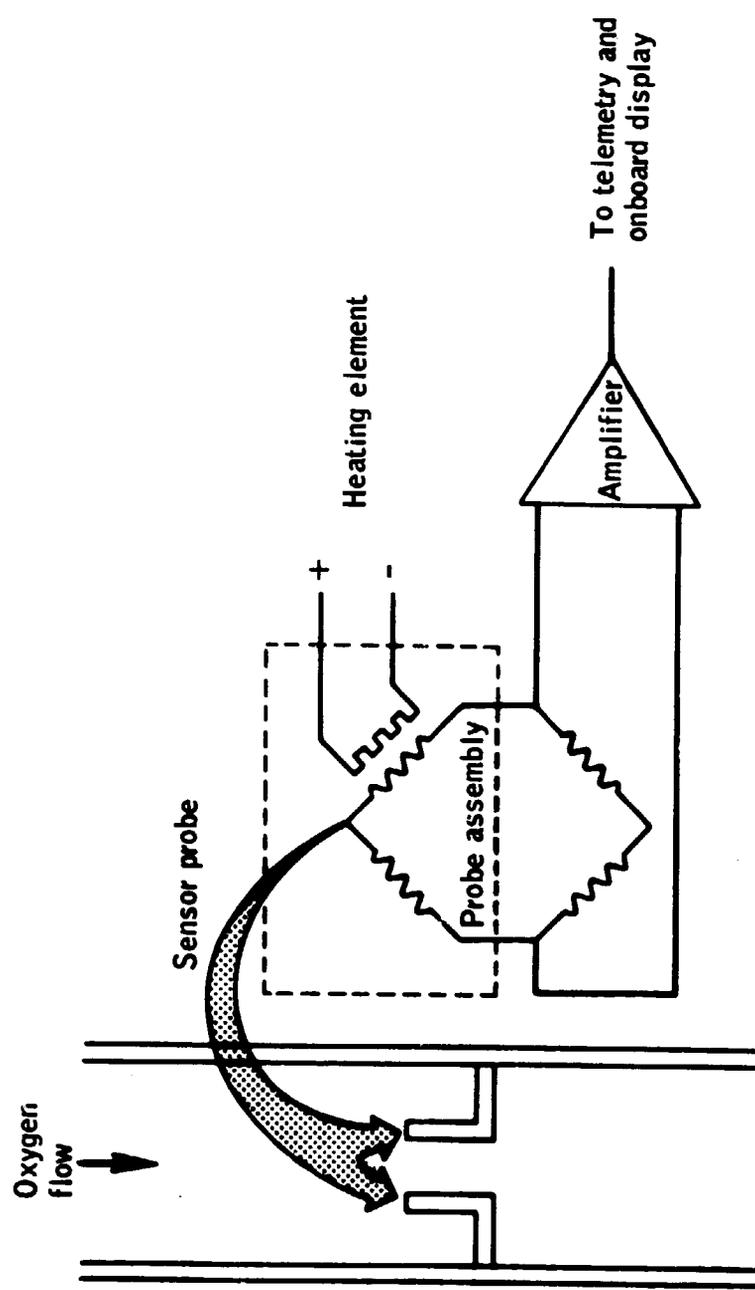
Figure 16-5.- Oxygen flow sensor.

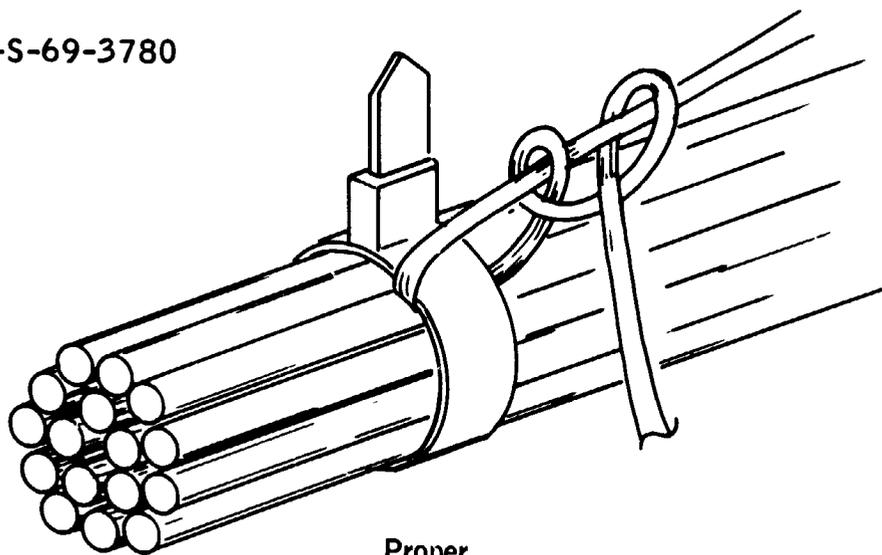
The knots should be two closely tied half-hitches which secure the tie-wrap to the lanyard (fig. 16-6). Examination of the Apollo 10 lanyard indicates that these knots were not two half-hitches but a clove hitch (see figure). After the lanyard breaks the tie-wraps, if the fragment of tie wrap pulls out of the knot, the clove hitch knot can untie, thus lengthening the lanyard. Lengthening this lanyard as the umbilical cable pays out can allow transfer of some loading into the umbilical disconnects. Should a sufficient load be transferred to the disconnect fitting to cause shear pins to fail, a disconnect of the forward heat shield mortar umbilical could result prior to the mortar firing. This would prevent deployment of the forward heat shield separation augmentation parachute, and there would be a possibility of forward heat shield recontact with the command module. Examination of the forward heat shield recovered from Apollo 10 confirmed that the mortar had fired and the parachute was properly deployed.

Figure 16-6.- Tie-wraps on lanyards.

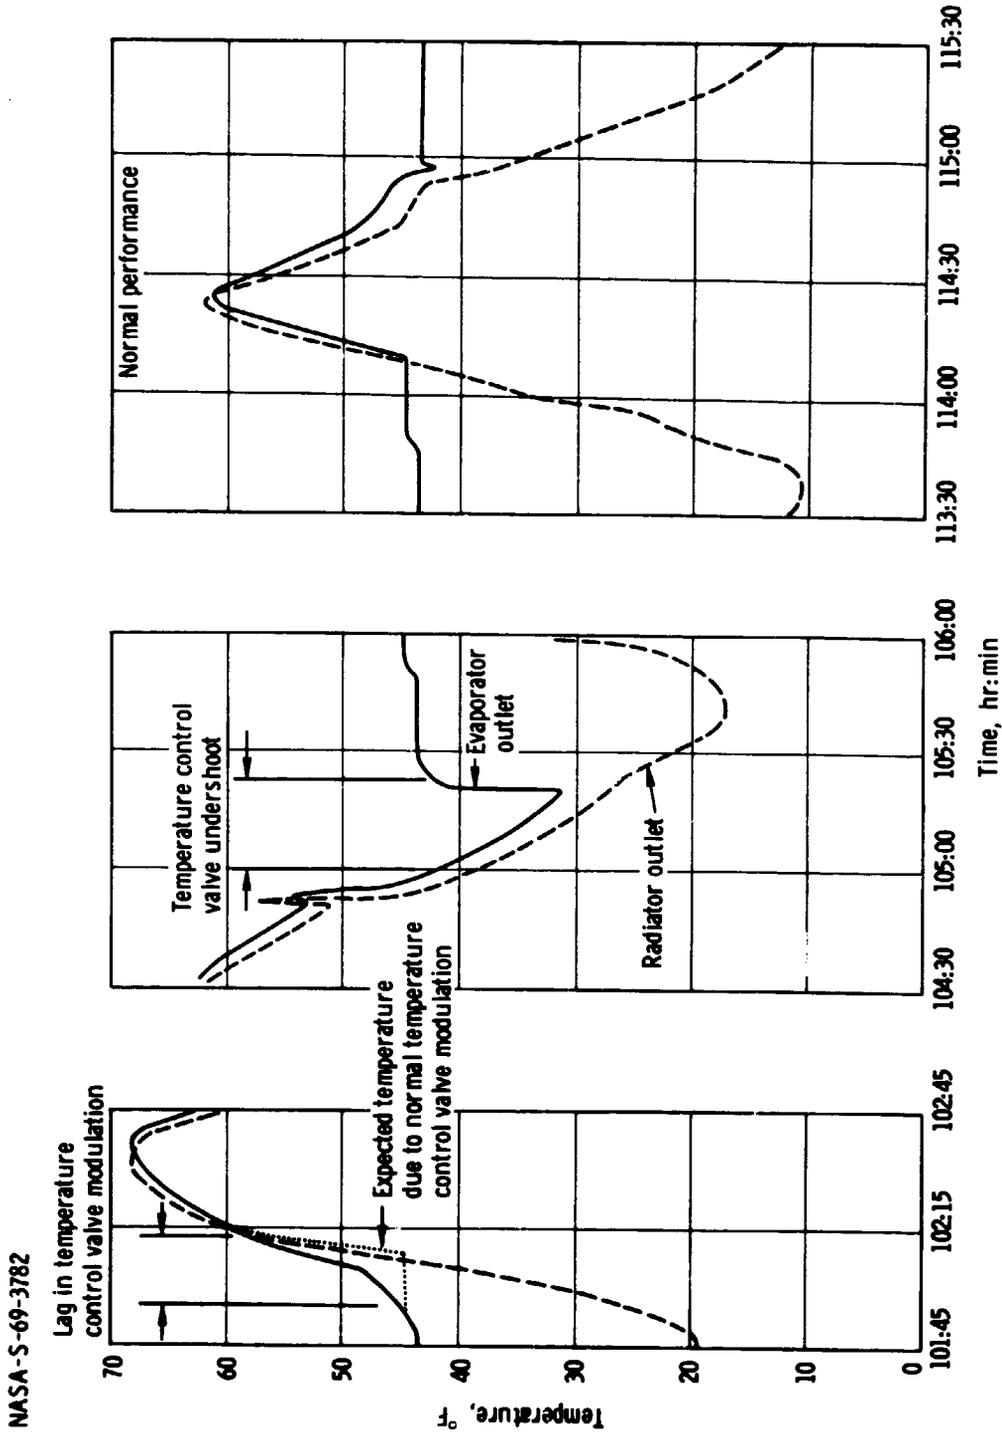
Figure 16-8. - Comparison of radiator and evaporator outlet temperatures.

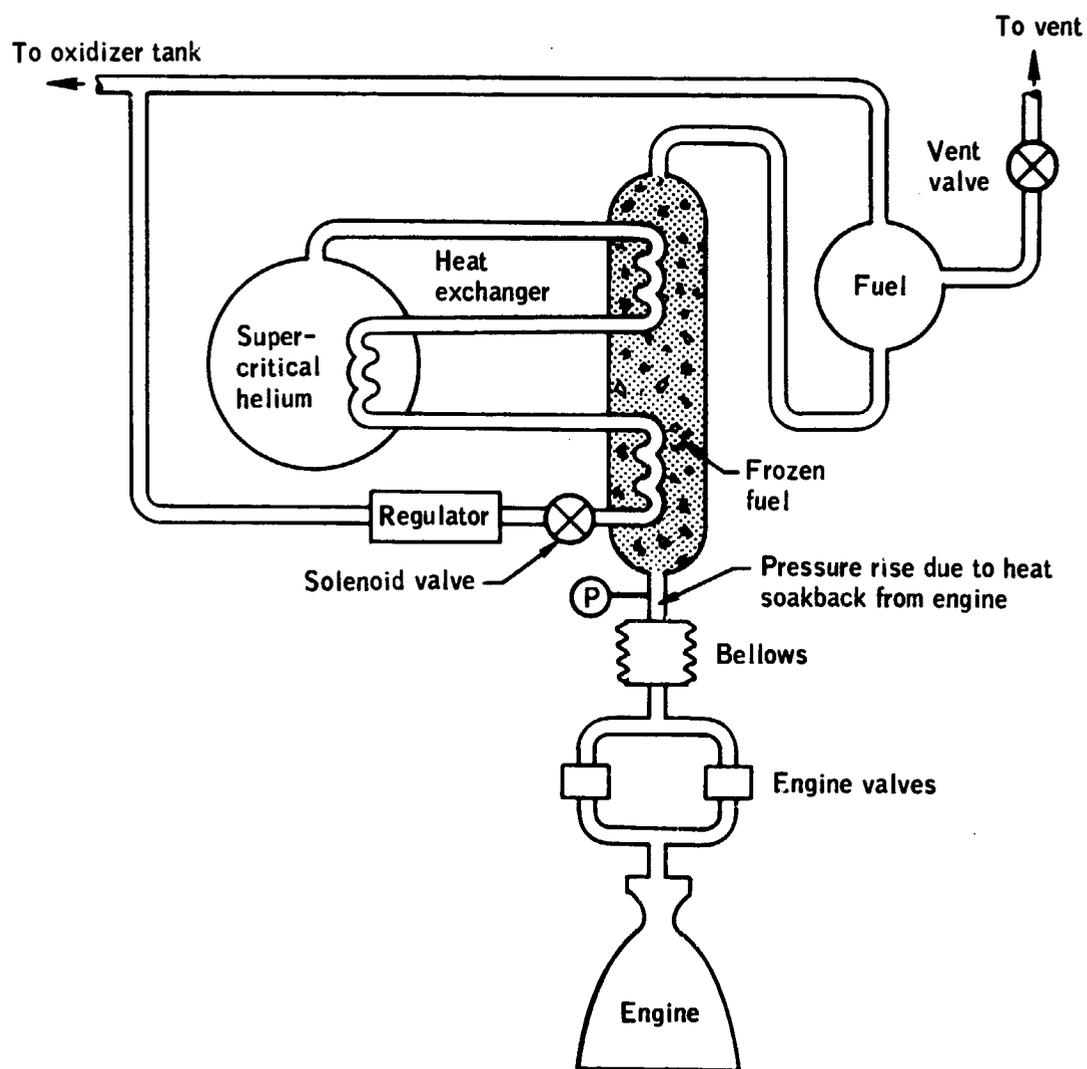
Figure 16-10.- Supercritical helium flow for descent propulsion system.

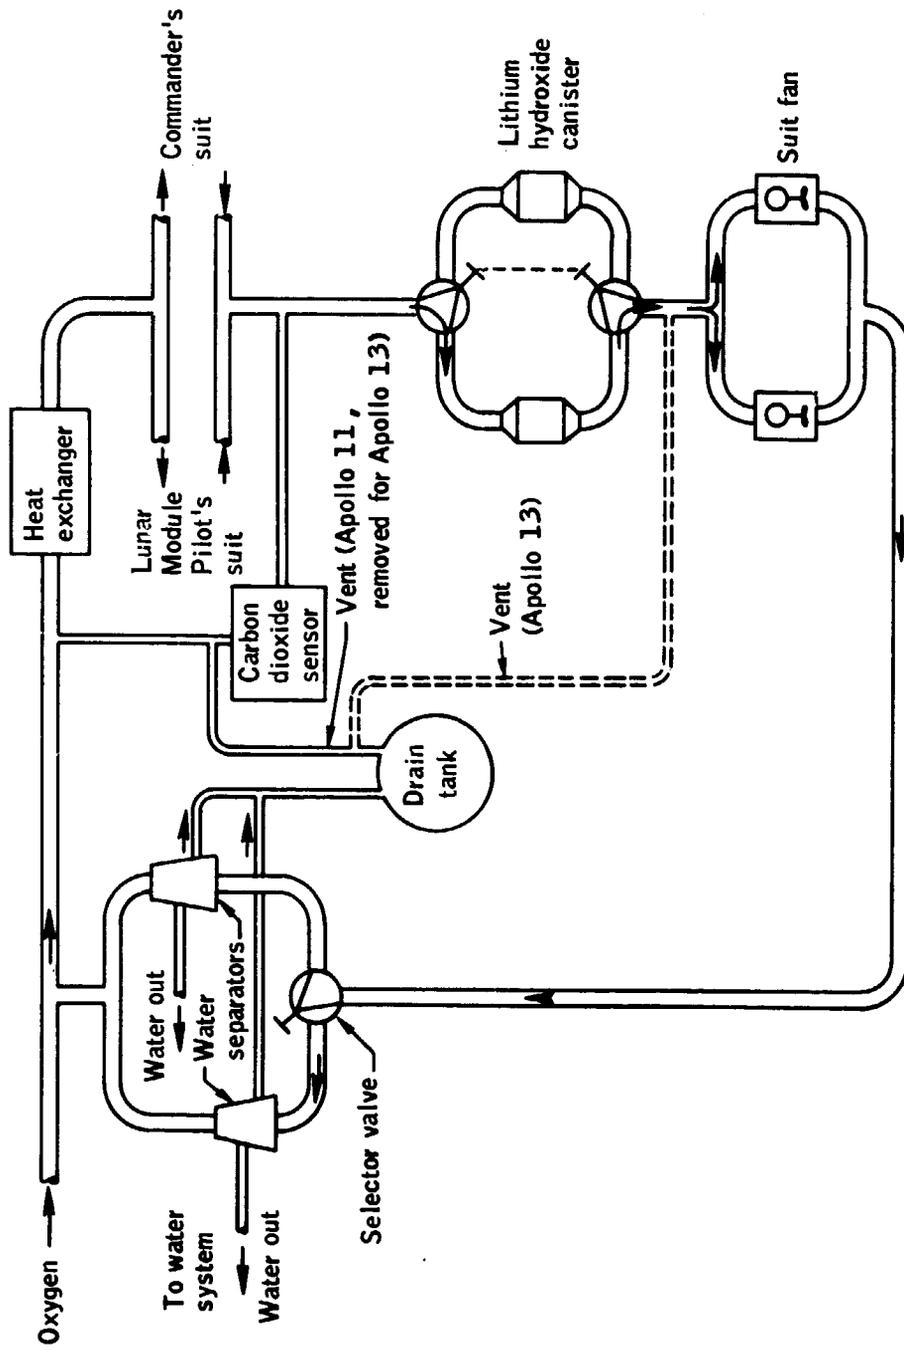
The possible sources of free water in the suit loop are the water separator drain tank, an inoperative water separator, local condensation in the suit loop, and leakage through the water separator selector valve. (see fig. 16-11). An evaluation of each of these possible sources indicated that leakage through the water separator selector valve was the most probable source of the free water.

Figure 16-11.- Simplified suit loop schematic.

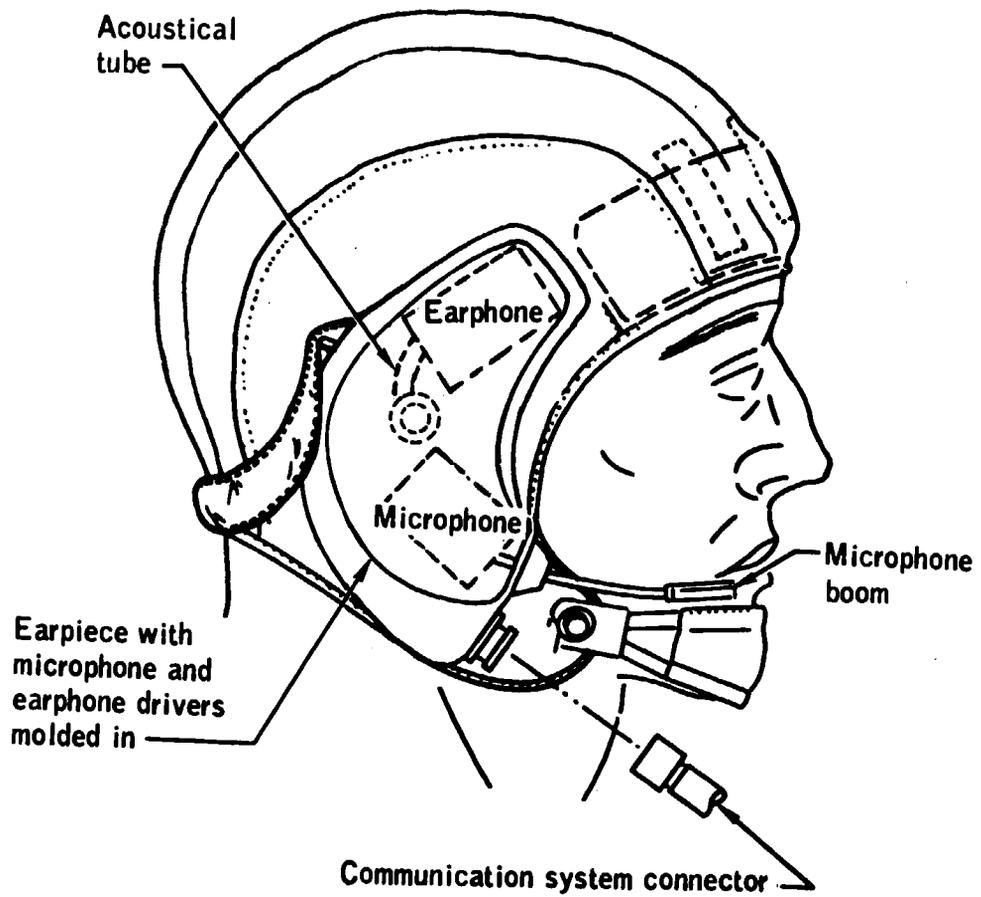
Figure 16-16.- Communications relays during extravehicular activity.

A voice turnaround (echo) was heard during extravehicular activity. At that time, the lunar module was operating in a relay mode. Uplink voice from the S-band was processed and retransmitted to the two extravehicular crewmen via the lunar module VHF transmitter. Crew voice and data were received by the lunar module VHF receiver and relayed to the earth via the lunar module S-band transmitter (see fig. 16-16). The echo was duplicated in the laboratory and resulted from mechanical acoustical coupling between the communications carrier earphone and microphone (fig. 16-17). The crew indicated that their volume controls were set at maximum during the extravehicular activity. This setting would provide a level of approximately plus 16 dBm into each crewman's earphones. Isolation between earphones and microphones, exclusive of air path coupling, is approximately 48 dB. The ground voice signal would therefore appear, at the microphone output, at a level of approximately minus 32 dBm. Assuming extravehicular communication keying is enabled, this signal would be processed and transmitted by the extravehicular communications system and would provide a level of approximately minus 12 dBm at the output of the lunar module VHF receiver. If the lunar module relay is enabled, this signal would be amplified and relayed to earth via S-band at a nominal output level.

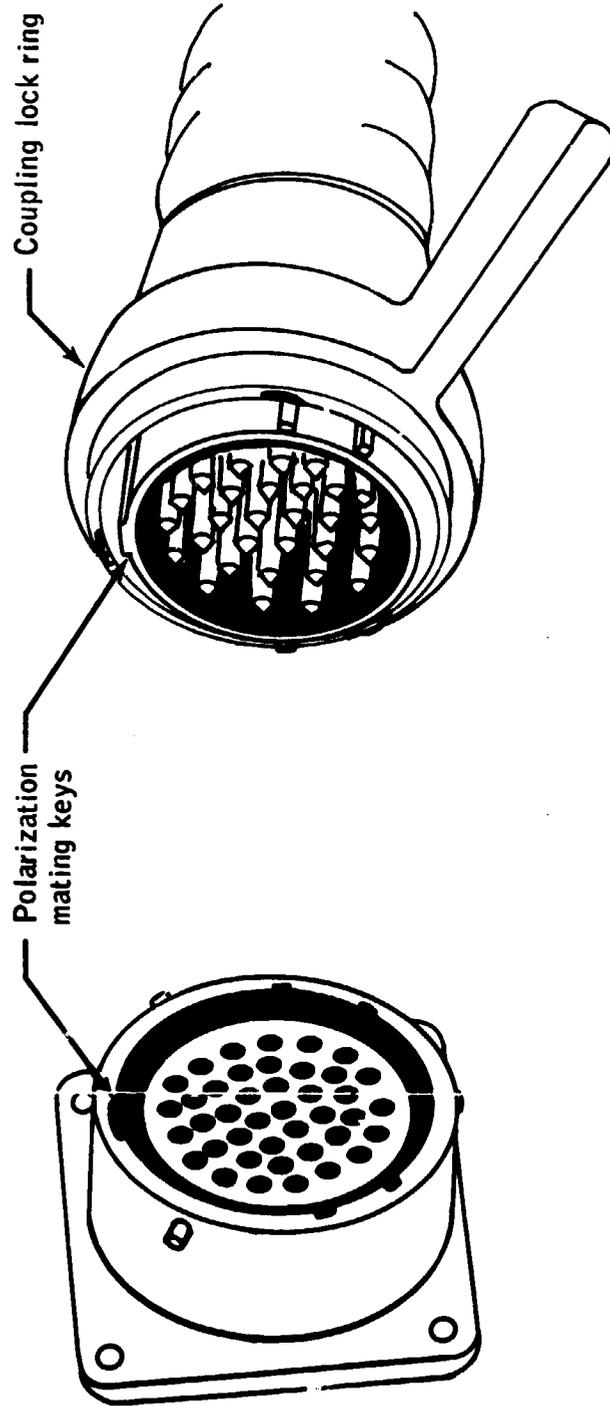
Figure 16-22.- Connector between remote control unit and portable life support system.

During preparation for extravehicular activity, the crew experienced considerable difficulty in mating the electrical connectors from the remote control unit to the portable life support system. For rotational polarization alignment, it was necessary to grasp the cable insulation because the coupling lock ring was free for unlimited rotation on the connector shell (see fig. 16-22).
