MSC-05101

APOLLO 14 MISSION  
ANOMALY REPORT NO. 1

FAILURE TO ACHIEVE DOCKING PROBE  
CAPTURE LATCH ENGAGEMENT

OCTOBER 1971

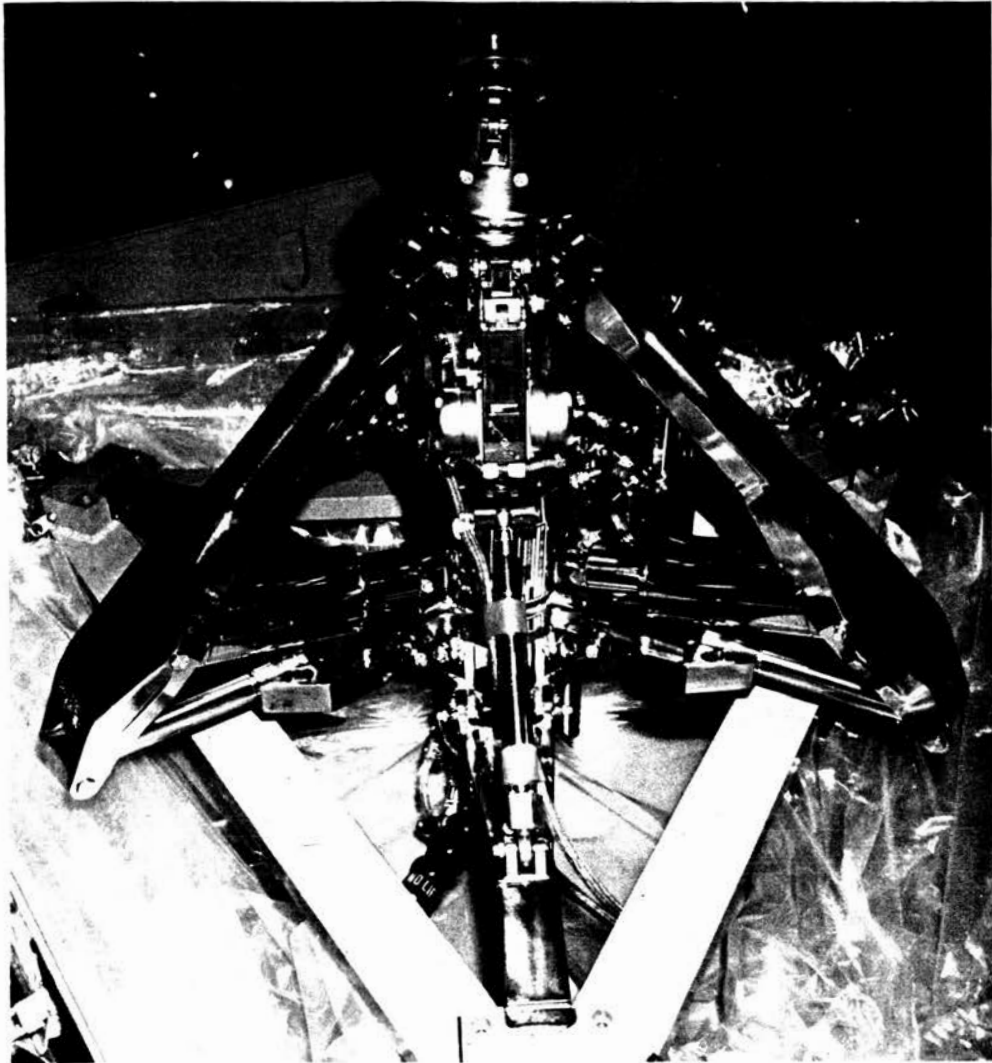
Figure 1.- Apollo 14 probe assembly.

Six docking attempts were required in order to successfully achieve capture latch engagement during the transposition and docking phase following translunar injection. After docking, the probe (fig. 1) and drogue (fig. 2) were examined by the crew. Probe operation appeared normal and radial marks were noted on the drogue. During all subsequent operations, the probe operated properly.

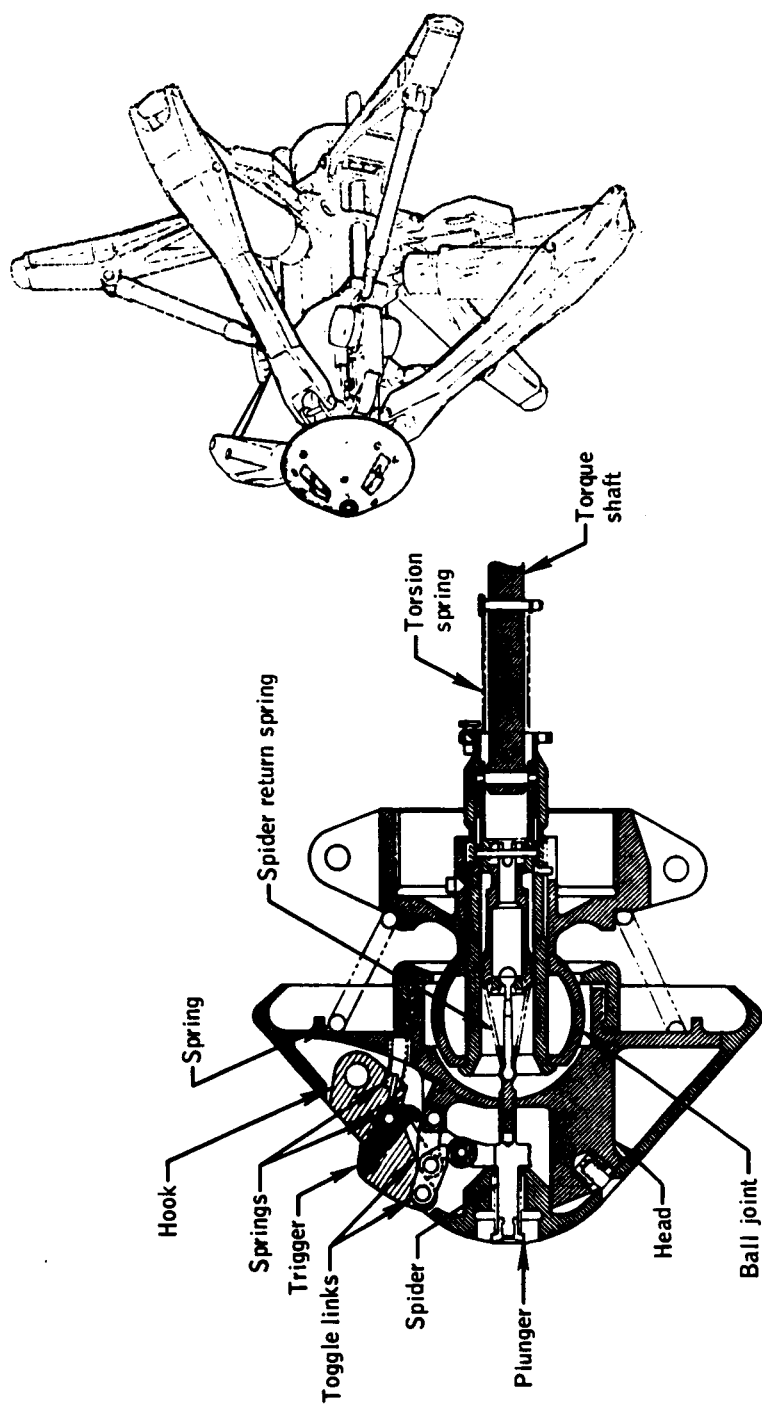
Figure 5.- Probe capture latch assembly shown in locked position.

The probe capture latch assembly (fig. 5) is contained within the probe head and is used for achieving the initial coupling between the command module and lunar module. Figure 6 shows the probe latches locked to a test tool in the same manner as they lock to the drogue. The capture latch assembly consists of three latch hooks (fig. 7) which are pin mounted in the probe head and spring loaded such that the hook protrudes beyond the surface of the probe head. Opposite each of the latch-hook pivot points is a two-piece toggle link (fig. 5) that connects the latch hook to a fixed point on the probe head.

Locking and releasing of the latch hook is determined by the axial position of a single, symmetrical spider (fig. 8) which is spring loaded to the full forward (locked) position (fig. 5). In this position, a roller on the spider (fig. 7) rests beneath each of the latch-hook toggle links such that the latch hooks cannot be depressed. To unlock the latch hooks, the spider must be moved aft and retained until subsequent latch lock is required (fig. 9).

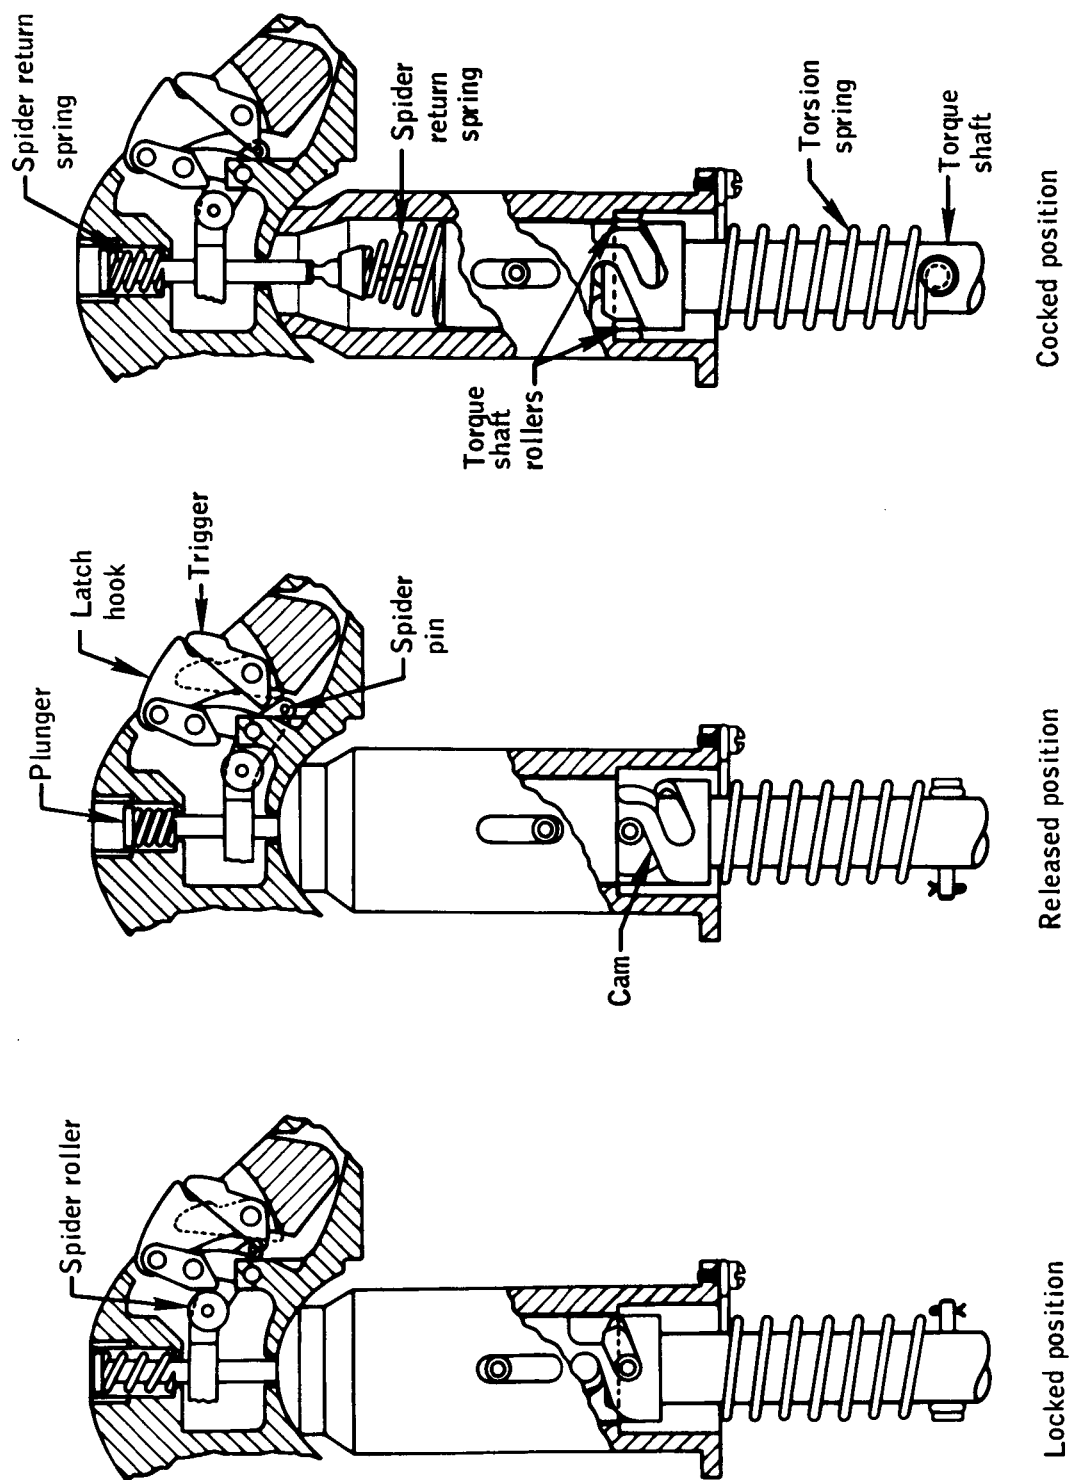
Figure 9.- Relationship of probe latch and cam mechanisms.

1. The probe status talkback displays functioned properly before and after the unsuccessful attempts, thus indicating proper switch operation and power to the talkback circuits. The talkback displays always indicated that the capture latches were in the cocked position during the unsuccessful attempts (fig. 9). (Note that no electrical power is required to capture the drogue, because the system is cocked prior to flight and the capture operation is strictly mechanical and triggered by the drogue.)

Since the latches were cocked, the problem was most likely caused by failure of the capture latch spider to reach the forward locked position.
