## APOLLO 15 MAIN-PARACHUTE FAILURE

By Donald D. Arabian and Joseph E. Mechelay\*

### ABSTRACT

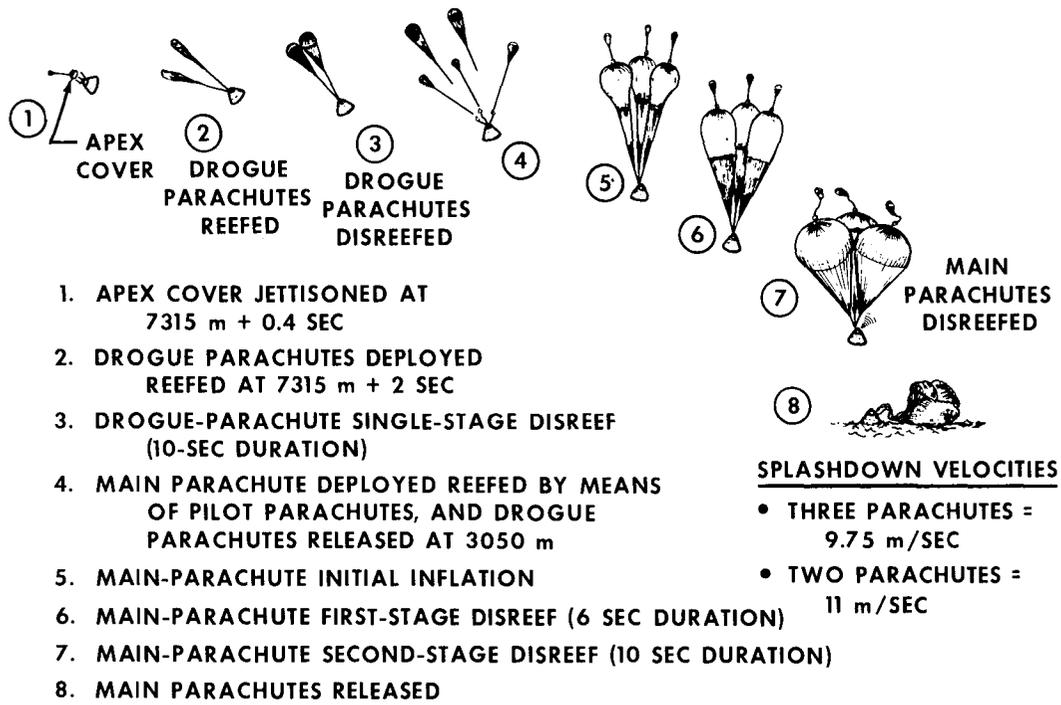
Trajectory analysis. - The landing sequence was initiated at a nominal altitude of 7315 meters with jettisoning of the forward heat shield (fig. 5), which is used to protect the parachute system. Immediately after separation of the heat shield from the command module, a 2.19-meter-diameter parachute was mortar deployed from the forward heat shield, an action that augments separation of the heat shield from the command module. Following a drogue- and pilot-parachute deployment sequence, the main parachutes are deployed and decelerate the command module to its final descent velocity of approximately 9 m/sec. The descent rate of the 172-kilogram forward heat shield is approximately 31 m/sec.

Figure 5. - Earth landing system normal sequence.
