**APOLLO 15 MISSION  
ANOMALY REPORT NO. 1  
MAIN PARACHUTE FAILURE**

(NASA-TM-X-6835C) APOLLO 15 MISSION MAIN  
PARACHUTE FAILURE Anomaly Report no. 1  
(NASA) Dec. 1971 32 p CSCL 22C

**MANNED SPACECRAFT CENTER  
HOUSTON, TEXAS  
DECEMBER 1971**

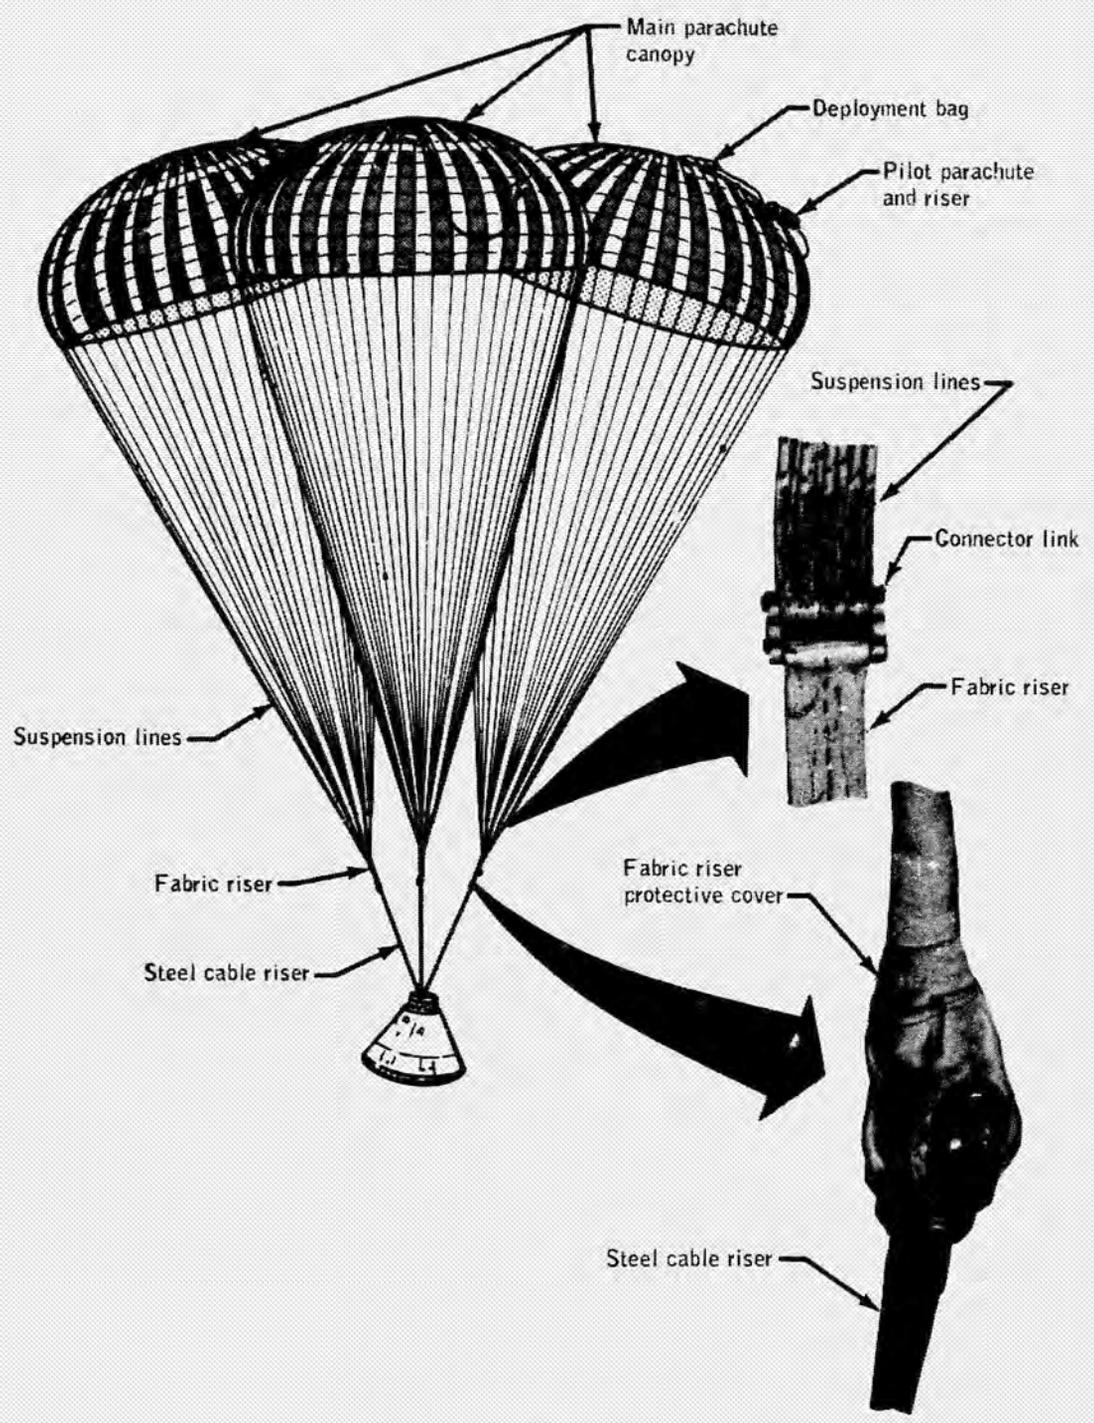
Figure 2.- Parachute system configuration.

lines which are attached by six steel connector links to six individual legs of a fabric riser. The six legs of the fabric riser converge into a single leg which connects to the end of a steel cable riser. The three steel cable risers of the parachute system converge and attach to the command module through the parachute attachment and disconnect assembly.

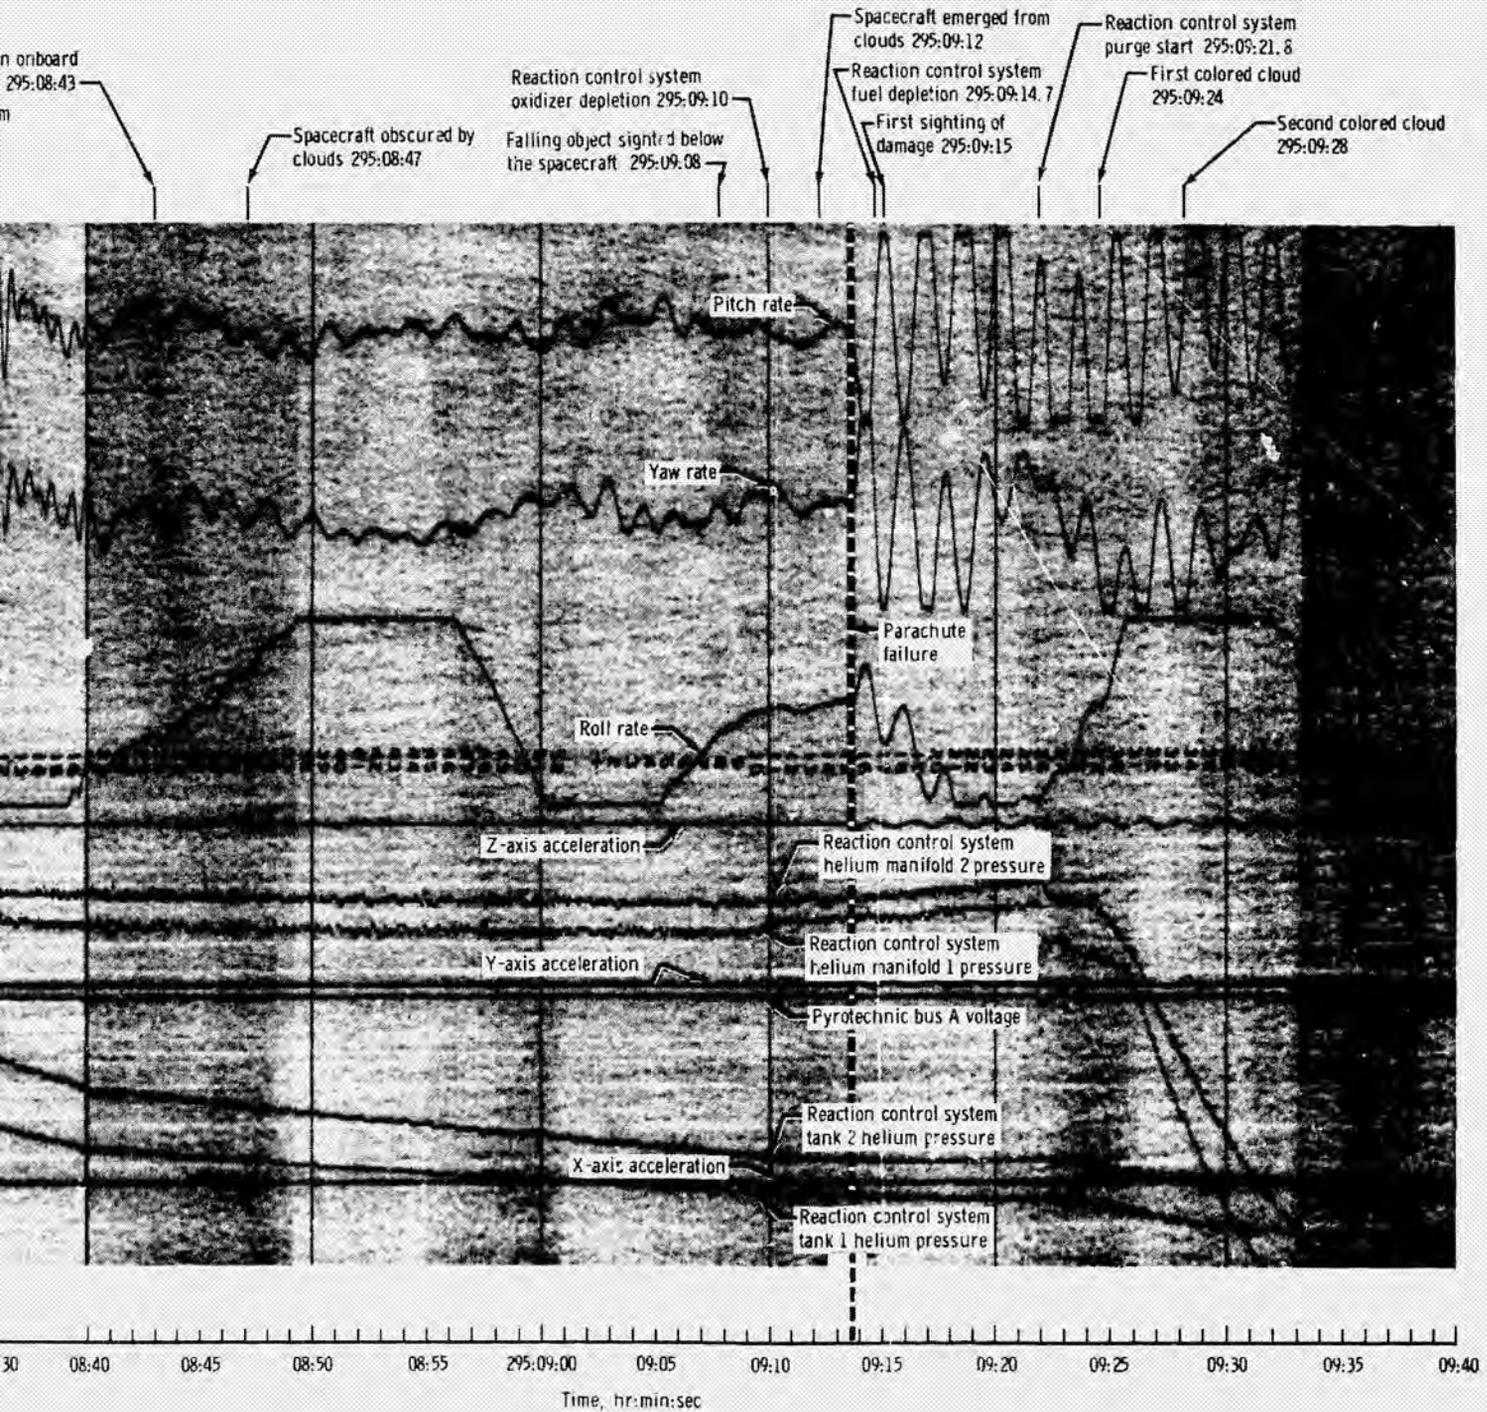
Figure 3.- Sequence of events during descent on the main parachutes.

Pertinent data and the sequence of events are shown in figure 3. The data showed no abnormal conditions or events prior to the failure. About 3.5 seconds before the failure, the reaction control system manifold pressure abruptly increased to a new level, indicating the regulator had closed because all the oxidizer was expelled from the tanks. The fuel, however, was still being expelled and was calculated to have been depleted about 4.7 seconds after the oxidizer depletion. This was based on a determination of about 7 pounds of fuel remaining at oxidizer depletion. About 8 seconds after the failure, the reaction control system purge was initiated by the crew. (The crew was unaware of the failure until some time after the purge.) The time of the purge is indicated in figure 3 by the abrupt decrease in system pressure.

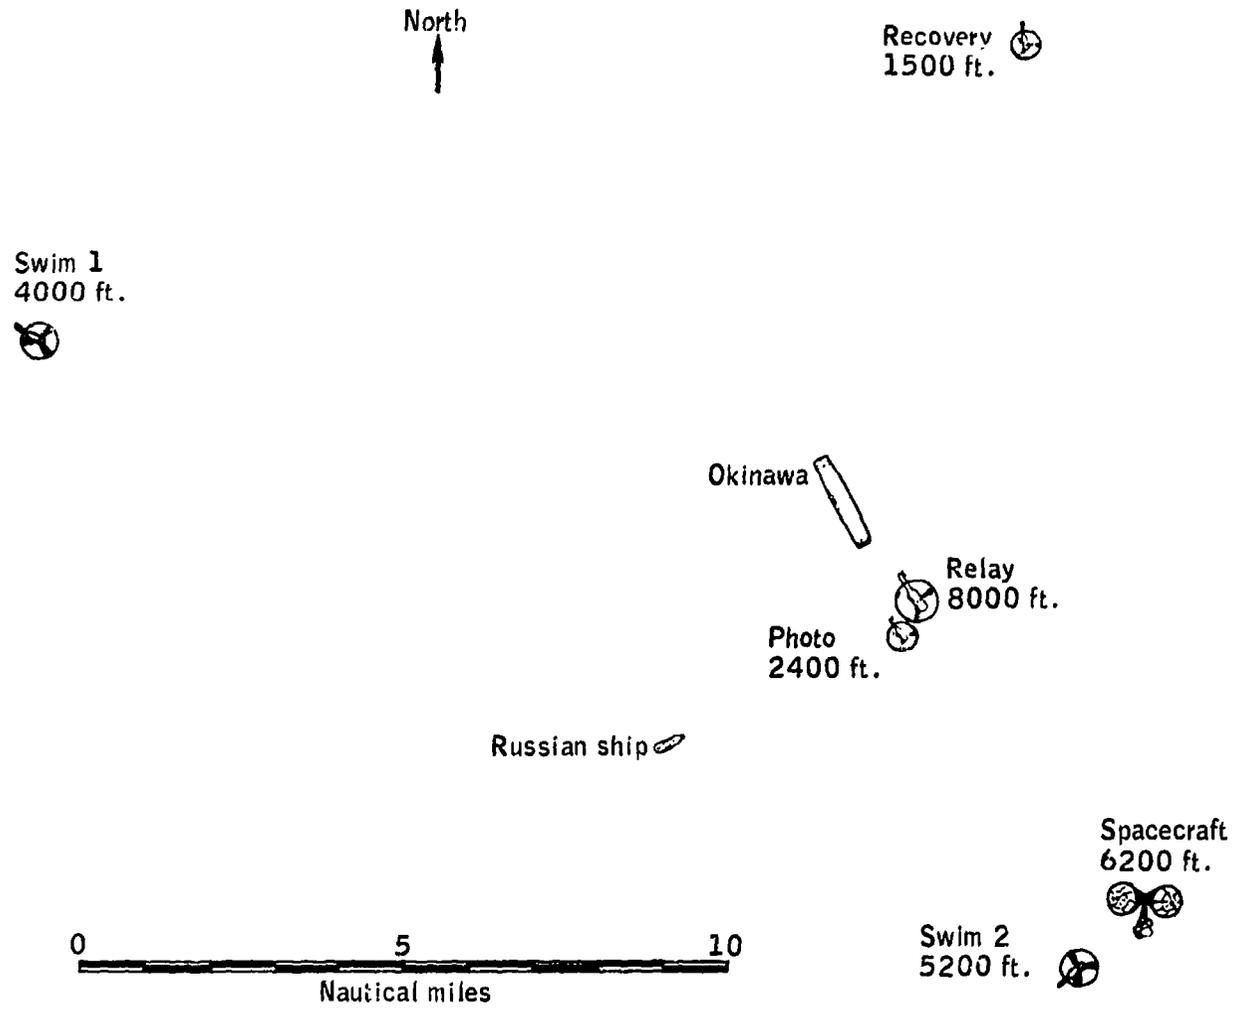
Figure 6.- Approximate location of recovery forces at 295 hours 9 minutes.

The pilots and copilots of three of the recovery helicopters (Swim 2, Photo, and Relay) observed the spacecraft between main parachute opening and landing. The locations of the recovery forces at the time of the anomaly are shown in figure 6. The observations of the three helicopter crews show that the anomaly occurred at approximately 6000 feet and that the forward heat shield was falling in close proximity to the spacecraft, but slightly out of plane from the observer's viewpoint. The helicopter crews observed the brownish cloud and puffs of white smoke which normally occur during the reaction control system purge.

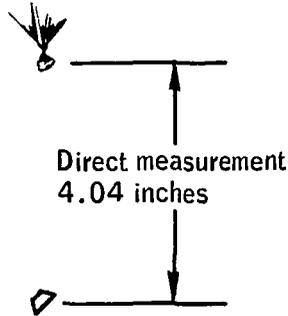
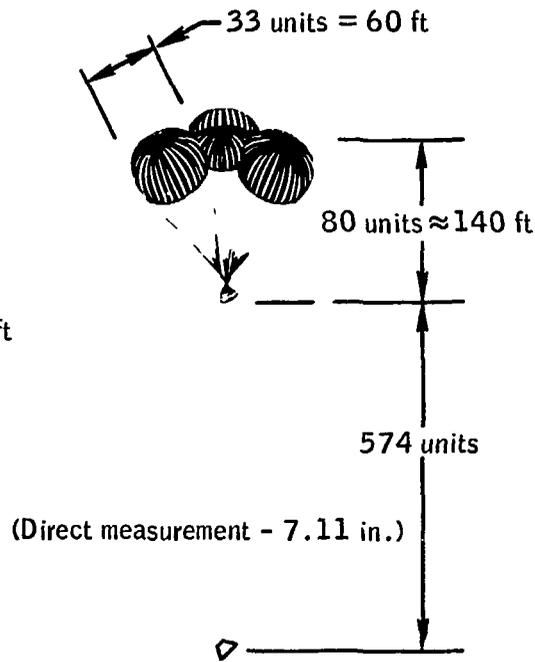
Figure 9.- Television frame and trajectory analysis .

Photographic analysis.- A close examination of the television record of spacecraft descent on the main parachutes establishes that the forward heat shield was below the spacecraft at the time of the failure. Specifically, the forward heat shield is seen below the spacecraft in frame 588 (fig. 9) at 295:09:11.3, approximately 2 seconds before the anomaly occurred. By correlation with frame 775, which shows the parachute and forward heat shield in the same frame at 295:09:17.5, and by direct measurement of the separation distance between the two objects and measurement of the known parachute dimensions, the vertical separation distances between the forward heat shield and the spacecraft were 580 feet for frame 588 and 1020 feet for frame 775.

$$\Delta H = \frac{4.04}{7.11} (1020 \text{ ft.}) = 580 \text{ ft}$$

$$\Delta H = 580 \text{ ft}$$

Television frame 775  
 295:09:17.5 elapsed time

$$\Delta H = 574 (60/33) \text{ ft} = 1042 \text{ ft}$$

$$\text{or } 574 (140/80) \text{ ft} = 1004 \text{ ft}$$

$$\Delta H = 1020 \text{ ft}$$

$$\Delta V = \frac{1020 - 580}{17.5 - 11.3} \text{ ft/sec}$$

$$\Delta V = 71 \text{ ft/sec}$$

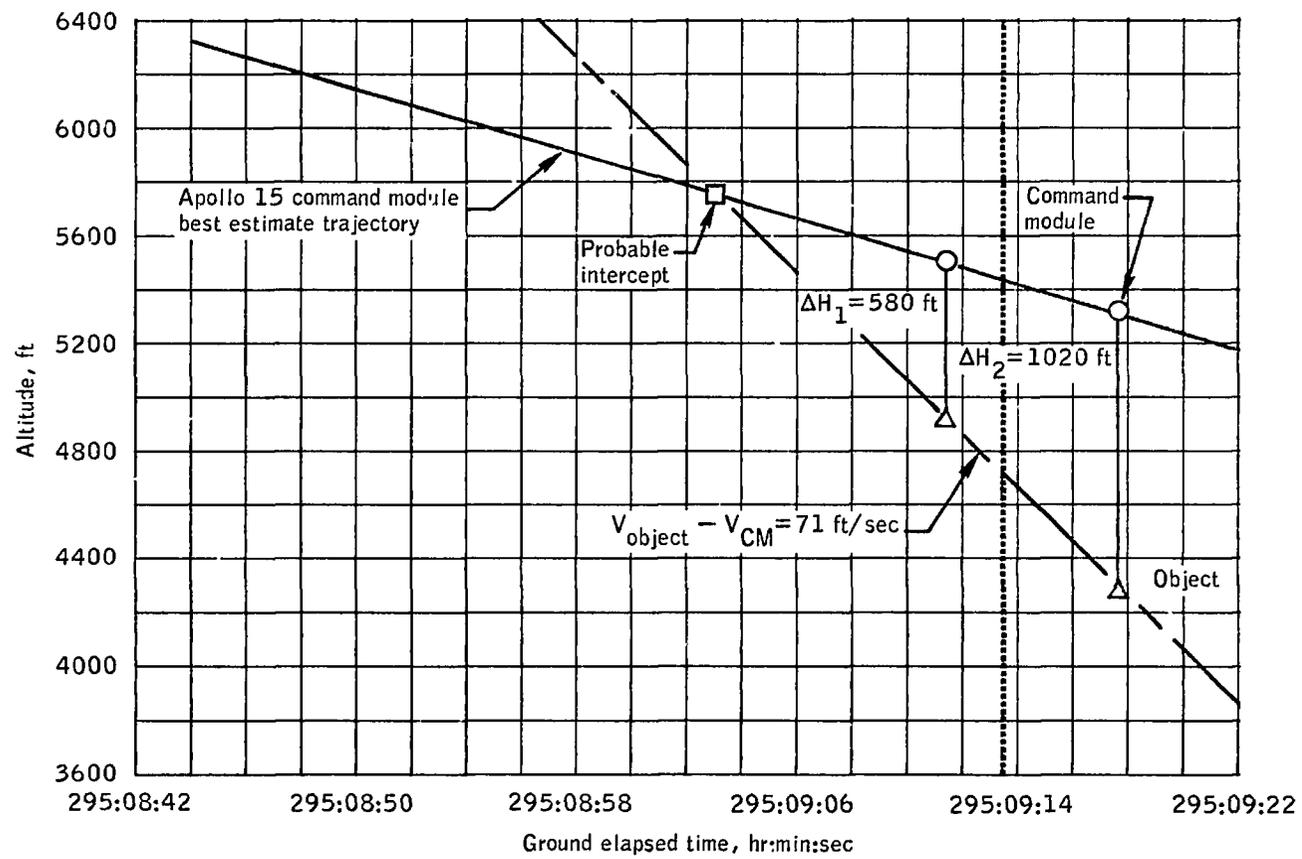
Figure 10.- Position of forward heat shield relative to spacecraft trajectory.

The position of the forward heat shield relative to the guidance-and-navigation-estimated trajectory is shown in figure 10. By extrapolating the forward heat shield trajectory, the forward heat shield would have intercepted the spacecraft at 295:09:03. This is 10.5 seconds before the spacecraft data indicate the anomaly occurred.

(b) Trajectory of command module and object.

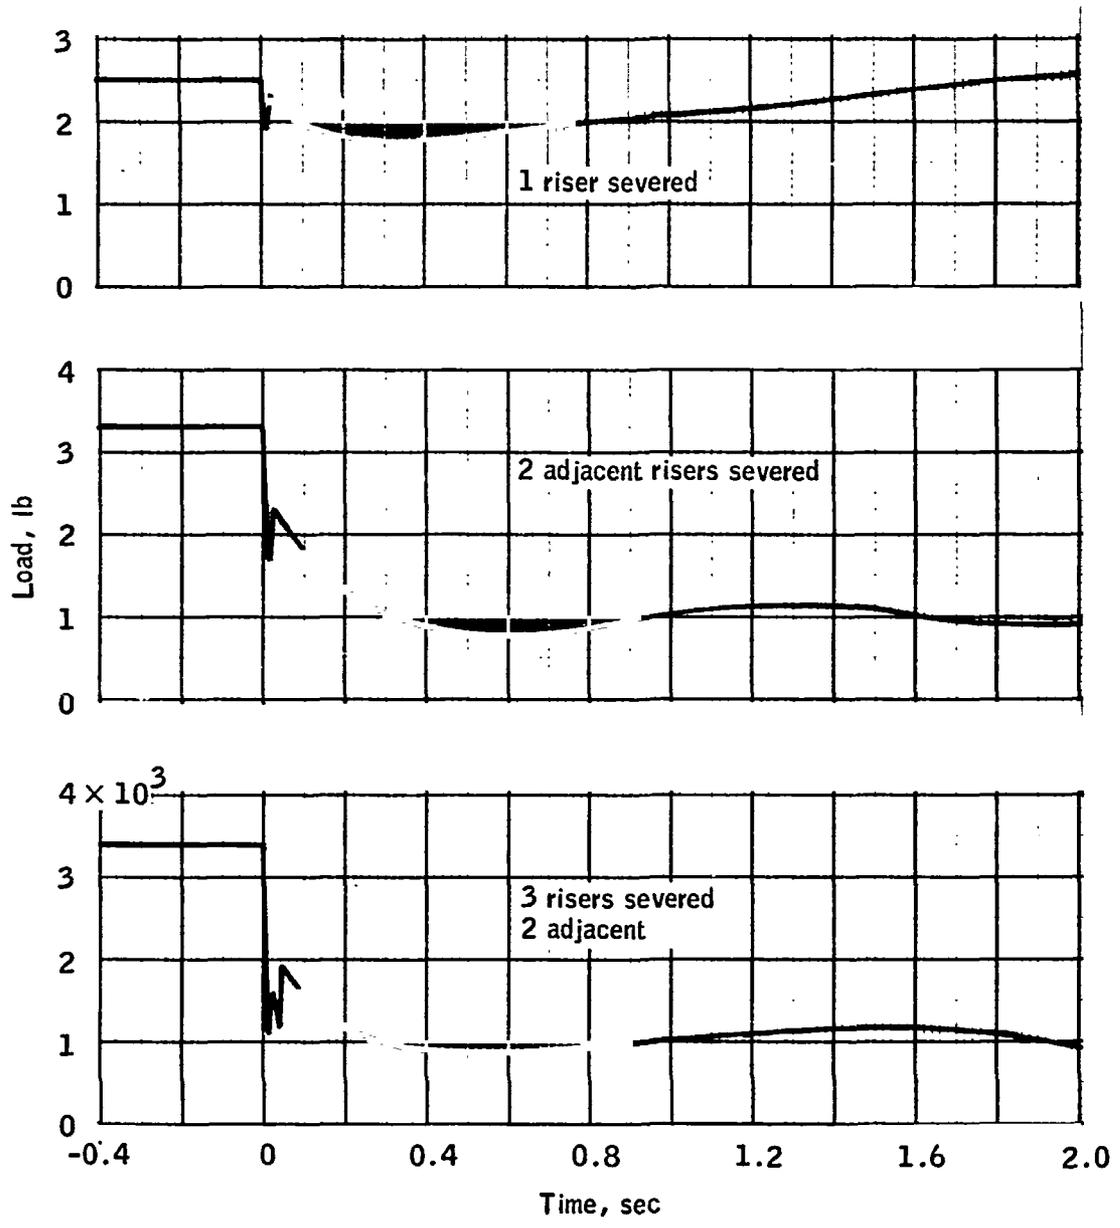
Figure 13.- Parachute tow test loads.

When one of the six riser legs was severed, the canopy remained fully inflated and, in approximately 2 seconds, exhibited full riser load. When two adjacent riser legs were severed, the canopy collapsed but did continue to provide a drag force of approximately one-third the fully inflated value. Three risers were severed in the third test; two were adjacent and the third was separated from them by a good riser leg. When the risers were severed, the canopy collapsed, with the portion opposite the severed risers holding air for several seconds. The load histories for each of the three tests are shown in figure 13. The initial load drop for the one-, two-, and three-riser test was 600, 1700, and 2300 lb, respectively.
