APOLLO 15 MISSION REPORT

MANNED SPACECRAFT CENTER  
HOUSTON, TEXAS  
DECEMBER 1971

Mission Evaluation Team

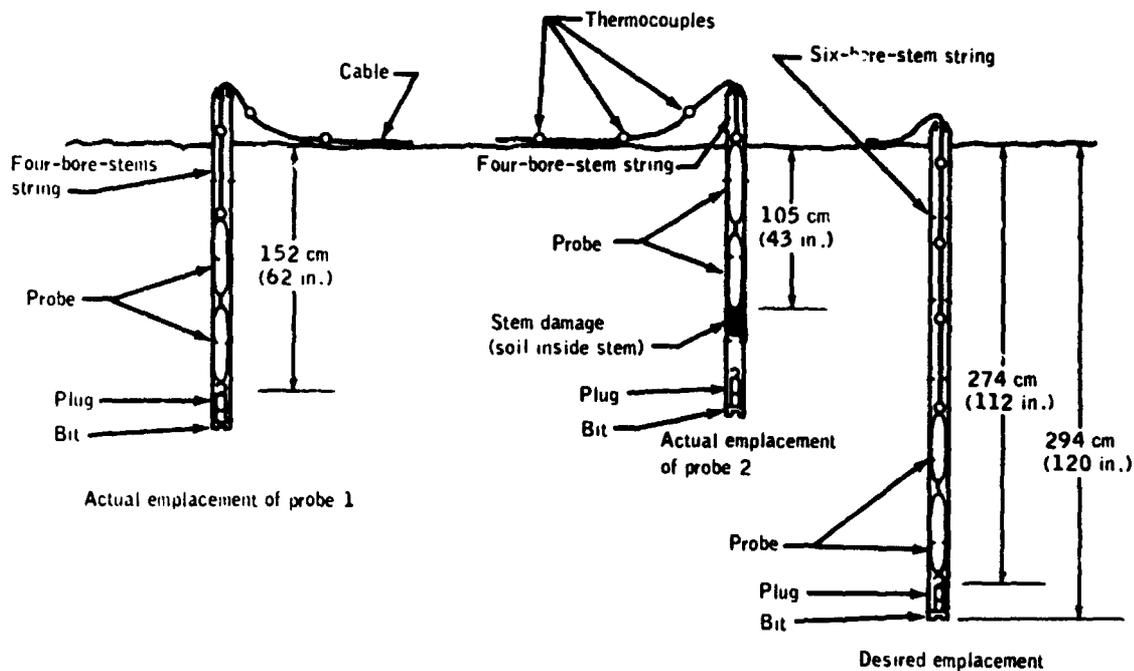
Figure 4-6.- Heat flow experiment bore-stem and probe emplacement.

Deployment of the heat flow experiment was started on the first extravehicular activity and completed on the second extravehicular activity. A minor problem was experienced in removing two Boyd bolts that fasten the heat flow experiment components to the subpallet and problems were encountered in drilling the holes for two probes and emplacing the second probe. Refer to sections 4.11 and 14.4.1 for further discussion. The electronics box was placed about 9 meters (30 feet) north-northeast of the central station. The first probe hole was drilled about 4 meters (12 feet) east of the electronics box and the second, about 4.5 meters (15 feet) west of the box. The first hole was drilled to a depth of about 172 centimeters (70 inches) and probe 1 was emplaced during the first extravehicular activity, but the drilling of the second hole and emplacement of probe 2 was deferred because of time constraints. Drilling was resumed at the second hole during the second extravehicular activity and a hole depth of about 172 centimeters (70 inches) was again achieved; however, damage to a bore stem section (sec. 14.4.1) prevented probe 2 from reaching the bottom of the hole. The first heat flow experiment probe extends from a point 47 centimeters (19 inches) below the surface to a point 152 centimeters (62 inches) below the surface. Because of the damage to the bore stem in the other hole, the second probe extends from the surface to 105 centimeters (43 inches) below the surface (see fig. 4-6).

The experiment was turned on at 1947 G.m.t., July 31, and valid temperature data were received from all sensors. Because of the shallow emplacement of probe 2, high near-surface temperature gradients will keep the differential thermometers on the upper section off-scale during most of a lunar day-night cycle. The lower section of probe 2 and both the upper and lower sections of probe 1 are returning valid data on subsurface temperatures. Sensors on these sections that are shallower than 80 centimeters (32 inches) are seeing the effects of the diurnal cycle of surface temperature, but these variations are well within the range of measurement. Lunar surface temperatures are being obtained from five of the eight thermocouples in the probe cables that are just above or on the lunar surface because of the shallow emplacement.

The performance of the drill power-head and the core stem was good. However, full depth penetration with the bore stems was a problem and extraction of the core stems from the hole was difficult (see sec. 14.4.1). The two bore stem holes were drilled to a depth of about 172 centimeters (70 inches) instead of the desired 294 centimeters (120 inches), with one of the bore stem strings probably sustaining damage at a point slightly above the first joint [about 105 centimeters (43 inches) below the surface] (see fig. 4-6).

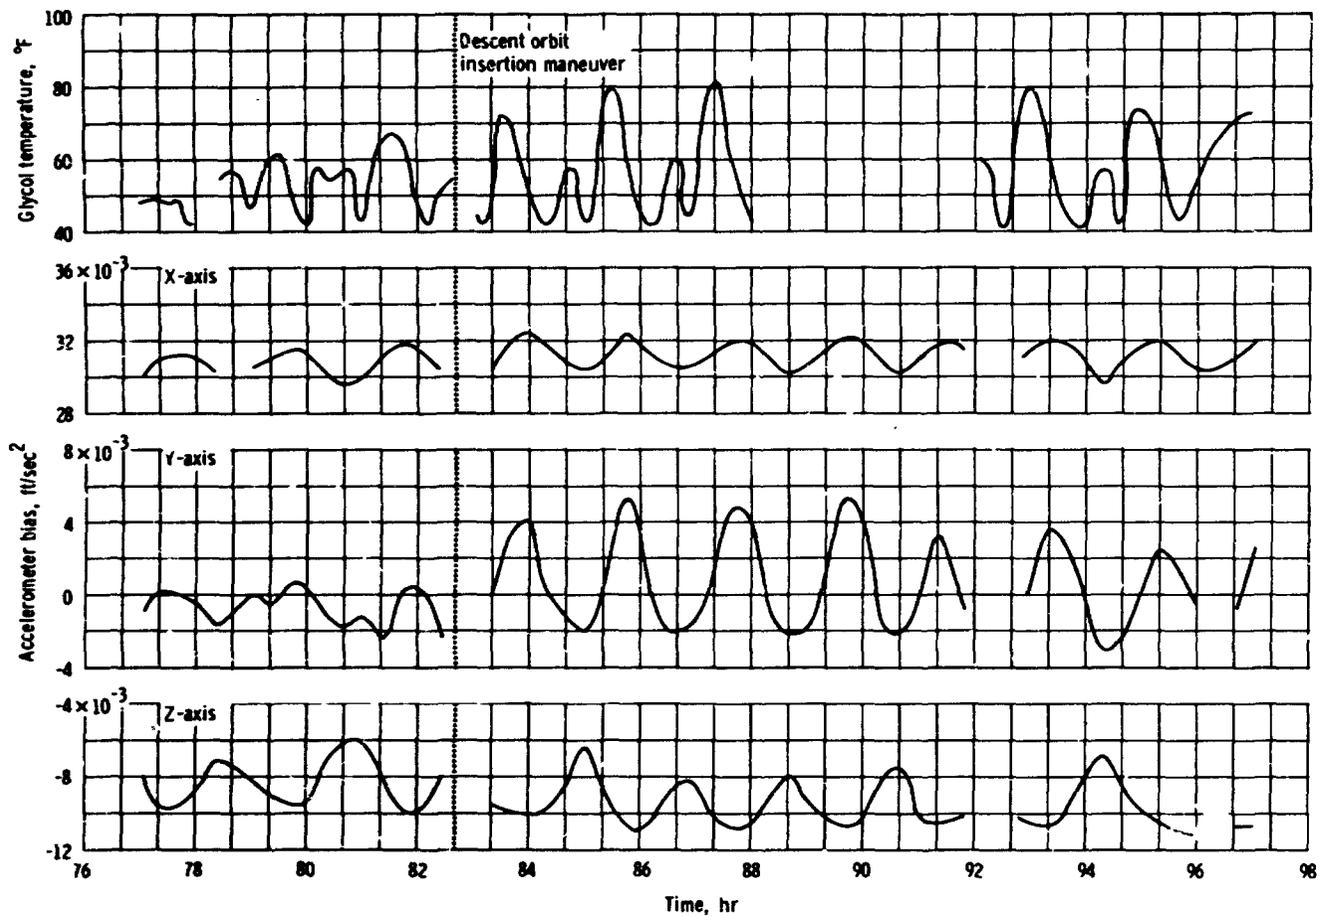
Figure 6-2.- Effect of coolant temperature oscillations on accelerometer bias during lunar orbit.

oscillations in the coolant loop gave some concern as to how these temperature excursions would affect the guidance equipment. Since no direct guidance equipment telemetry measurements of coolant temperatures were available, an analysis was performed using a thermal model of the coolant loop and a ground test was performed with non-flight guidance equipment. Both indicated that considerable temperature attenuation exists in the coolant loop and that temperatures experienced during the flight were within acceptable limits. As a result of the thermal analysis, the maximum temperature limits in the systems operational data book are being raised to 90° F, peak, and 75° F, average, over a 2-hour period. The effect of coolant temperature oscillations upon accelerometer bias is shown in figure 6-2.

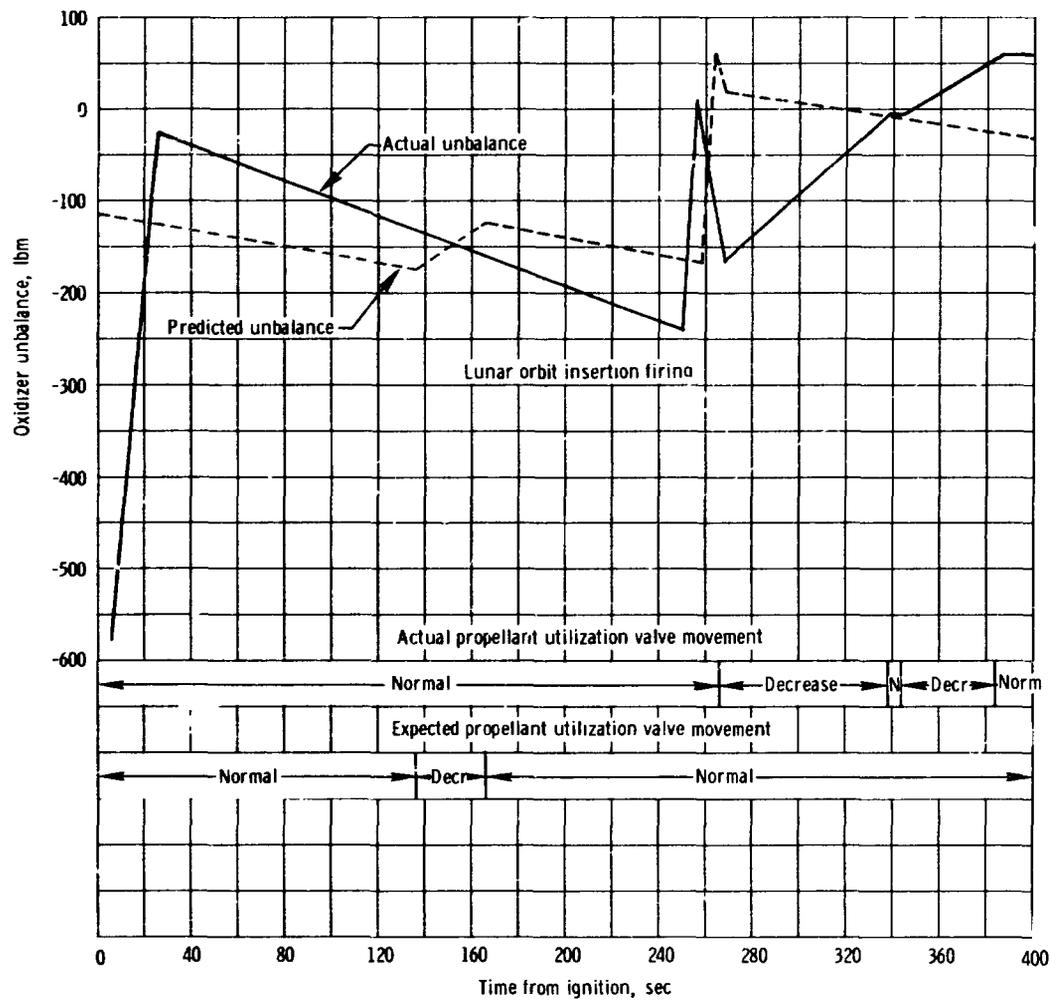
Figure 6-3.- Propellant unbalance during the lunar orbit insertion and transearth injection firings.

Previous flight results have shown the inflight mixture ratio to be significantly less than expected from engine acceptance test data. The service propulsion system engine was re-orificed to increase the mixture ratio for this mission. Figure 6-3 shows the propellant unbalance for the two major engine firings compared with the predicted unbalance. The unbalance at the end of the transearth injection firing was very small and shows that the modifications to the engine were satisfactory.

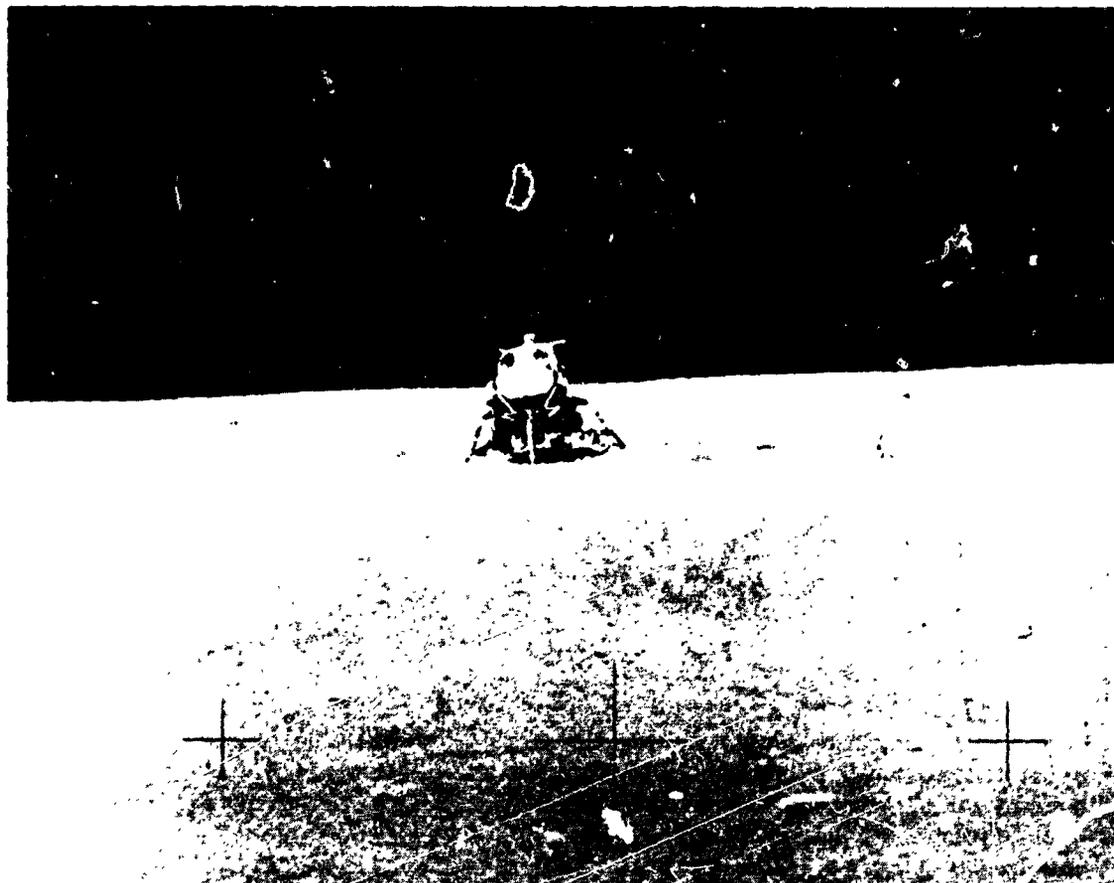
Figure 7-2.- Attitude of lunar module on lunar surface.

The vehicle contact velocity and attitude data at touchdown show that the landing was very stable in spite of the relatively high lunar surface slope at the landing point. The plus-Z and plus-Y footpads contacted the lunar surface nearly simultaneously, providing a nose-up pitch rate of 17 deg/sec and a roll rate to the left of 15 deg/sec. Final spacecraft settling occurred 1.8 seconds later. The vehicle at-rest attitude, as determined from the gimbal angles, was 6.9 degrees pitch up and 8.6 degrees roll to the left, resulting in a vehicle tilt angle on the lunar surface of approximately 11 degrees from the horizontal (fig. 7-2).

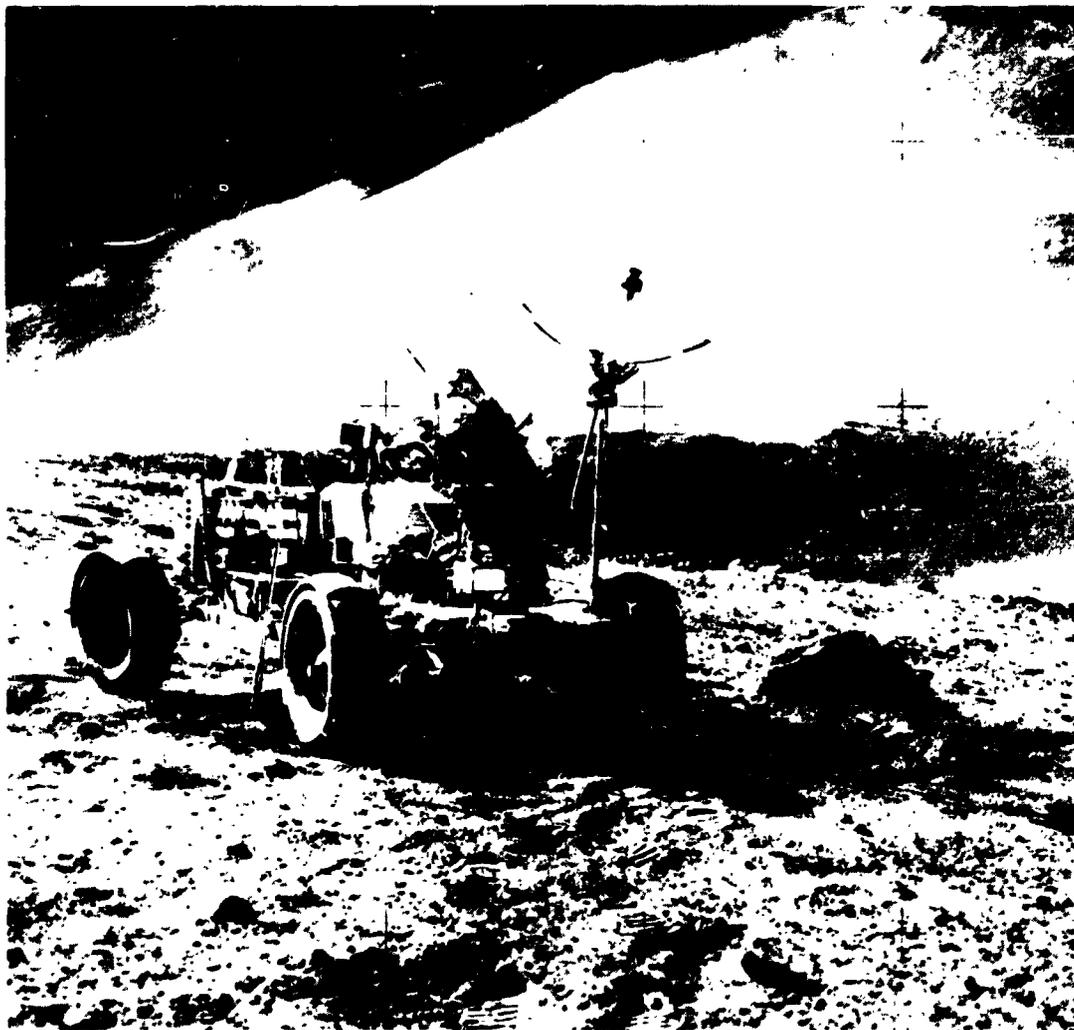
Figure 8-2.- Lunar roving vehicle.

The lunar roving vehicle (fig. 8-2) performed well during the mission. During the three lunar surface extravehicular activities, the vehicle traveled 27.9 kilometers (15.1 miles) during 3 hours and 8 minutes of driving at an average speed of 9.2 kilometers (4.97 miles) per hour. A total of approximately 52 ampere-hours was consumed. Navigation errors were within expected tolerances with small distance errors and no apparent gyro drift. The combined wander and wheel slip factor was within predicted limits.

The front-wheel steering was inoperative during the first extravehicular activity, but operated normally for the second and third extravehicular activities. Simultaneous front- and rear-wheel steering was found to be more sensitive than desired, and difficulties were experienced with the seat belts; but overall, the crew was very pleased with the vehicle's performance, particularly, the speed and hill-climbing capability.

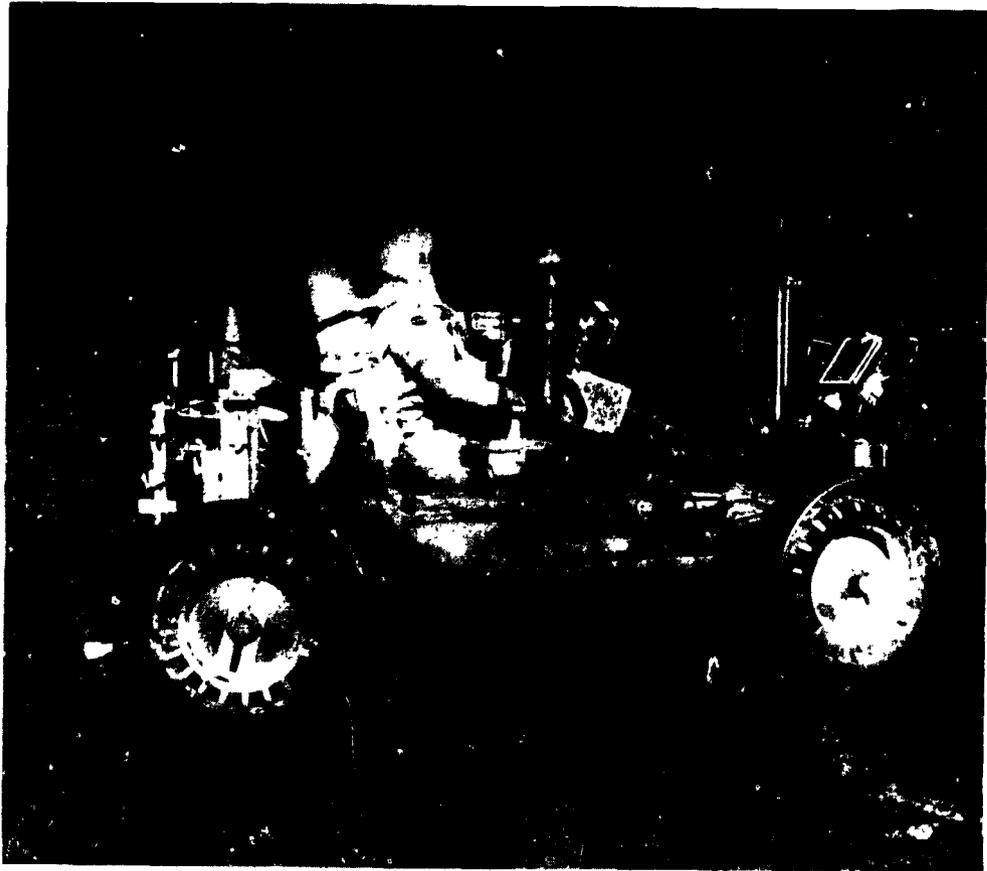
Figure 9-5.- Commander seated on the lunar roving vehicle.

Front steering was inoperative during the first extravehicular activity. All switches and circuit breakers were cycled a number of times

during the early portion of the first extravehicular activity with no effect on the steering. Subsequently, at the beginning of the second extravehicular activity, cycling of the front steering switch apparently enabled the front steering capability which was then utilized throughout the remaining traverses.

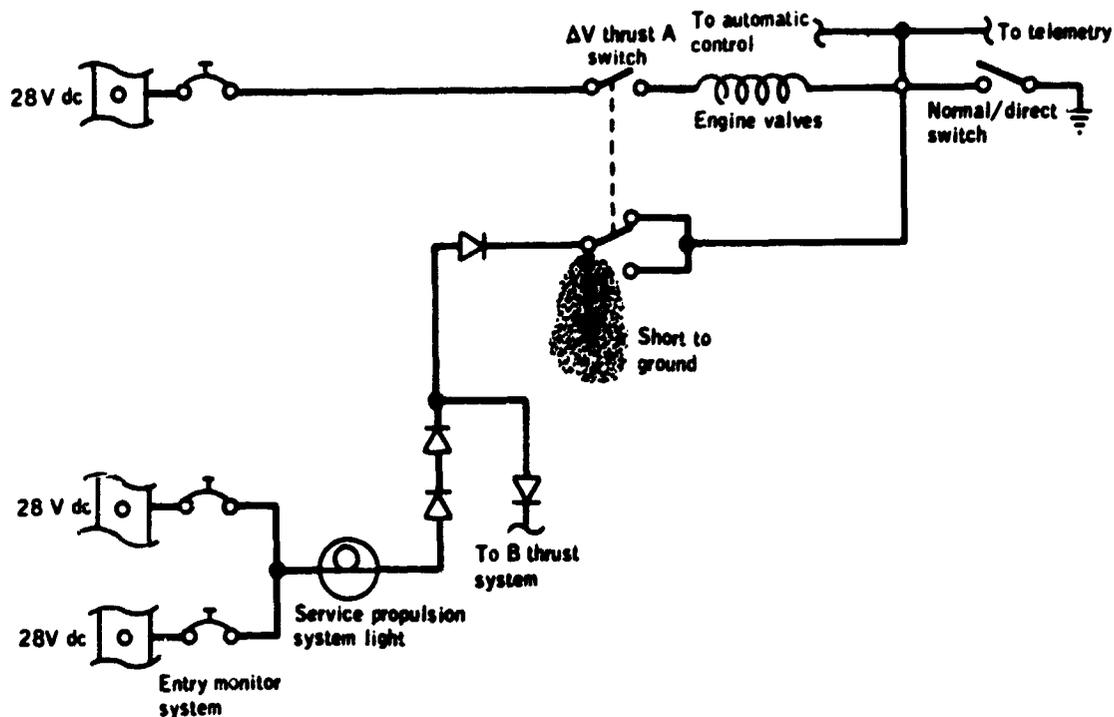
APPROVED BY

The short was isolated to the system A delta-V thrust switch which was found to be intermittently shorted to ground (fig. 14-3). A test firing performed at 28:40:22 verified that the short existed on the ground side of the service propulsion system pilot valve solenoids.

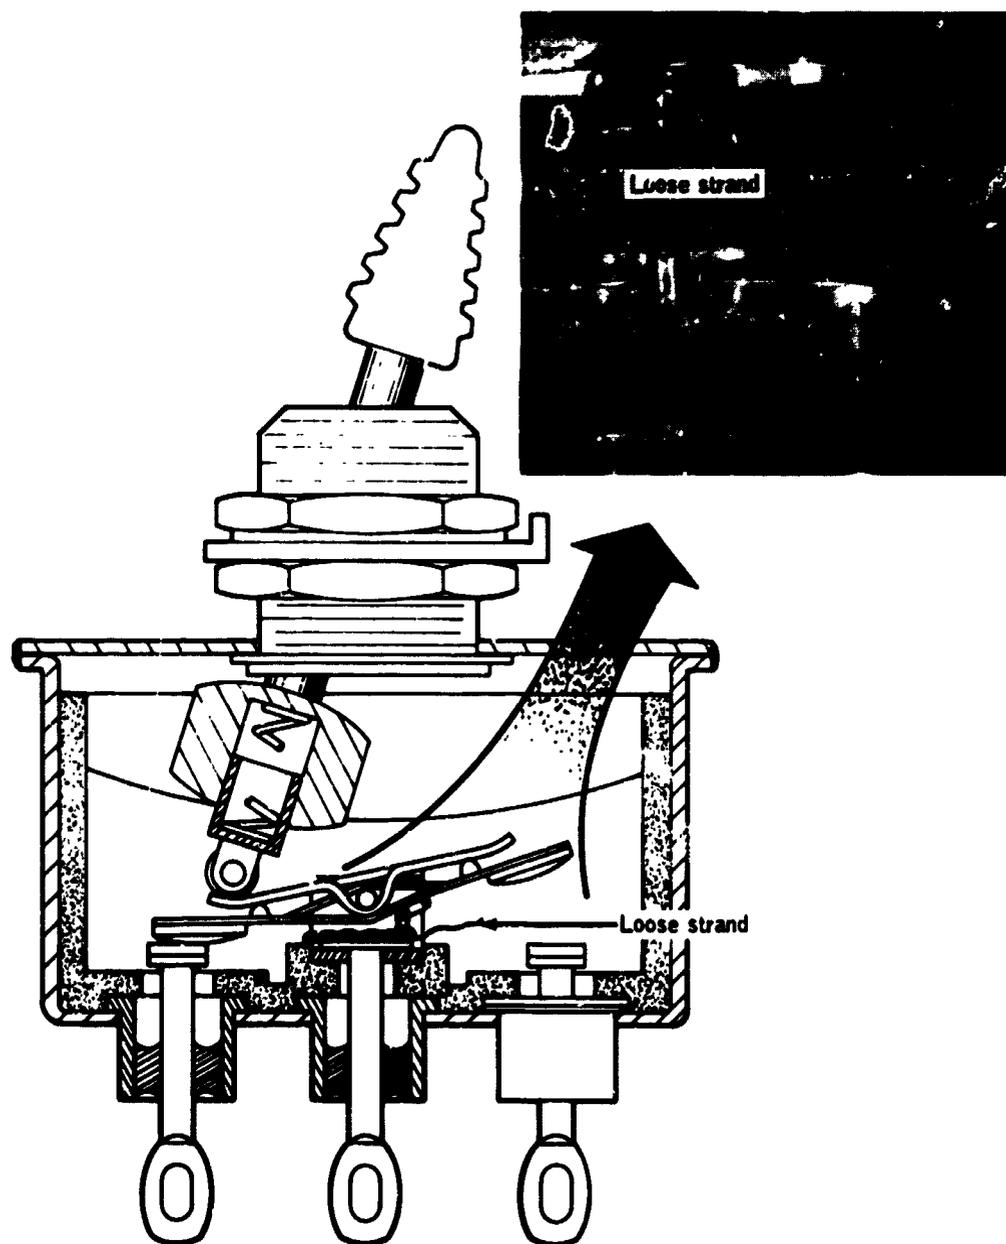
NATIONAL AERONAUTICS AND SPACE ADMINISTRATION

The delta-V thrust switch (fig. 14-4) was shorted to ground both before and after removal of panel 1 from the command module during post-flight testing. After a change in panel position, the short-to-ground disappeared. The switch was then removed from the panel and X-rayed. The X-rays showed a wire strand extending from the braid strap which was thought to have caused the grounding problem. After switch dissection, an internal inspection verified that a strand extended from the braid strap; however, it did not appear to be long enough to cause a ground at any point within the switch (fig. 14-4). The bracket assemblies (pivot brackets, pigtail braids, and movable contacts) and the plastic liner were removed from the switch. Microscopic examination revealed that a wire strand (approximately 0.055 inch long) was present on the flange on terminal 2 (fig. 14-5). The strand appeared to be attached, but was later moved quite easily.

Most of the switches on Apollo 16 and 17 spacecraft (3000 or 4000 series) required for crew safety or mission success were screened according to the following procedures.

- a. Additional inspection points were employed during manufacturing.
- b. The switches were X-rayed prior to acceptance testing.

c. The acceptance vibration test was 3-axis random (4000 series) or single-axis sinusoidal (3000 series) test.

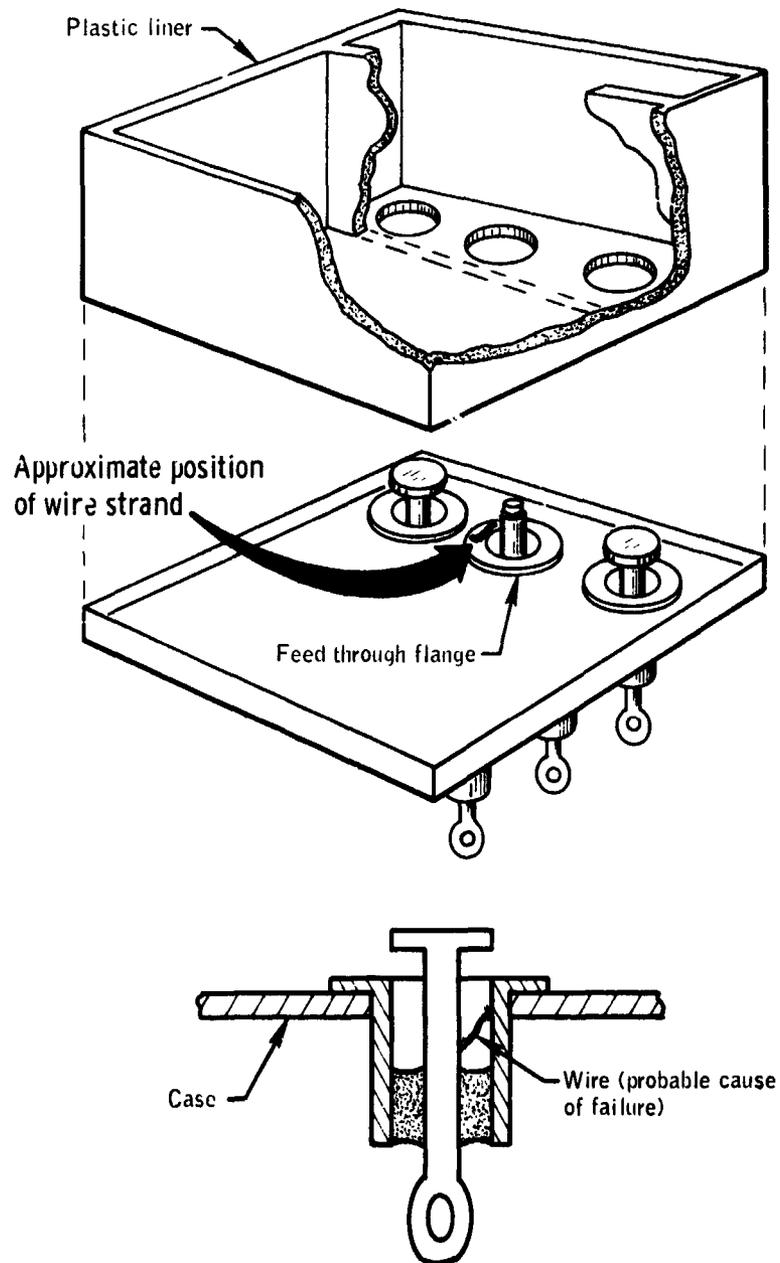
HOUSTON, TEXAS

The bottom of the plastic case liner was examined, and showed no evidence of a scratch or deformation conforming to the shape of the wire strand. A sample wire strand was placed on a feed-through flange of a scrap switch unit, and the plastic case liner was pressed on as would occur during normal switch assembly. When the scrap switch was disassembled an indentation in the plastic case liner was readily apparent. This test indicated that the strand could not have been trapped between the case

liner and the flange surface; therefore, it is postulated that it might have been enclosed in the cavity of feed-through terminal 2 (fig. 14-5). The maximum clearance between the interior of the feed-through terminal wall and the terminal itself is 0.040 inch. A 0.055-inch-long wire strand could easily have bridged this distance, and yet is short enough to move quite freely within the feed-through terminal cavity. In fact, the strand subsequently fell into the cavity. Examination of the strand and cavity wall showed evidence of arcing. The strand could not be detected on the X-rays because that area was obscured by other poles in the switch.

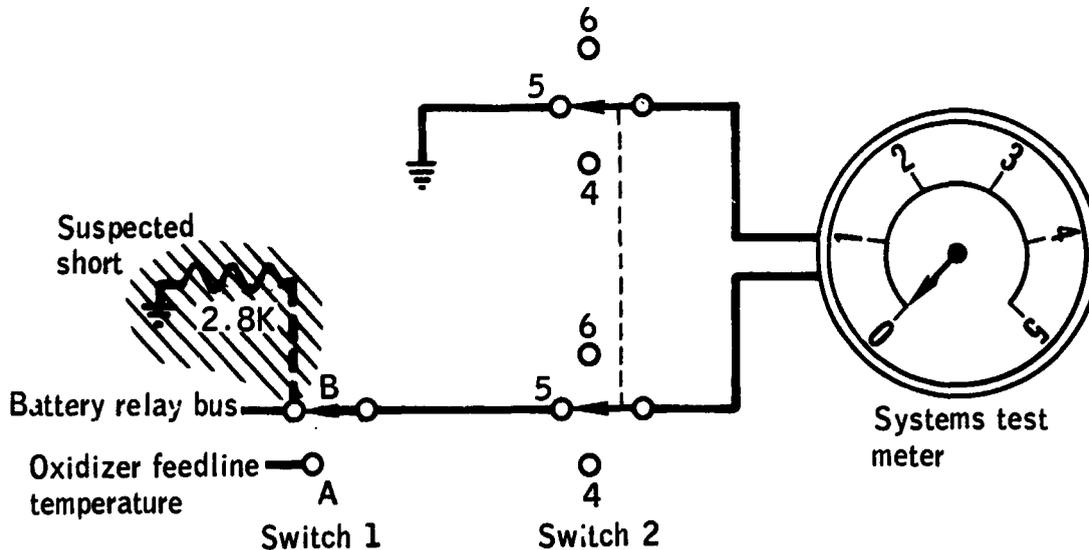
Section		Page
	7.7 PROPULSION . . . . .	7-13
	7.8 ENVIRONMENTAL CONTROL SYSTEM . . . . .	7-14
	7.9 CONSUMABLES . . . . .	7-15
8.0	<u>LUNAR SURFACE OPERATIONAL EQUIPMENT</u> . . . . .	8-1

Postflight testing of the vehicle and all of the involved components revealed no anomalous condition which could have caused the problem but did isolate the problem to the instrumentation circuitry and verify that the functional operation of the bus was not impaired. Analysis indicates that the only way to duplicate the flight problem would be to connect a resistance of 2800 ohms from ground to the battery relay bus measurement circuit (fig. 14-6). No resistance near this magnitude was measured during postflight testing. The most probable cause of the anomaly was that insulation resistance at the output terminal of the switch was lowered because of humidity.

This is the only time that a problem of this type has occurred during the Apollo Program and the probability of recurrence is considered to be very low. If the problem does occur again, other measurements are available for the determination of the battery relay bus voltage.

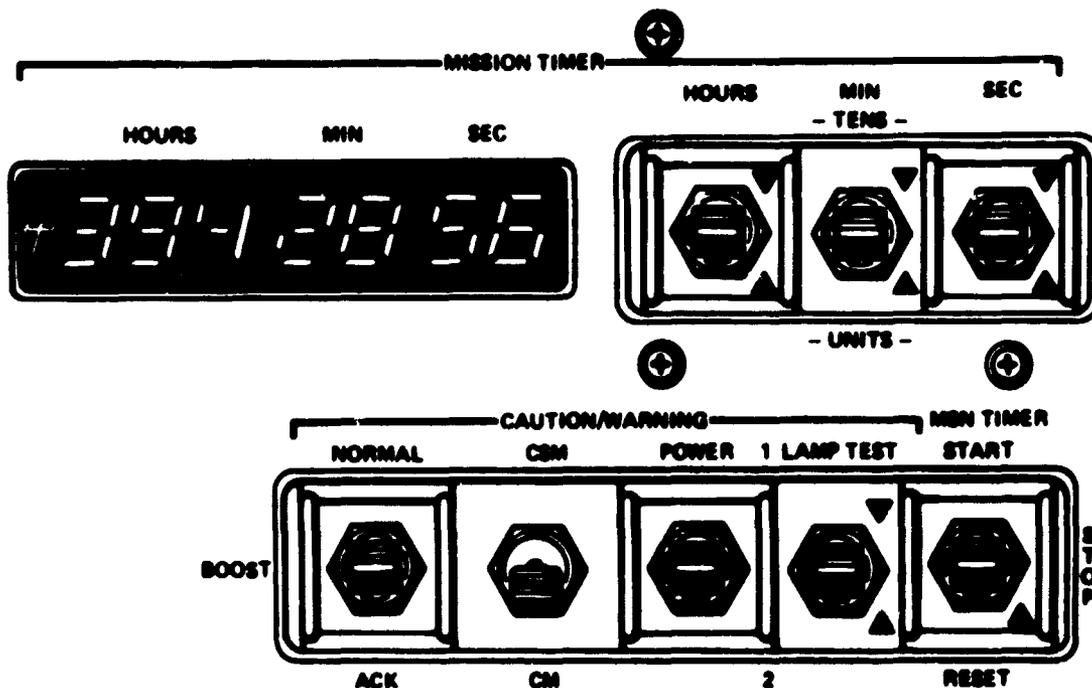
The panel 2 mission timer stopped at 124:47:37. Several attempts to start the clock by cycling the start/stop/reset switch from the stop to the start position failed (fig. 14-10). The timer was reset to 124:59:00 using the hours, minutes, and seconds switches, and the timer again failed to start when the switch was cycled. The switch was then placed in the

Figure 14-10.- Mission timer.

The timer and all associated equipment were still operating properly after the flight. Thermal, vacuum, and acceptance tests were performed and the cause of the failure could not be determined. Circuit analysis showed that the problem could be caused by one of five integrated circuits on the mounting board circuitry. These suspect components were removed and tested with negative results.

The failure was most probably caused by an intermittent problem within a component which later cured itself. If the problem occurs on a future mission and the timer will not restart, mission time can be obtained

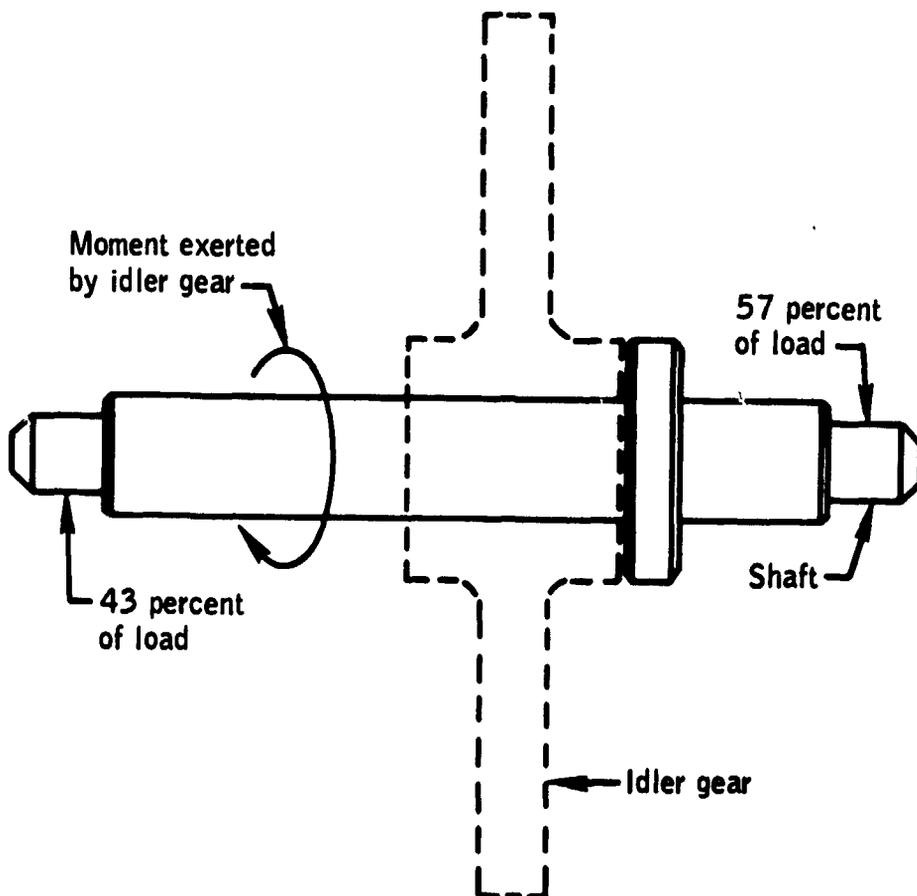
The idler gear is free to rotate on the shaft (fig. 14-16); however, the design allows the stainless-steel shaft to also rotate. The stainless-steel shaft bearing points are in the magnesium motor plate and the shaft rotation wears away the softer magnesium material.

Inspection of the unit showed that the magnesium bearing points had been elongated as shown in figure 14-17. Torque from the stepping motor applied to the idler gear not only resulted in rotation of the shaft but also caused the shaft to tilt (fig. 14-17). The wearing eventually allowed the shaft to tilt sufficiently to cause the gear to rub against the

Figure 14-16.- Forces on idler gear shaft in countdown mode.

Units for future flights will be visually inspected by looking through the window for paint flakes and signs of wear.

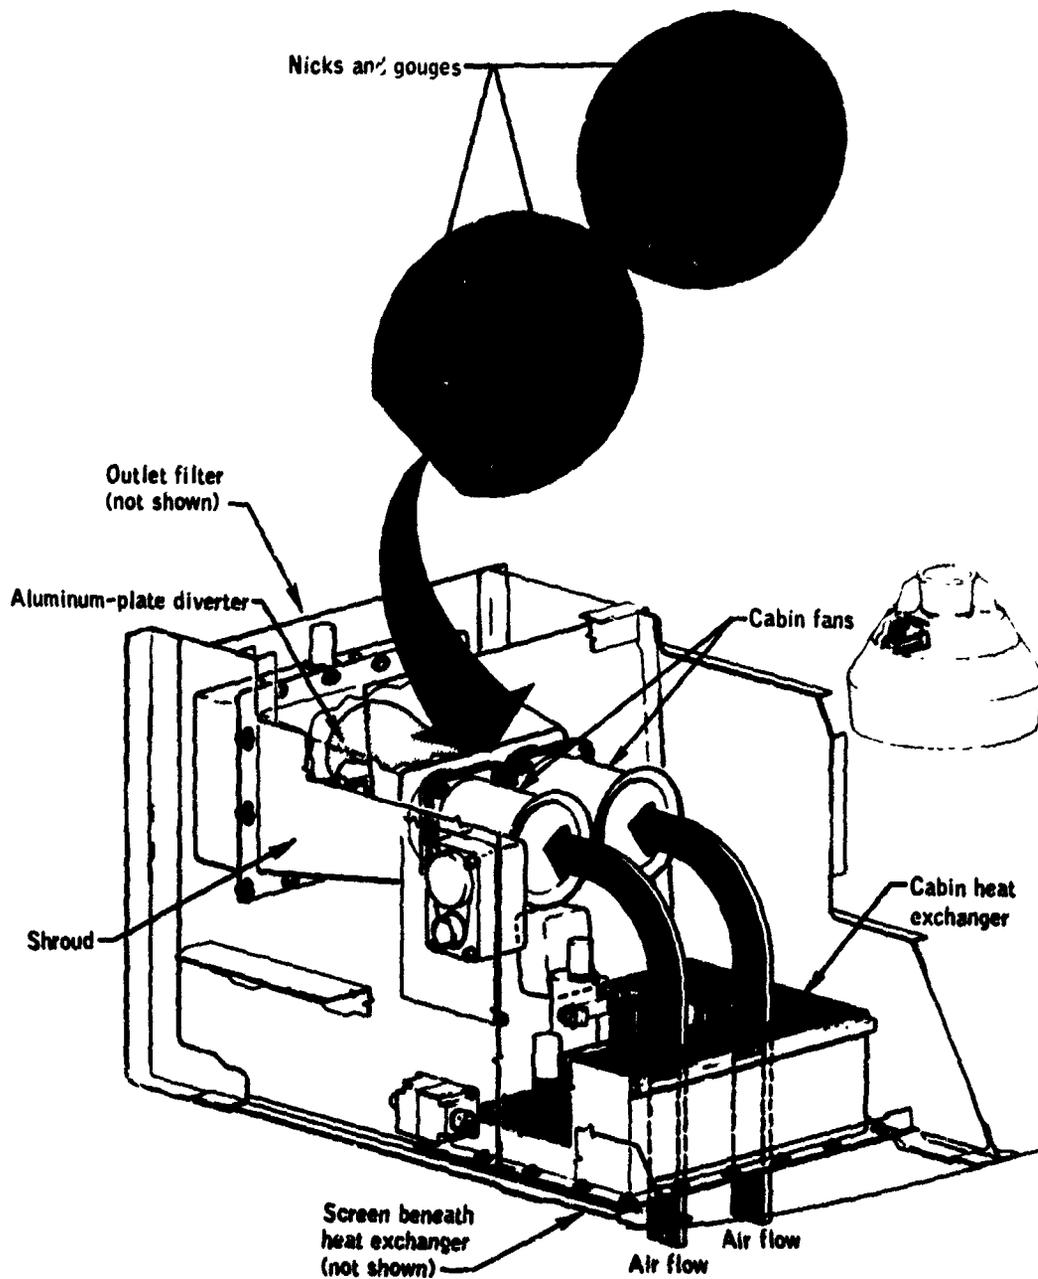
Inspection of the fans revealed considerable gouging on the leading edges of the blades of both fans (fig. 14-19). No marks were found on the outlet de-swirl vanes of either fan. After extensive examination, including the lunar dust filter, a 1/4-inch washer was found in the ducting.

Figure 14-19.- Cabin fan installation.

drifted in and out when the fans were not operating. The outlet was protected only during the limited time when the lunar dust filter was installed. The washer could also have been left in the duct during assembly.

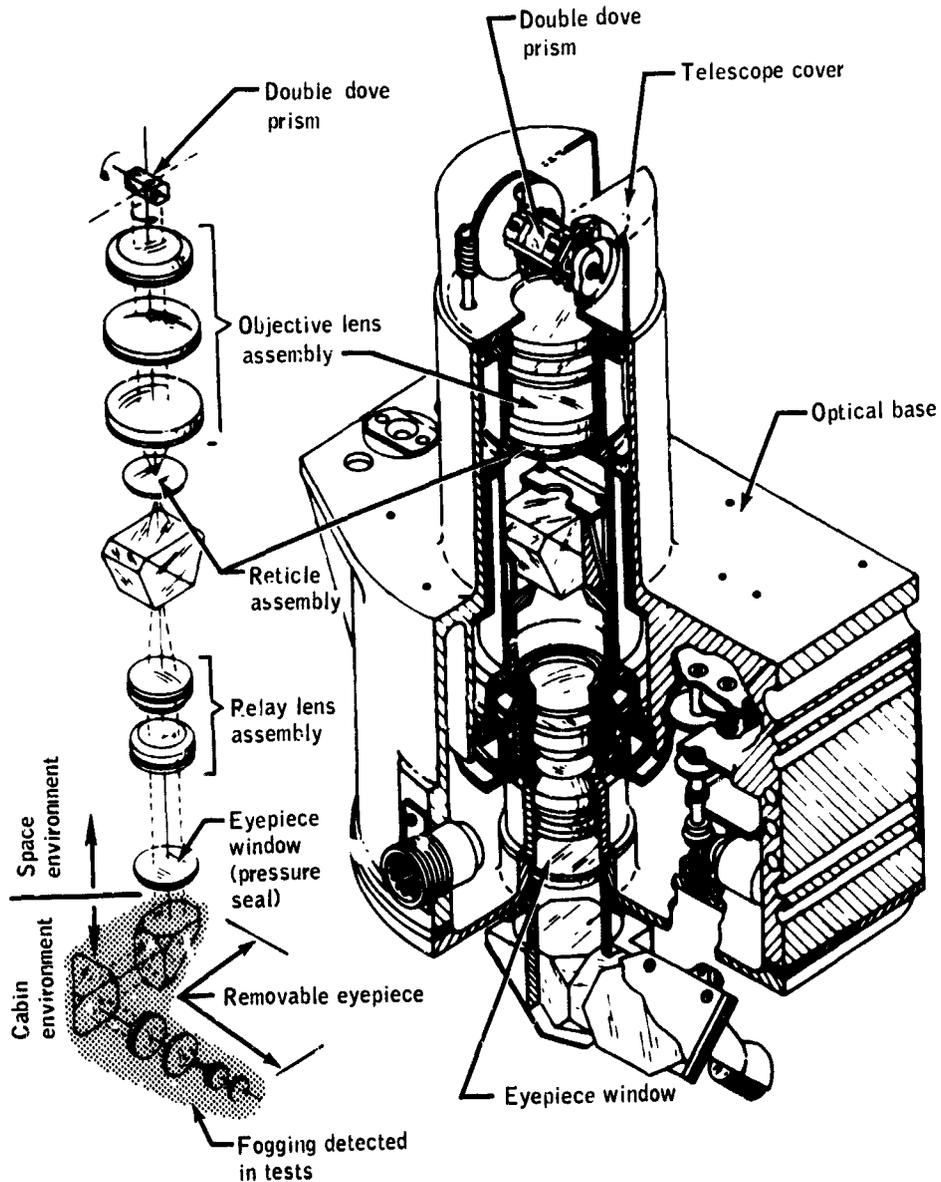
Figure 14-20.- Scanning telescope assembly.

A heater will be added to the removable eyepiece to prevent fogging in the eyepiece assembly and on the eyepiece window.

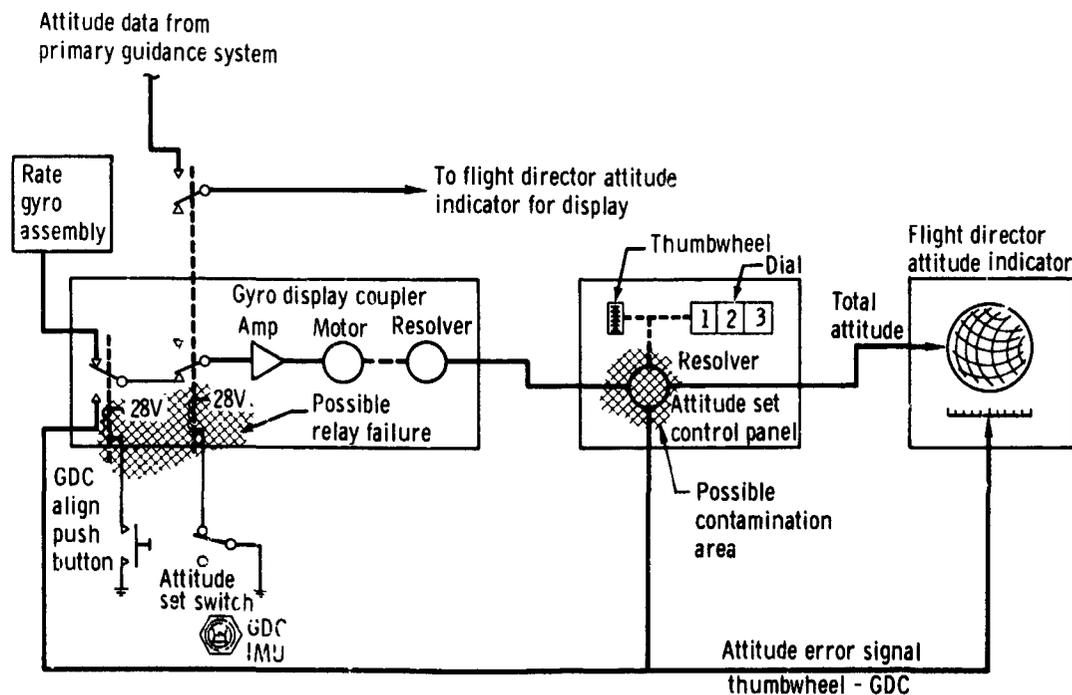
For normal operation during alignment, resolvers in the gyro display coupler electronics are compared to resolvers, one for each axis, on the thumbwheels used to set desired attitude. The difference is an error signal. The error is displayed on the attitude error needles, and the signal is used to drive the resolvers to match the attitude set on the thumbwheels. The anomaly could have been caused by either of two failure modes. An intermittent open in the roll axis align loop or a low gain problem in the electronics (fig. 14-21).

Figure 14-21.- Simplified align loop.

caused a gain type problem and been the cause of the flight anomaly. The measured resistance of the thumb wheel resolvers increased from the nominal in all three axes by as much as 1000 ohms. Normally, this value does not vary by more than 1 ohm. In order for this condition to have been the cause of the anomaly, a resistance change in the roll axis would have had to be an order of magnitude larger than that measured postflight. The resistance change is caused by contamination between the slip rings and the thumbwheel resolvers. As a result of the flight anomaly, several resolvers were examined and contamination was detected. The corrective action is to wipe the resolvers clean by rotating them several hundred revolutions. The attitude set control panels in Apollo 16 and 17 will be checked and the resolvers will be wiped clean, or will be replaced if necessary.

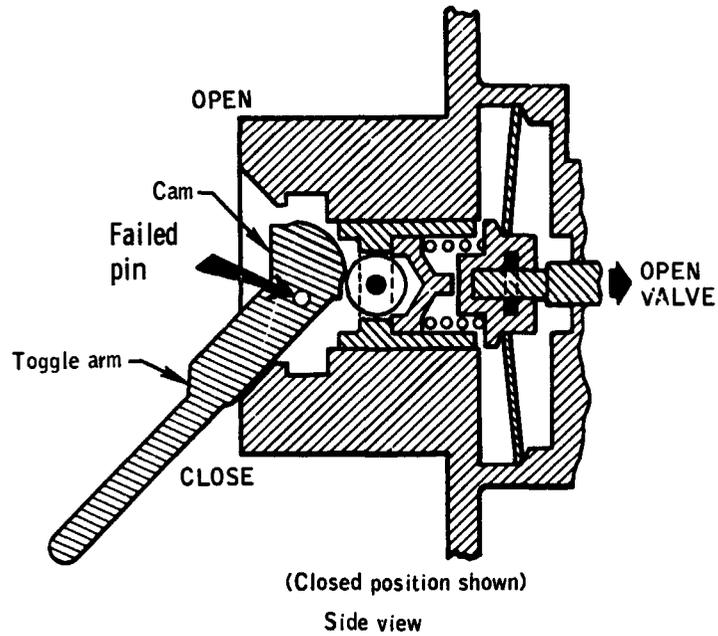
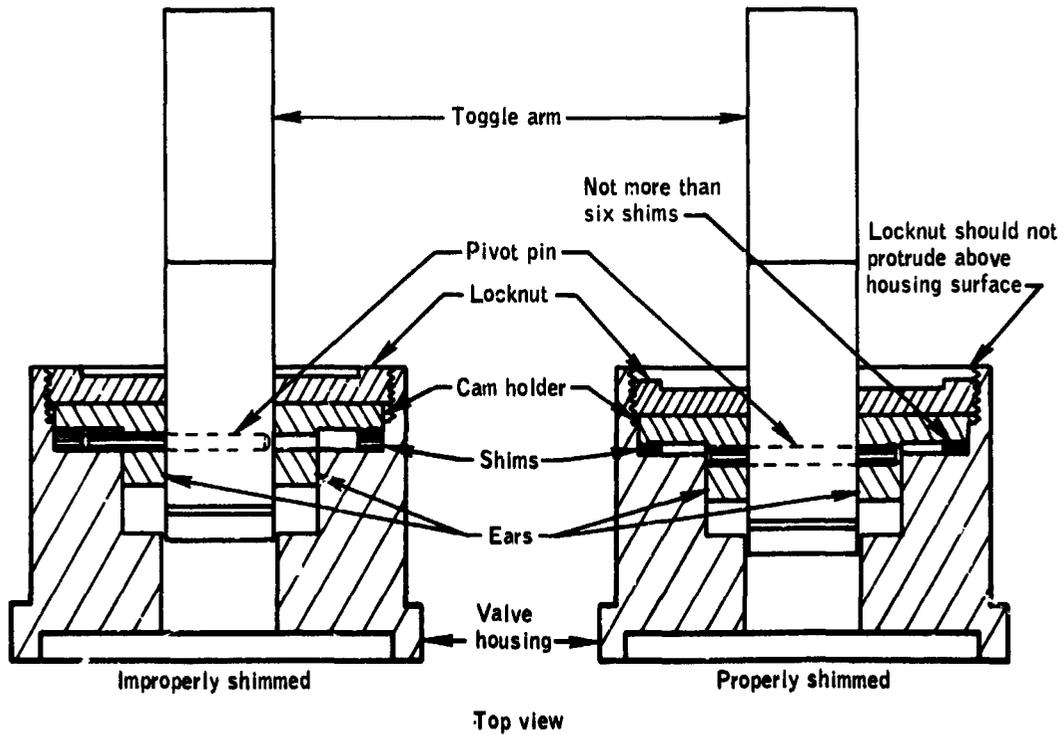
The pivot pin attaches the toggle arm to the cam holder and is retained in place by the valve housing when properly assembled (fig. 14-22).

Failure analysis showed that the pivot pin failed in single shear and bending. This failure resulted from improper shimming which allowed the pivot pin to come out of one side of the cam holder as shown in figure 14-22. Analysis and testing has shown that the pin strength is adequate in double shear, but will fail in single shear and bending with a force of about 70 pounds applied at the tip of the toggle arm when it is in the closed position. No marks were found on the toggle arm to indicate that it had been struck by some object.

Figure 14-22.- Oxygen regulator shutoff valve.

Inspection criteria to assure that valves now installed in other spacecraft are properly assembled have been developed from a study of adverse tolerance buildups associated with the valve components. These criteria are that the lock nut does not protrude and the number of shims does not exceed six (fig. 14-22).

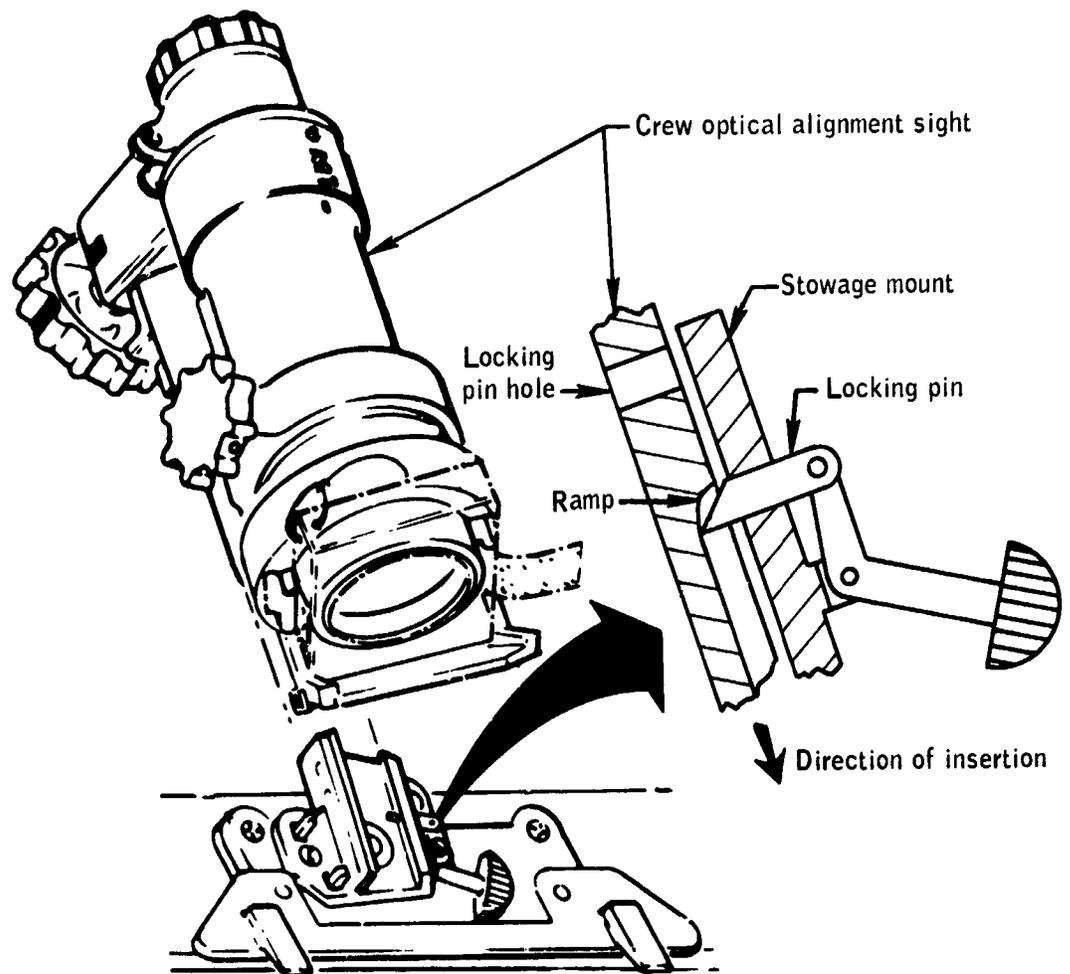
The crew optical alignment sight fell from its stowage mount during landing because the locking pin which secures it was not engaged.

Figure 14-23.- Crew optical alignment sight stowage.

pin hole by spring action (fig. 14-23). Postflight examination showed that the ramp had been gouged preventing raising of the pin by the ramp. The cause of the gouge is not known.

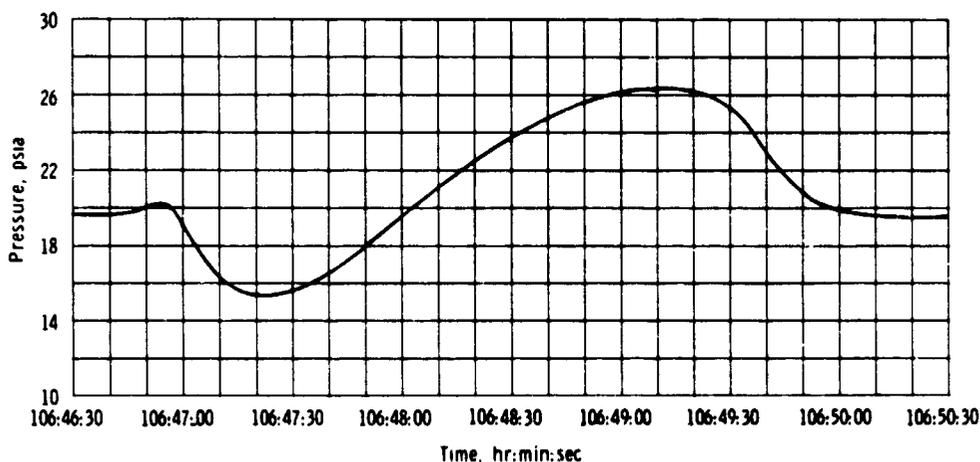
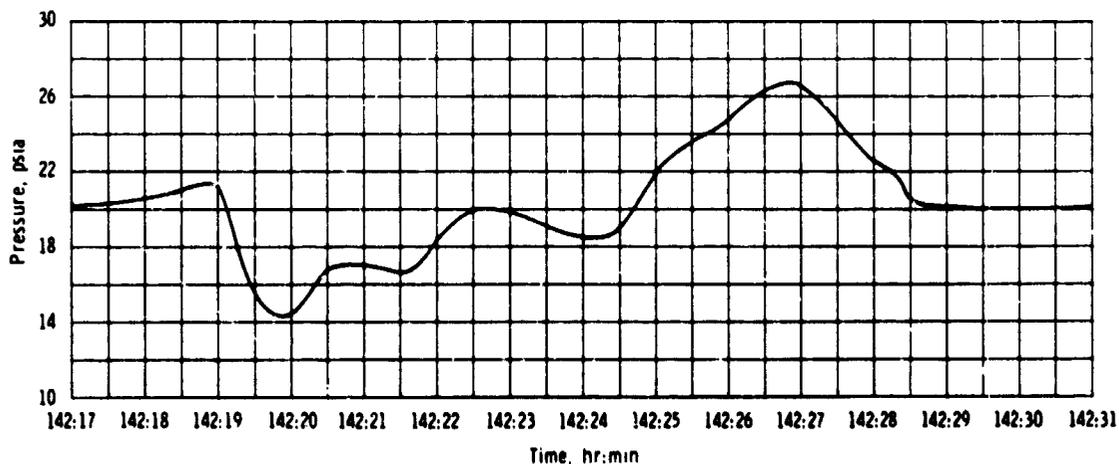
Variations were noted in the water/glycol pump differential pressure shortly after the cabin depressurizations for the standup extravehicular activity and the second extravehicular activity. The variations were similar on both occasions. The pressure differential decreased from about 20 psid (normal) to about 15 psid, then increased to about 27 psid and returned to normal (fig. 14-24). The total times for the cycles were 3 minutes during the standup extravehicular activity and 10 minutes during the

Figure 14-24.- Glycol pump differential pressure variations during extravehicular periods.
