APOLLO 15 MISSION REPORT

MANNED SPACECRAFT CENTER  
HOUSTON, TEXAS  
DECEMBER 1971

Mission Evaluation Team

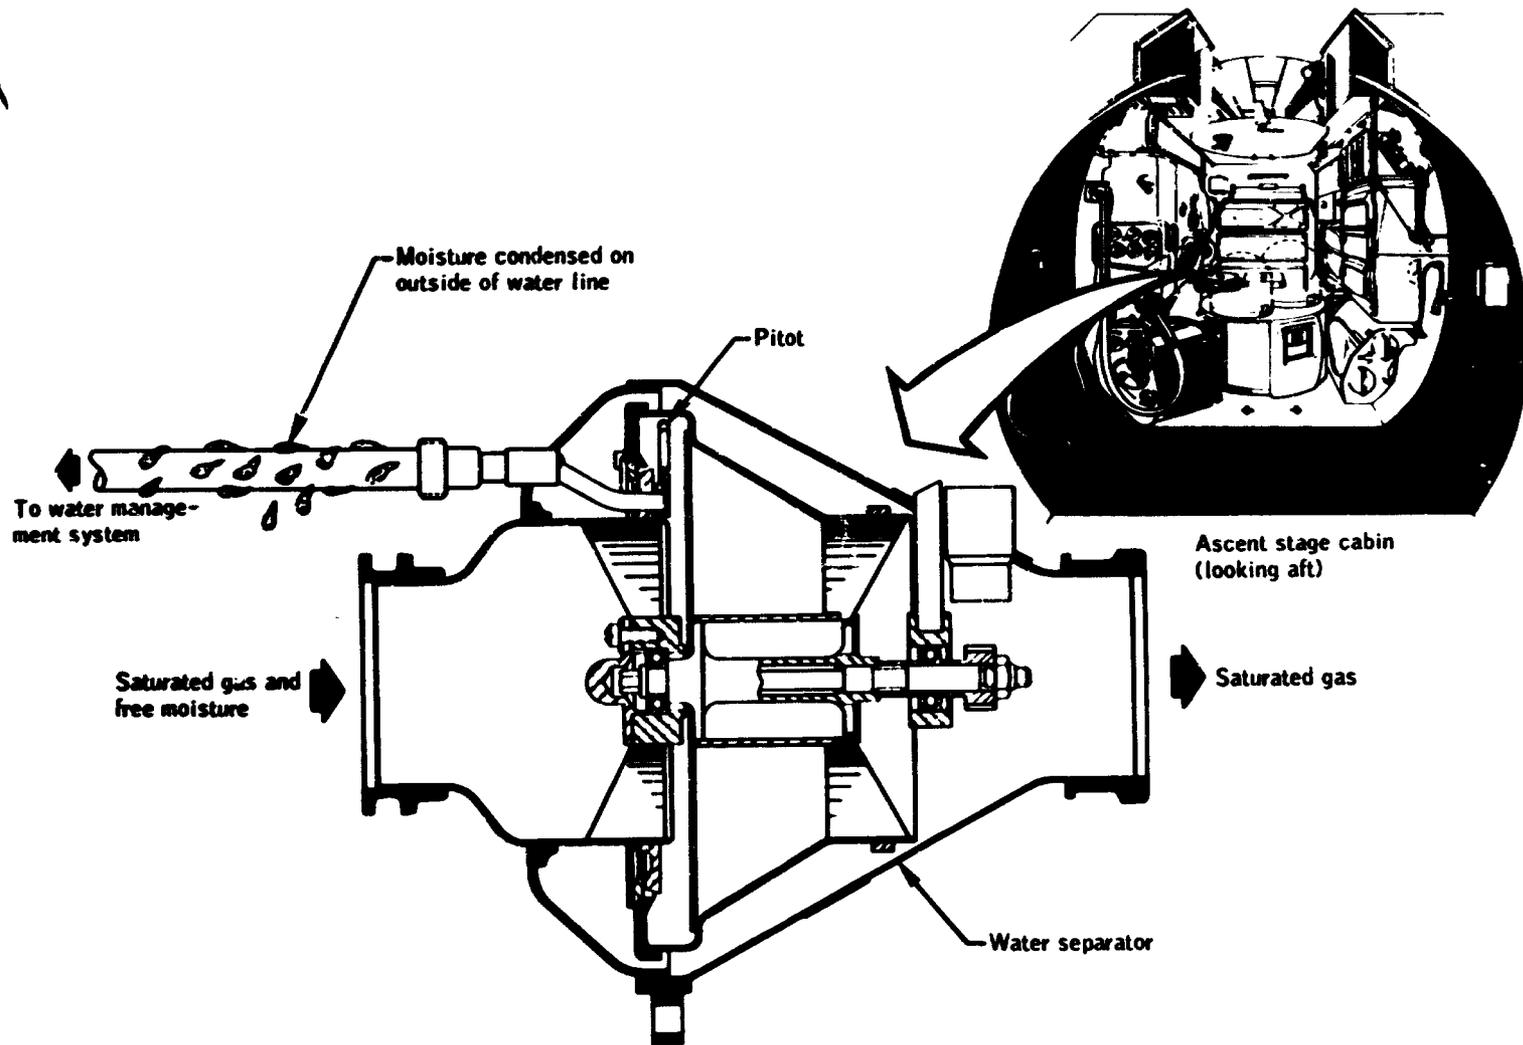
Cabin atmosphere is cooled and passed through one of the water separators (fig. 14-27) where condensed water is separated by centrifugal force and picked up by a pitot tube. The water is then piped from the pitot tube, through a check valve, to the water management system where it is used the sublimator.

conditions, water would condense on the outside of the line (fig. 14-27), and when the cabin was depressurized for the standup extravehicular activity, the water on the outside of the line would boil, freeze, and sublime, thereby freezing the water in the line.

Analysis shows that as little as a 0.01-inch film of water on the outside of the line will freeze the line at cabin depressurization. Freezing within the line will cause the separator to slow down and stall because of excessive water. Separator 2 had not been used. Therefore, no water was in its outlet line to freeze. Consequently, it operated successfully when activated.

Figure 14-27.- Cross section of water separator.

Analysis and tests have shown that freezing of the line will not damage any spacecraft hardware. If such freezing occurs, the other separator would be used. Therefore, no corrective action is required.

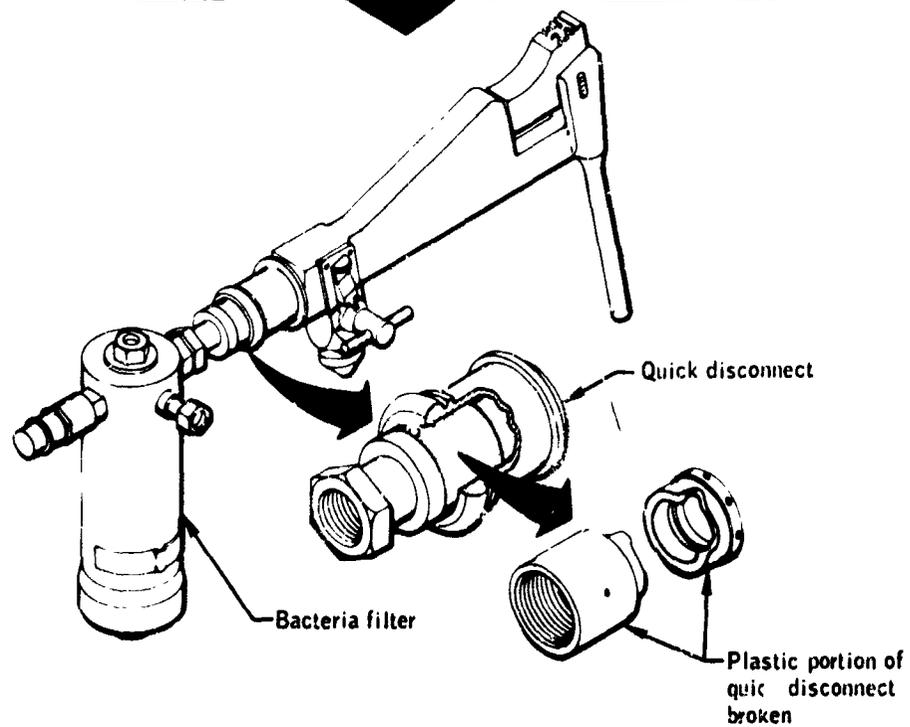
A water leak occurred at the quick disconnect between the bacteria filter and the water gun (fig. 14-28) shortly after the first extravehicular activity. The leak was caused by the plastic portion of the disconnect being broken and was stopped by removing the filter.

When the water gun/bacteria filter combination is properly stowed, the gun is held in a U-shaped boot (fig. 14-28). Both the gun and filter are held in place by straps with the hose protruding above the liquid cooling assembly. Bending the hose can easily exceed the force required to break the quick disconnect between the bacteria filter and the water gun if the filter is not strapped down. A test showed that a torque of 204.6 inch-pounds caused a similar quick disconnect to break in half.

Figure 14-28. - Water gun/bacteria filter.

Based on the torque value of 204.6 inch-pounds, a force of approximately 27 pounds applied at the hose quick disconnect interface would break the disconnect between the filter and the water gun.

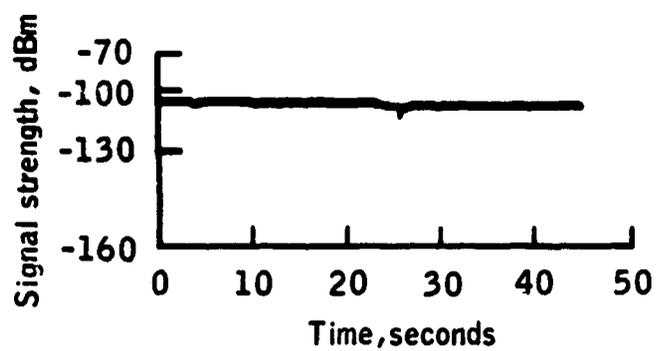
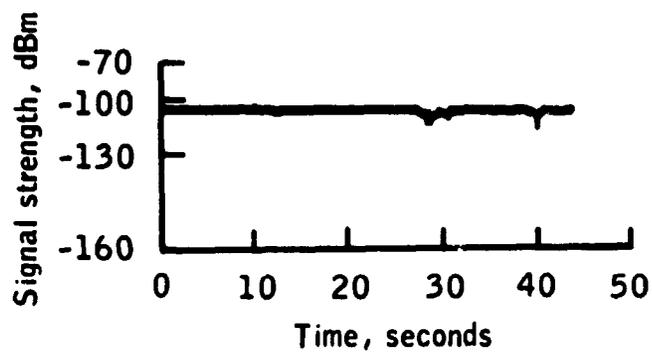
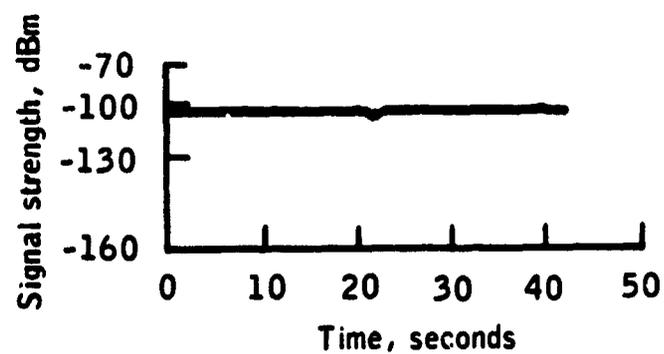
Random oscillations occurred while the steerable antenna was in the auto-track mode. The oscillations were small, and damped without losing auto-track capability (fig. 14-29). The three times when the oscillations became divergent are shown in figure 14-30.

Figure 14-29.- Damped antenna oscillations at random times.

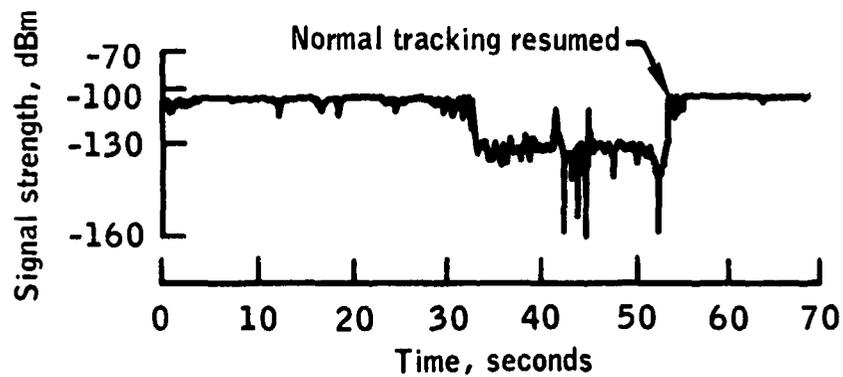
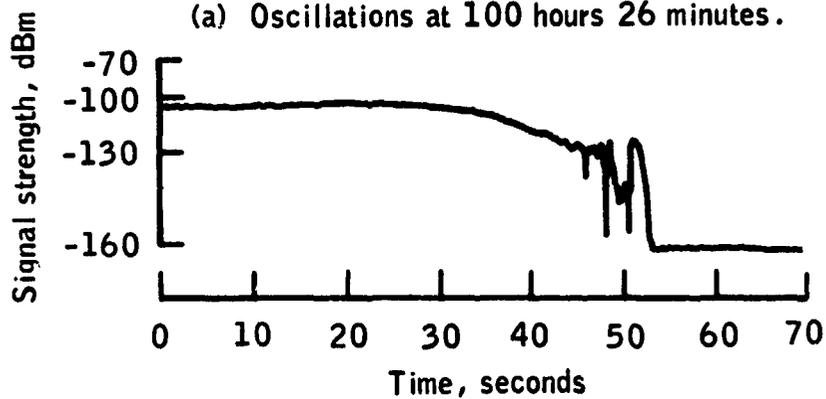
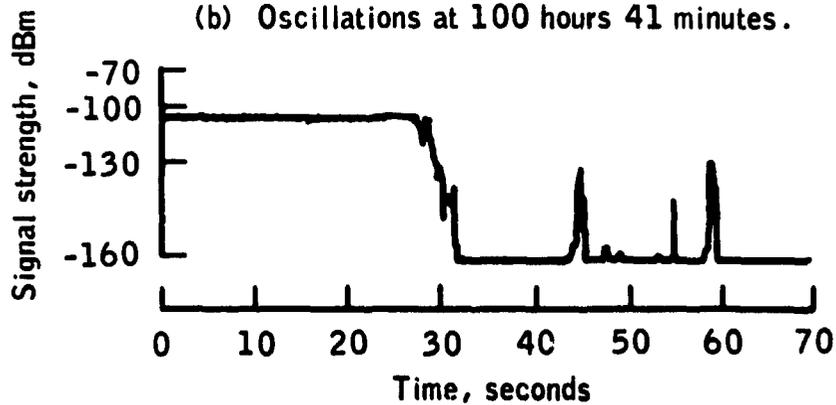
Figure 14-30.- Received signal strength plots associated with divergent antenna oscillations.

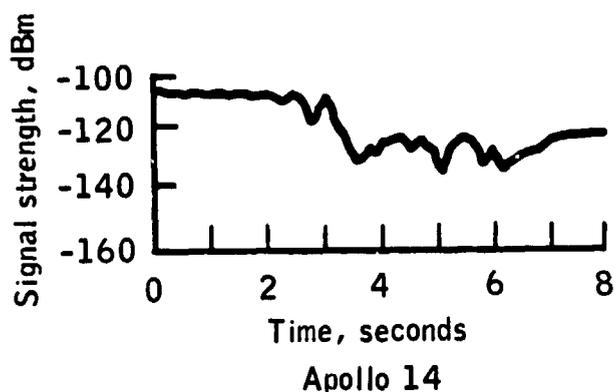
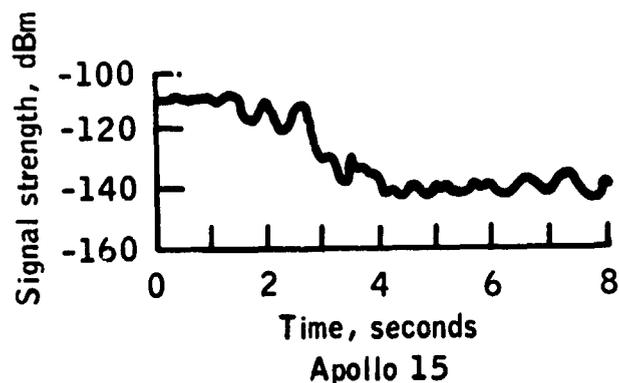
All oscillations indicated characteristics similar to the conditions experienced on Apollo 14 (fig. 14-31). After Apollo 14, one of the prime candidates considered as a possible cause was incidental amplitude modulation on the uplink signal. A monitor capable of detecting very small values of incidental amplitude modulation was installed at the Manned Space Flight Network Madrid site for Apollo 15. The data from this monitor indicated that no amplitude modulation existed on the uplink at the frequencies critical to antenna stability during the problem times. Consequently, incidental amplitude modulation has been eliminated as a possible cause of the antenna oscillations, and the problem must be in the spacecraft.

Figure 14-31.- Ground-received signal strength showing spacecraft antenna oscillation characteristics.

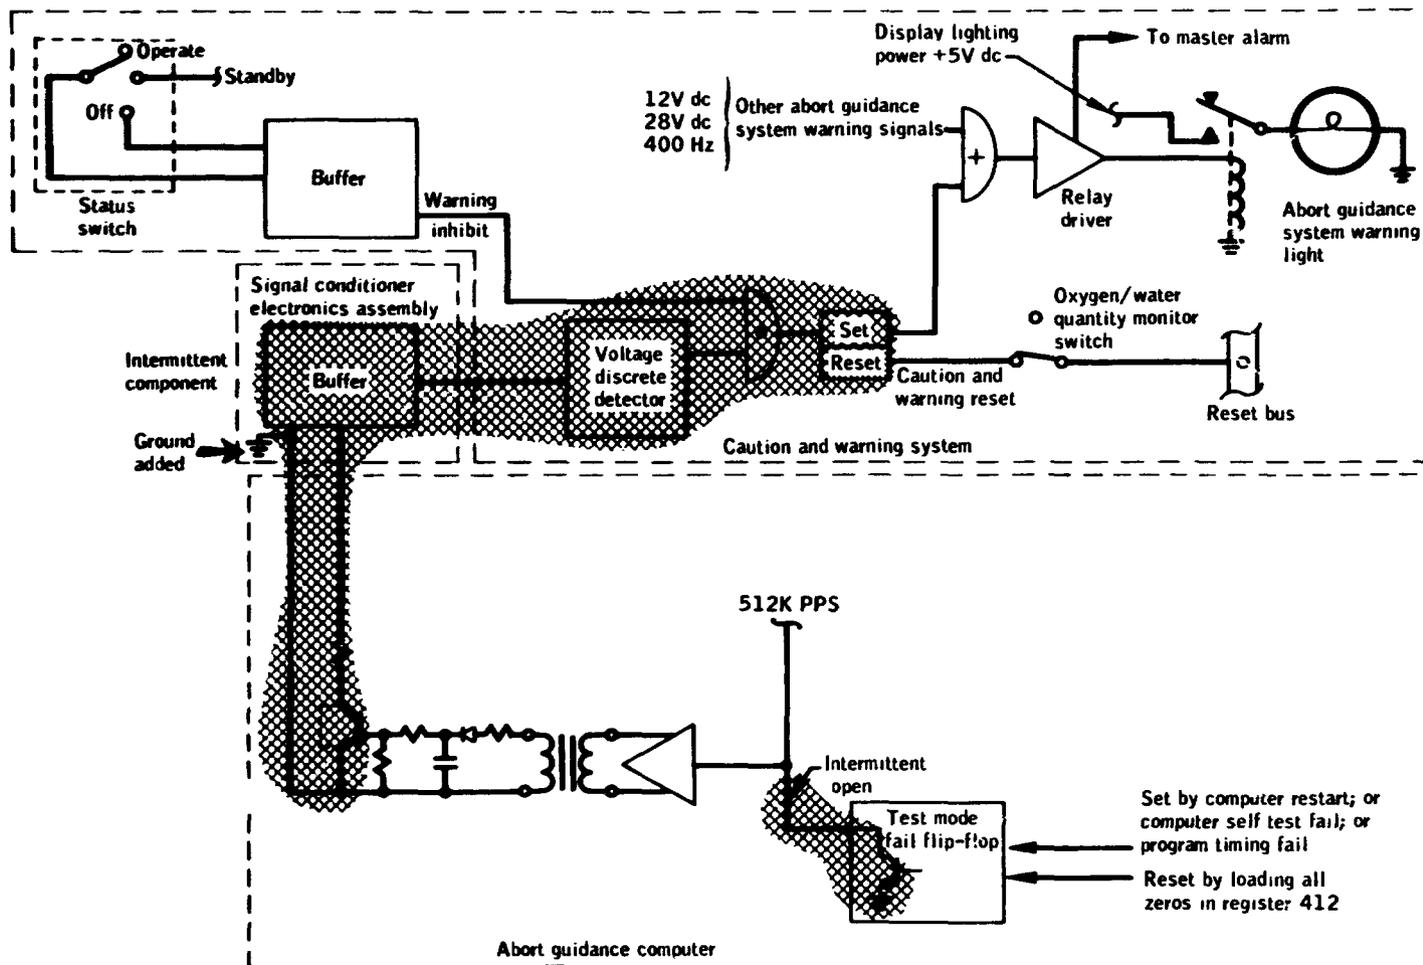
After the warning at insertion, the crew read out the contents of the computer self test address 412, but there was no indication of a test-mode fail. The crew did not, however, reload all zeros into address 412 as is required to reset the flip-flop (fig. 14-32) which controls the test-mode fail output in the computer. Consequently, a second test-mode fail would not have caused an abort guidance system warning. The fact that a second warning did occur restricts the location of the failure to the output circuit of the computer, the signal conditioner electronics assembly, or the caution and warning system.

The abort electronics assembly test mode fail output drives a buffer (fig. 14-32) in the signal conditioner electronics assembly which, in turn supplies the test mode fail signal to the caution and warning system. The test mode fail buffer is the only application in the lunar module where a transistor supplies the input signal to the buffer and where the low side of the input to the buffer is not grounded. Tests have shown that some buffers feed back 10-kHz and 600-kHz signals to the buffer input lines. These signals are completely suppressed when the low side of the buffer input is grounded.

Figure 14-32.- Abort guidance system test mode fail circuitry.

For future spacecraft, the low side of the input to the buffer will be grounded.

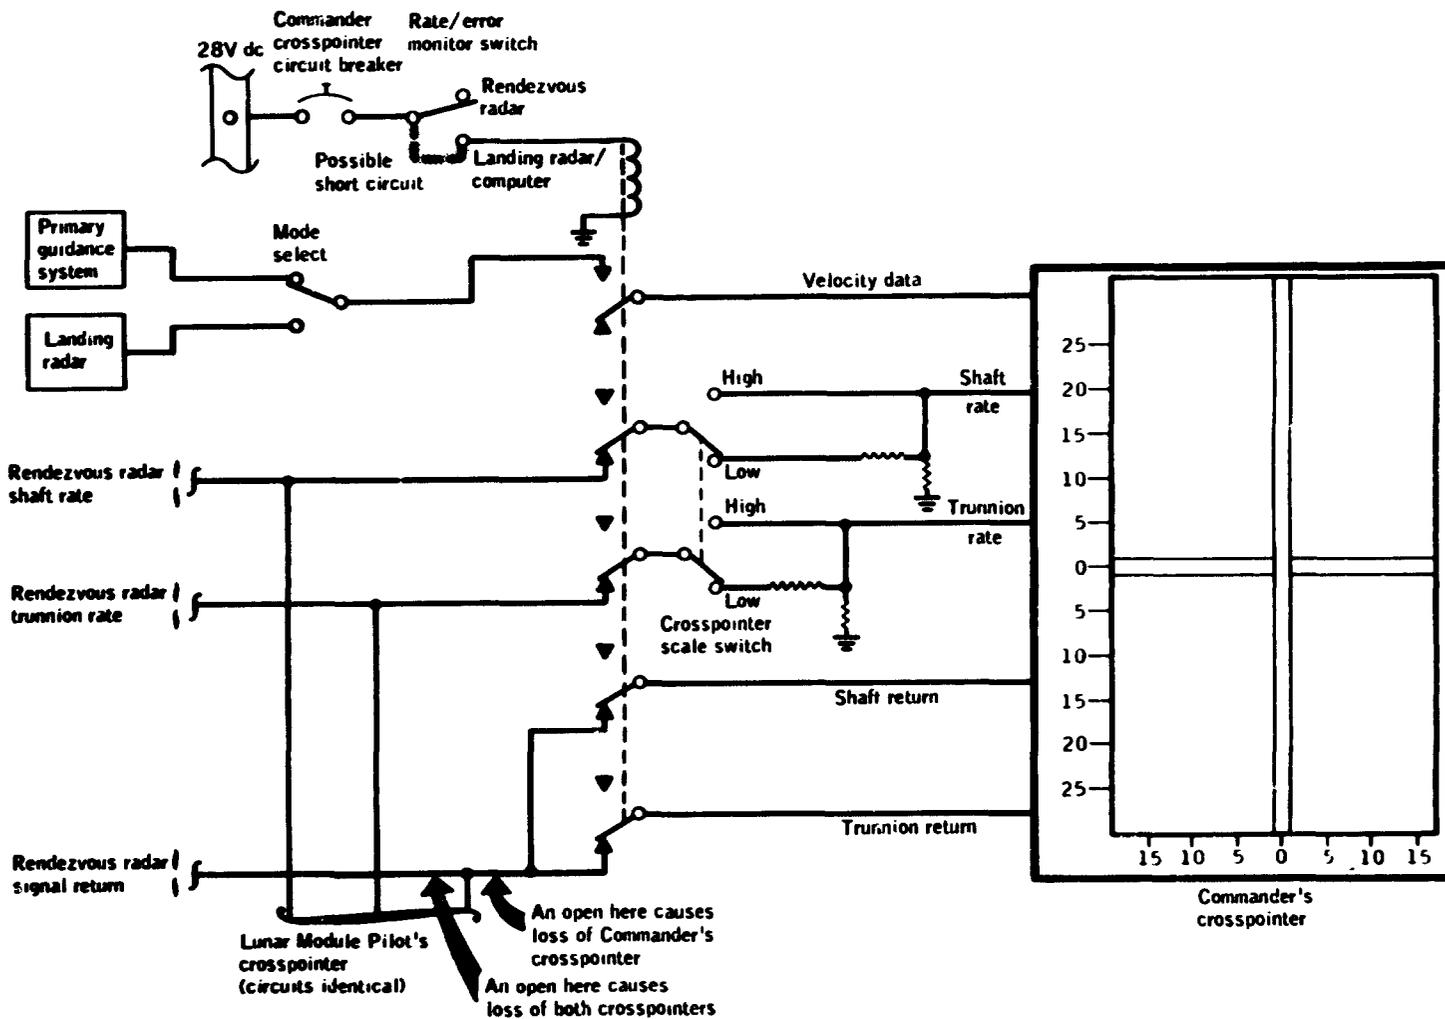
Figure 14-33.- Simplified schematic of crosspointer circuits.

The most probable failure is an open in the signal return line. Rate information could still be deduced from antenna position data which is displayed on the flight director attitude indicators. Ground tests and checkout may not show this type of failure. If the open is temperature-sensitive, a complete vehicle test involving vacuum, temperature, and temperature gradients would be required to insure that failures of this type would not occur in the flight environment. This type of testing is not practical at the vehicle level. Consequently, no corrective action is planned.

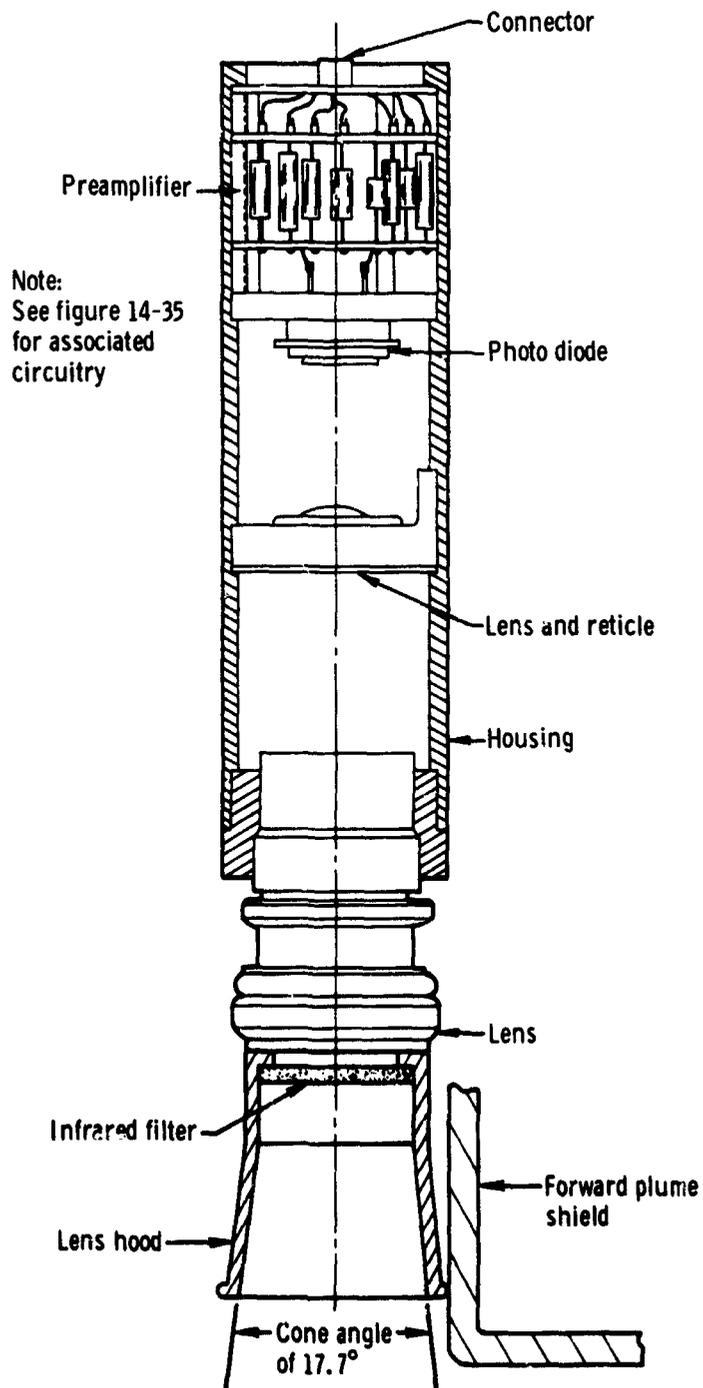
Telemetry received from the first panoramic camera pass on revolution 4 indicated that the velocity/altitude sensor (fig. 14-35) was not operating correctly.

Figure 14-35.- Velocity/altitude sensor assembly.

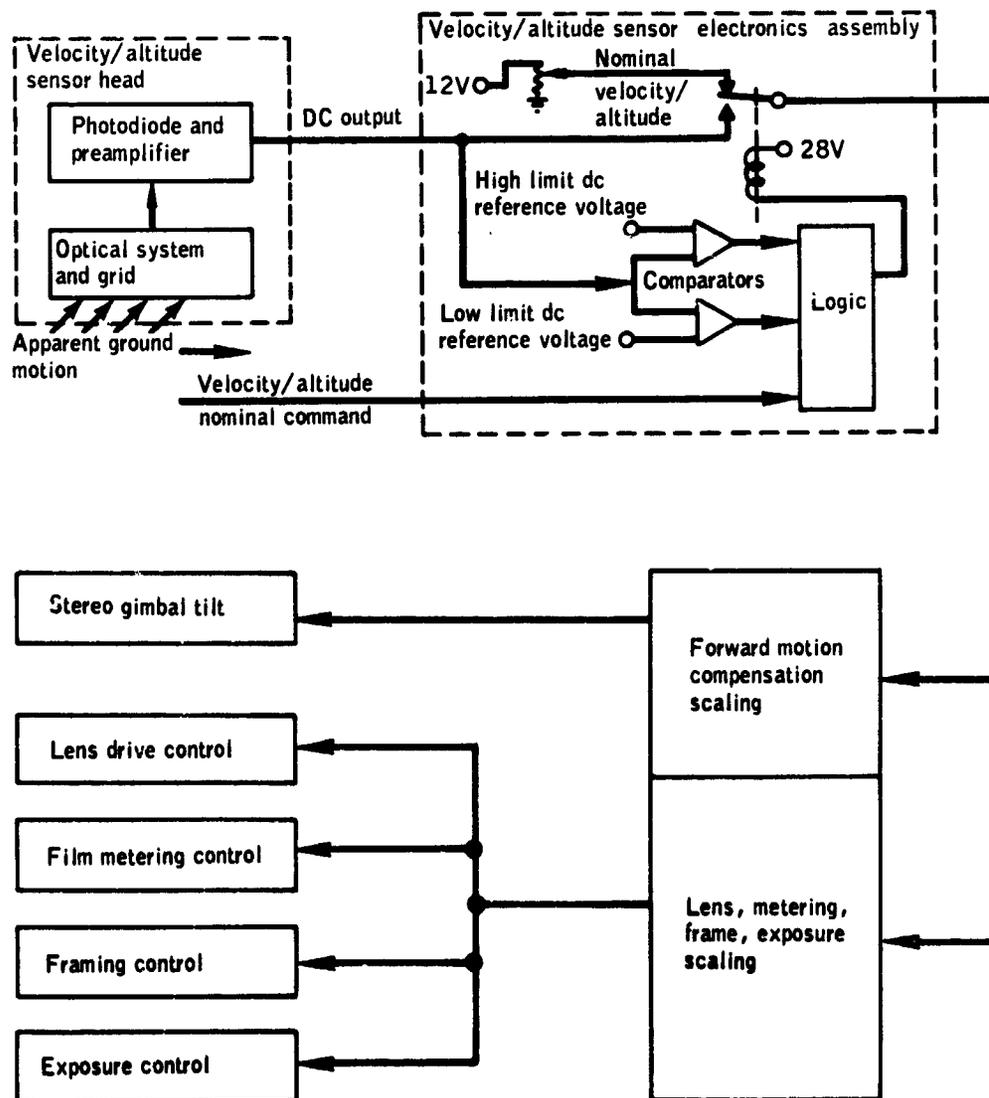
Figure 14-36.- Velocity/altitude output circuitry.

Breadboard tests and circuit analyses of the velocity/altitude electronics (fig. 14-36) did not indicate failure. Tests were conducted in which endless belts of lunar scene photography from Apollo 8 and 15 were passed in front of velocity/altitude sensors. Sensors from the prototype and qualification units, and flight unit number 1 were used. By varying the illumination level, sensor performance somewhat similar to the Apollo 15 anomaly could be obtained.

The results of the tests, coupled with analyses of the basic sensor design, indicate that the problem is related to the optical signal-to-noise ratio. The remaining flight hardware will be modified to improve this ratio. The optical signal will be enhanced by increasing the lens aperture from f/4.0 to f/3.5 and by deleting the infrared filter. The optical noise (reflections) will be reduced by increasing the length of the lens hood and by repositioning the sensor so that the camera's forward plume shield will not be in the field of view of the sensor. In addition, a manual override of the velocity/altitude sensor will be provided on the remaining flight units. By using a three-position switch, two preselected velocity/altitude ratios will be provided, as well as the automatic function.

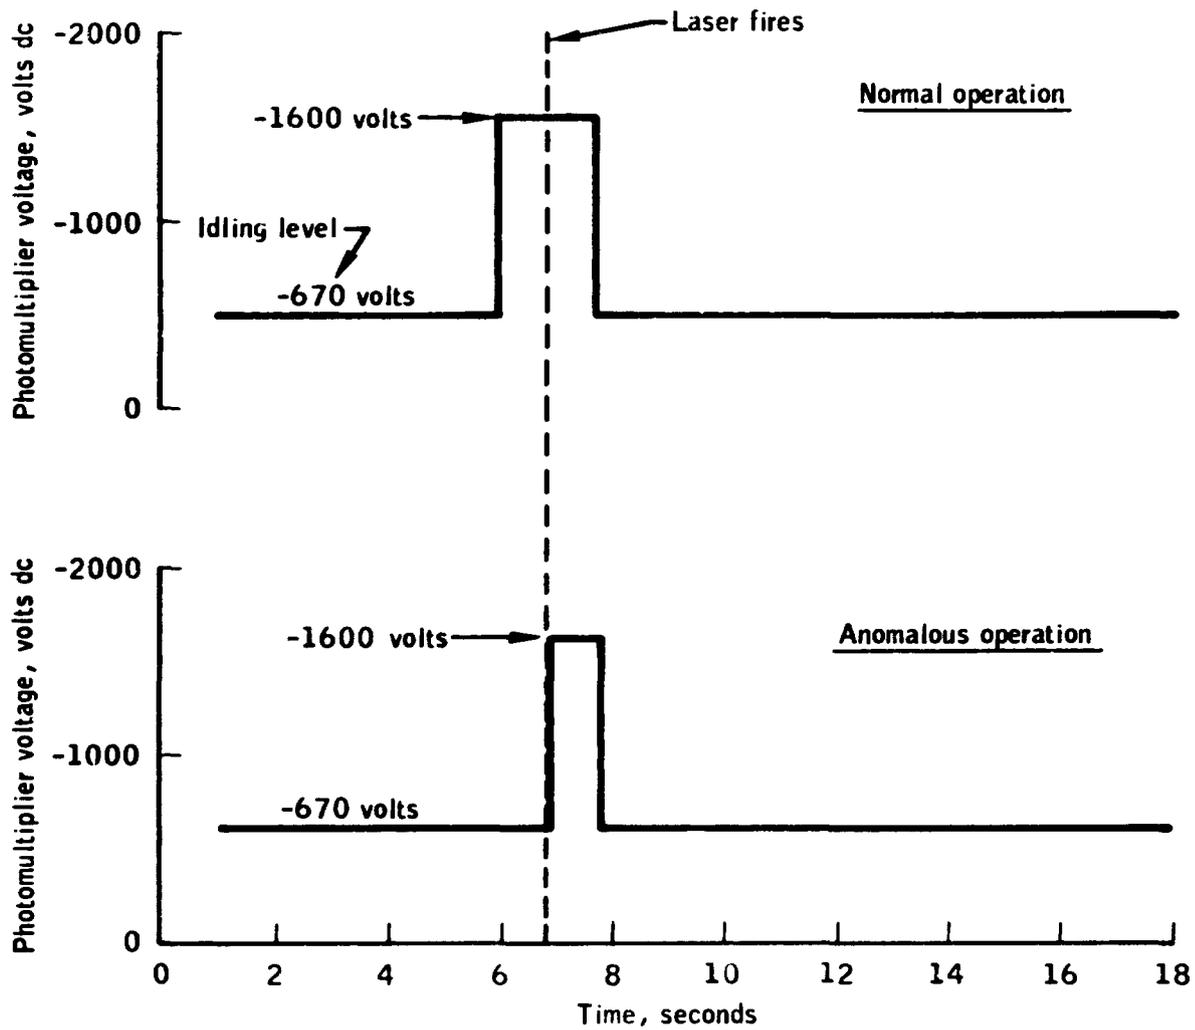
Figure 14-37.- Comparison of photomultiplier power supply voltages.

- a. Altitude data became intermittent after revolution 24 as the result of a decrease in the laser output power.
- b. Beginning with revolution 38, the photomultiplier tube high-voltage power supply was held in the idling (minimum-voltage level) mode until after the laser fired, thereby causing the receiver to miss the return pulse from the lunar surface (fig. 14-37). No altitude data were obtained after this anomaly occurred.

The photomultiplier tube power supply anomaly was duplicated when a relay which had been removed from a flight unit because it had an audible "buzz" was installed in the prototype altimeter. The relay serves no function in flight, but is a safety precaution for ground personnel working on the altimeter (fig. 14-38). The relay contacts close when the altimeter is turned off, discharging the high voltage stored in the pulse-forming network capacitors.

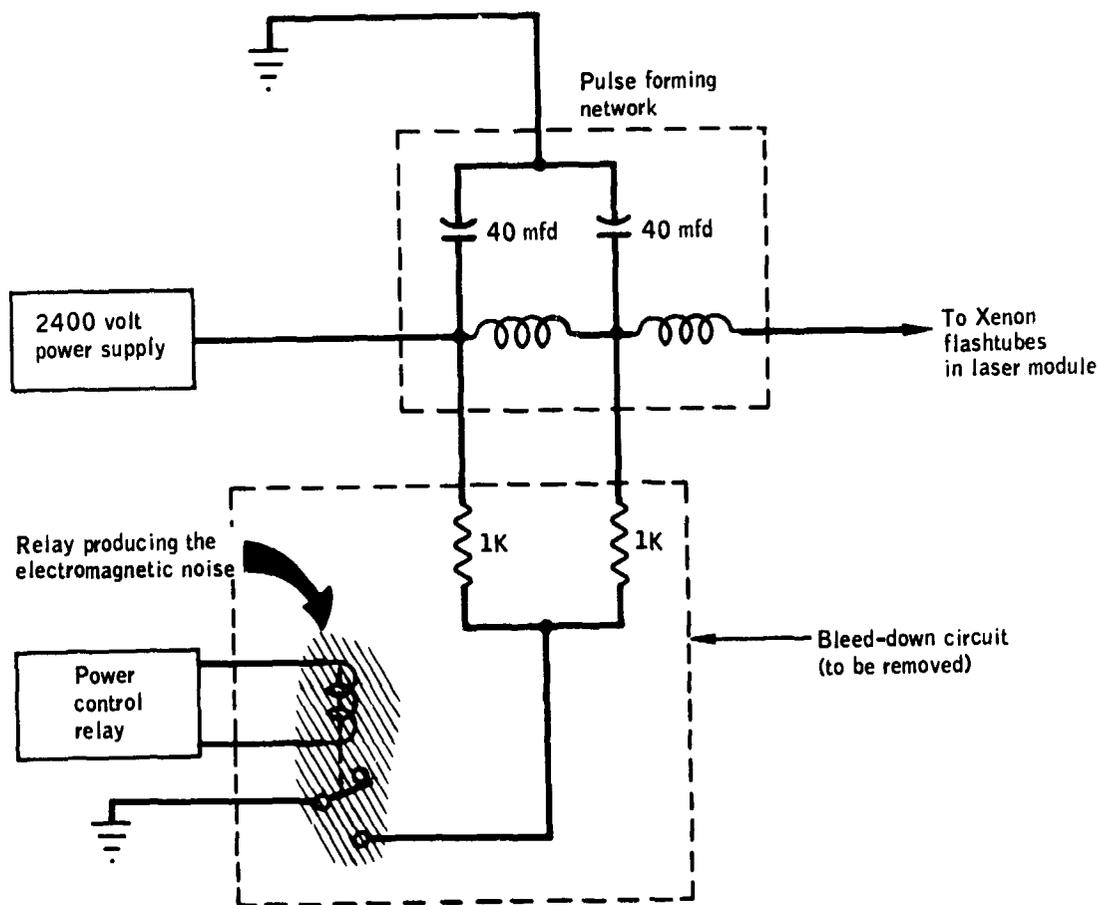
Figure 14-38.- Pulse forming network bleed-down circuit.

It is suspected that the audible "buzz" is accompanied by electromagnetic interference that is coupled into the video amplifier in the laser receiver (fig. 14-39). The video amplifier is a principal element in the automatic gain control circuit which controls the output of the photomultiplier tube power supply. The electromagnetic interference from the relay can thereby result in the automatic gain control holding the power supply in the idling mode until the pulse forming network is discharged in firing the laser. The relay and resistors that comprise the bleed-down circuit will be removed from the remaining flight altimeters.

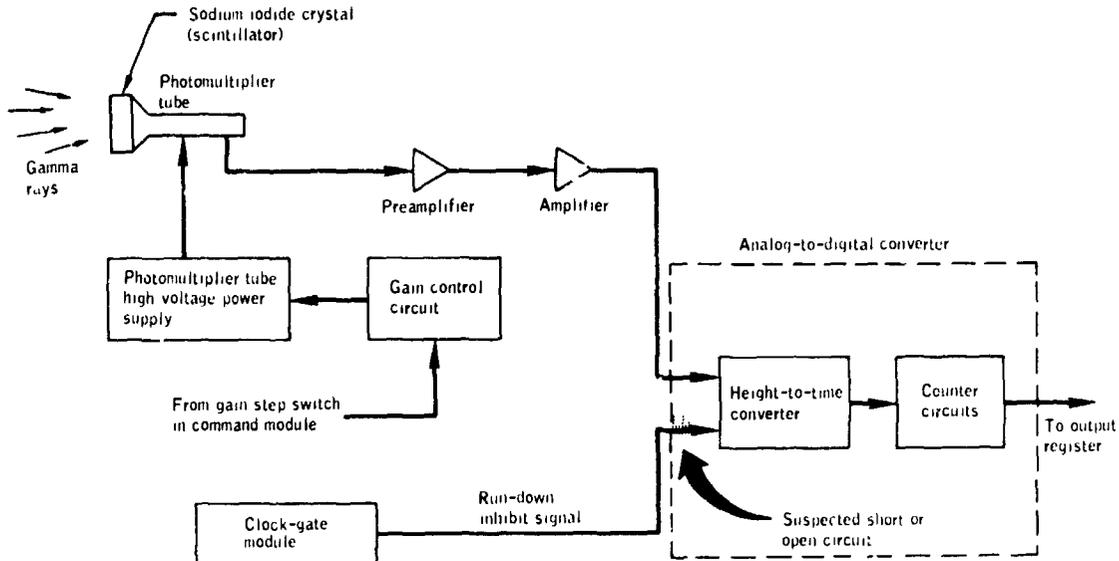
Figure 14-40.- Gamma ray spectrometer circuitry.

During the mission, the gamma ray spectrometer experienced a downward gain shift of approximately 30 percent, but this was compensated for by commanding the high-voltage step function from the command module. The drift decreased with time at an initial rate of 1 percent per hour and a final rate of 0.4 percent per day. Near the end of the mission, the gamma ray spectrometer was operating in a relatively stable state at 824.8 volts (high voltage step 6). (A step 4 voltage of 777.8 volts was the normal position in preflight operation.) The spectrometer to be flown on Apollo 16 was aged at flux rates representative of those encountered in lunar operation. The unit has stabilized after having experienced a gain change of approximately 8 percent.

After transearth injection, a temporary eight-channel zero reference shift was observed. This shift disappeared when the instrument was re-powered after the transearth extravehicular activity, and subsequent instrument operation was normal for about 25 hours during transearth coast. Shortly before entry, the offset shift reappeared and remained until the experiment was turned off. Normalization of the data during processing will compensate for this offset.

Tests conducted with the qualification unit verified that the change in gain was due to aging effects of the photomultiplier tube in the gamma ray detector assembly as a result of high cosmic ray flux rates in lunar operation. The zero shift appears to be associated with the run-down inhibit signal between the clock-gate module and the analog-to-digital converter (fig. 14-40). Absence of this signal at a particular point in the analog-to-digital converter removes a 3-microsecond offset in the pulse height analyzer. The resulting effect is an overall eight-channel offset in the spectrum. The qualification unit was partially disassembled and tests showed that either an open or a shorted wire within the pulse height analyzer can result in an eight-channel offset. An inspection of the circuit in the qualification unit disclosed no design deficiency which would cause this type of failure. Since the eight channel zero offset does not significantly impact overall data quality, no corrective action is contemplated.

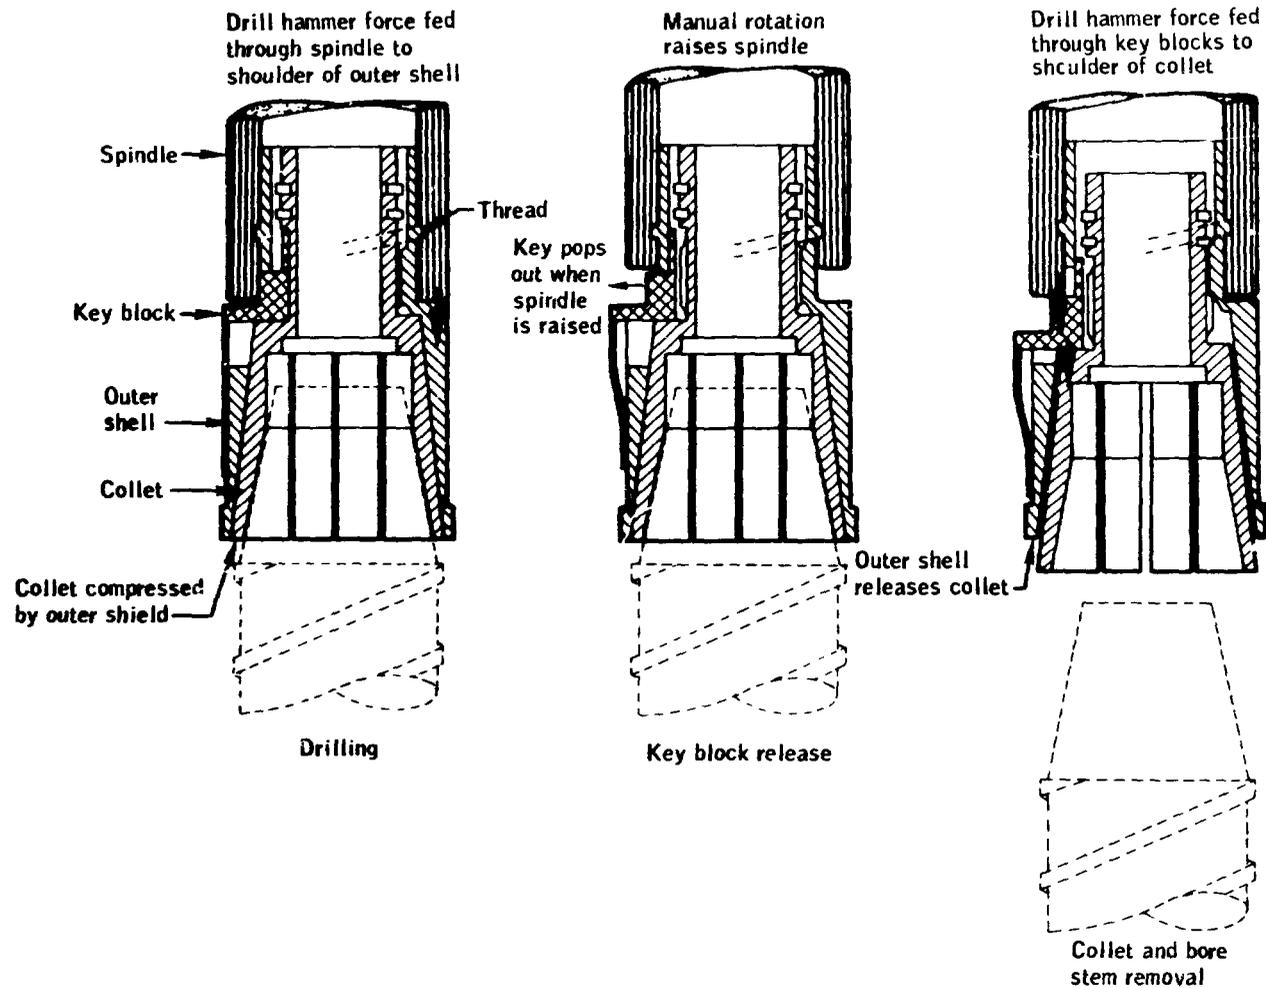
Figure 14-42.- Release of bore stem from drill.

In the bore stem drilling position, the key blocks are restrained inside, and the spindle drives against the shoulder of the adapter outer shell (fig. 14-42). The operational sequence to release the bore stem from the adapter includes the following steps:

In development ground tests, the soil friction usually kept the bore stem from turning in this operation. When there was insufficient friction from the soil, the bore stem was grasped with the gloved hand. On Apollo 15, the soil did not hold the bore stem, and the core-stem wrench was used to hold the bore stems for this operation.

The single-purpose core stem wrench is fitted to the 0.983-inch-diameter titanium core stem, but the 1.088-inch throat will admit the 1.075-inch-diameter bore stem. The softer bore stem (boron-fiberglass laminate) can be deformed and present some difficulty in wrench removal, with possible damage to the bore stem. A wrench to fit both bore and core stems will be provided.

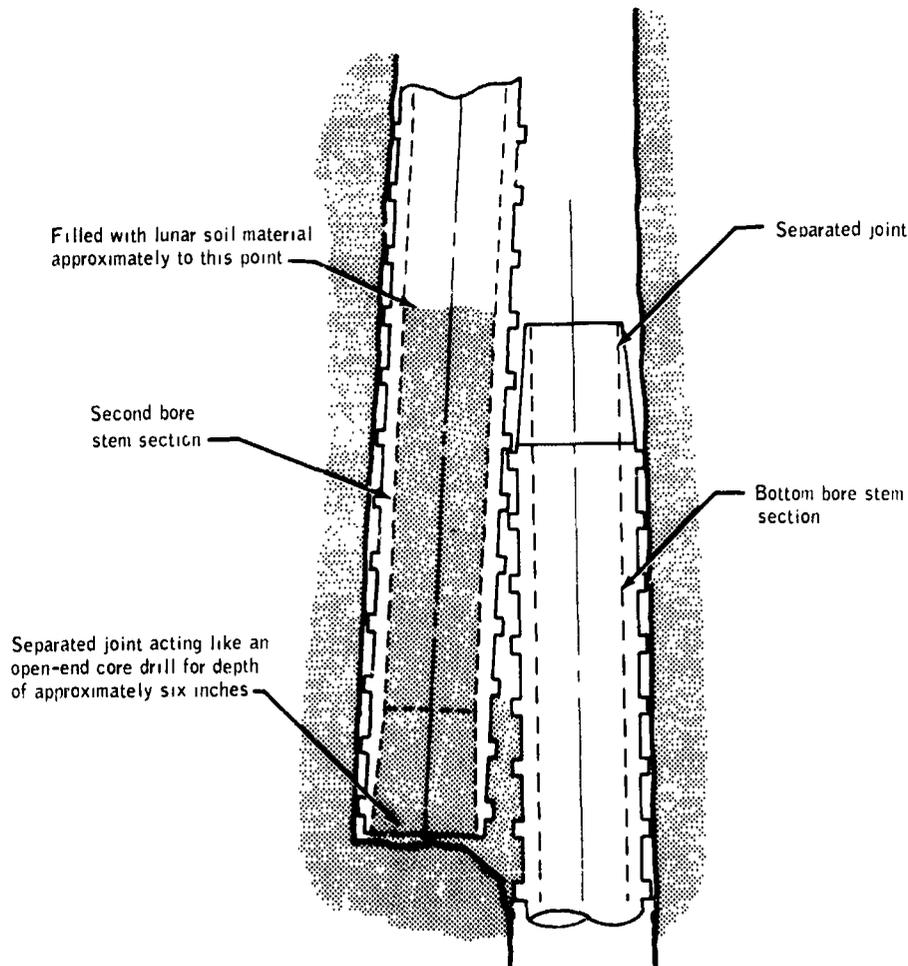
Figure 14-43.- Bore stem joint separation.

14.4.1.3 Bore stem damage near first joint.- The probe would not go to the bottom plug of the bottom bore stem in hole 2, but stopped at a point about 6 inches above the first joint. Examination of photographs and heat flow probe data indicate that, near the end of the bore stem drilling operation, the first joint was separated when the drill and drill string were moved vertically (up and down) in an attempt to improve the drill penetration rate. Easier penetration (for approximately 6 inches) was reported by the crew, but it resulted from the bottom of the second section apparently performing more in a coring manner (fig. 14-43) with the lunar soil entering the second section of the bore stem.

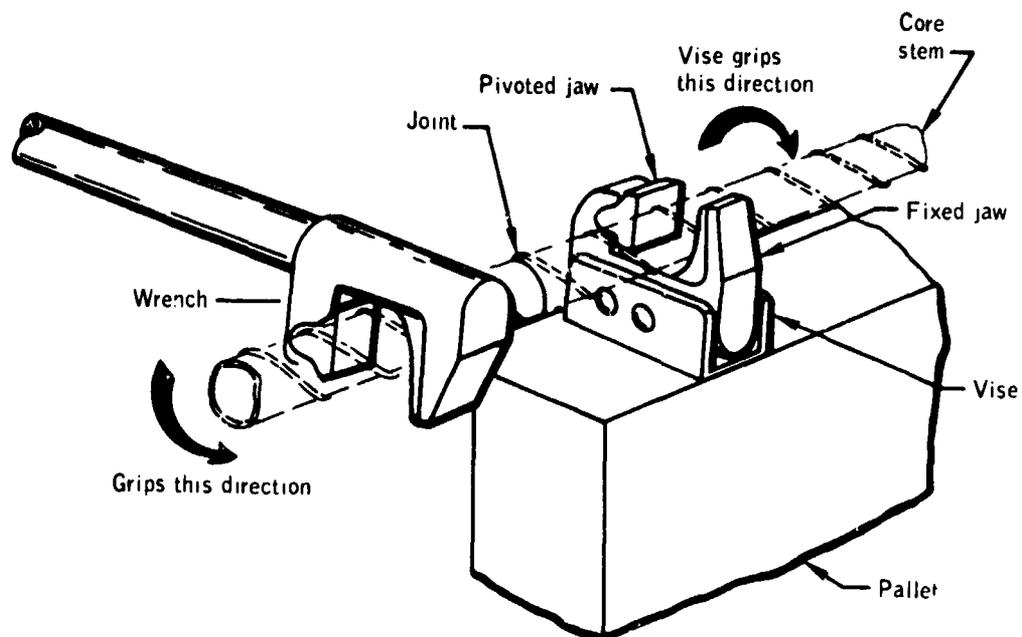
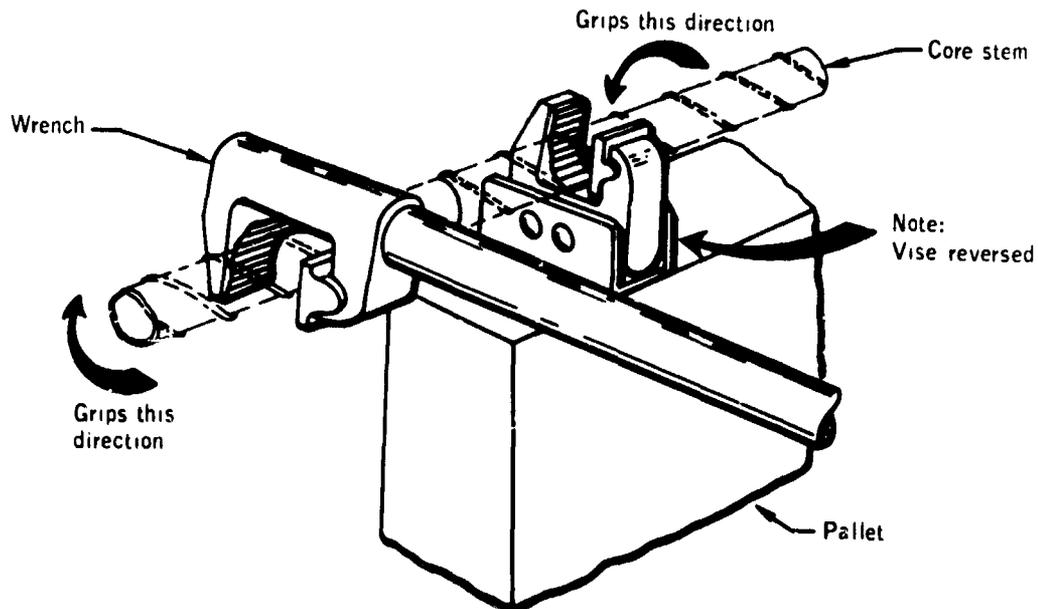
Figure 14-44.- Installation of core stem vise on rover pallet.

As mounted, the vise would hold the core stem so that the joint could be tightened by rotating the wrench on the adjoining section. However, the vise would not hold in the opposite direction so that the joint could be loosened and separated (fig. 14-44). Working on the inboard side of the vise, the core stem could have been held properly for loosening; however, there is insufficient clearance on the inboard side of the vise for wrench rotation, and the distance to the other side of the lunar roving vehicle is greater than the length of a core stem section.

(a) Correct vise installation - will only loosen joint.

(b) Incorrect vise installation - will only tighten joint.

The installation drawing of the vise was in error and has been corrected to assure correct orientation of the vise for Apollo 16. The training vise was installed backward from the erroneous drawing, but correct for loosening the stems.

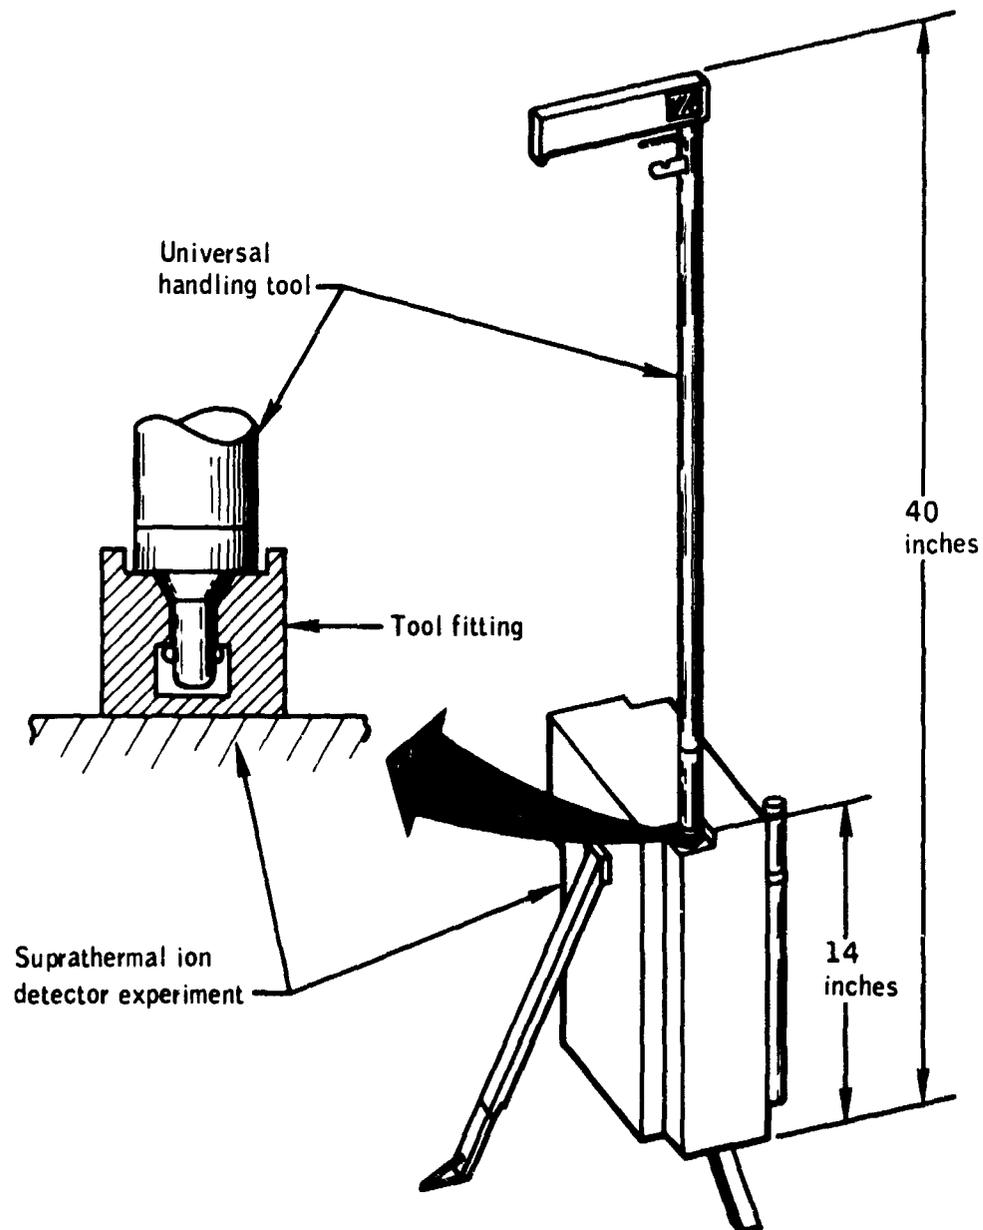
Figure 14-46.- Universal handling tool - suprathreshold ion detector experiment interface.

While carrying the suprathermal ion detector experiment from the sub-pallet to the emplacement site, the experiment fell off the universal handling tool at least twice. The experiment sustained no visible damage and has been operating satisfactorily.

The universal handling tool fitting on this experiment is in the highest location above the lunar surface of any of the fittings and presents an awkward position of the tool for insertion, locking, and maintaining lock in the fitting (fig. 14-46).

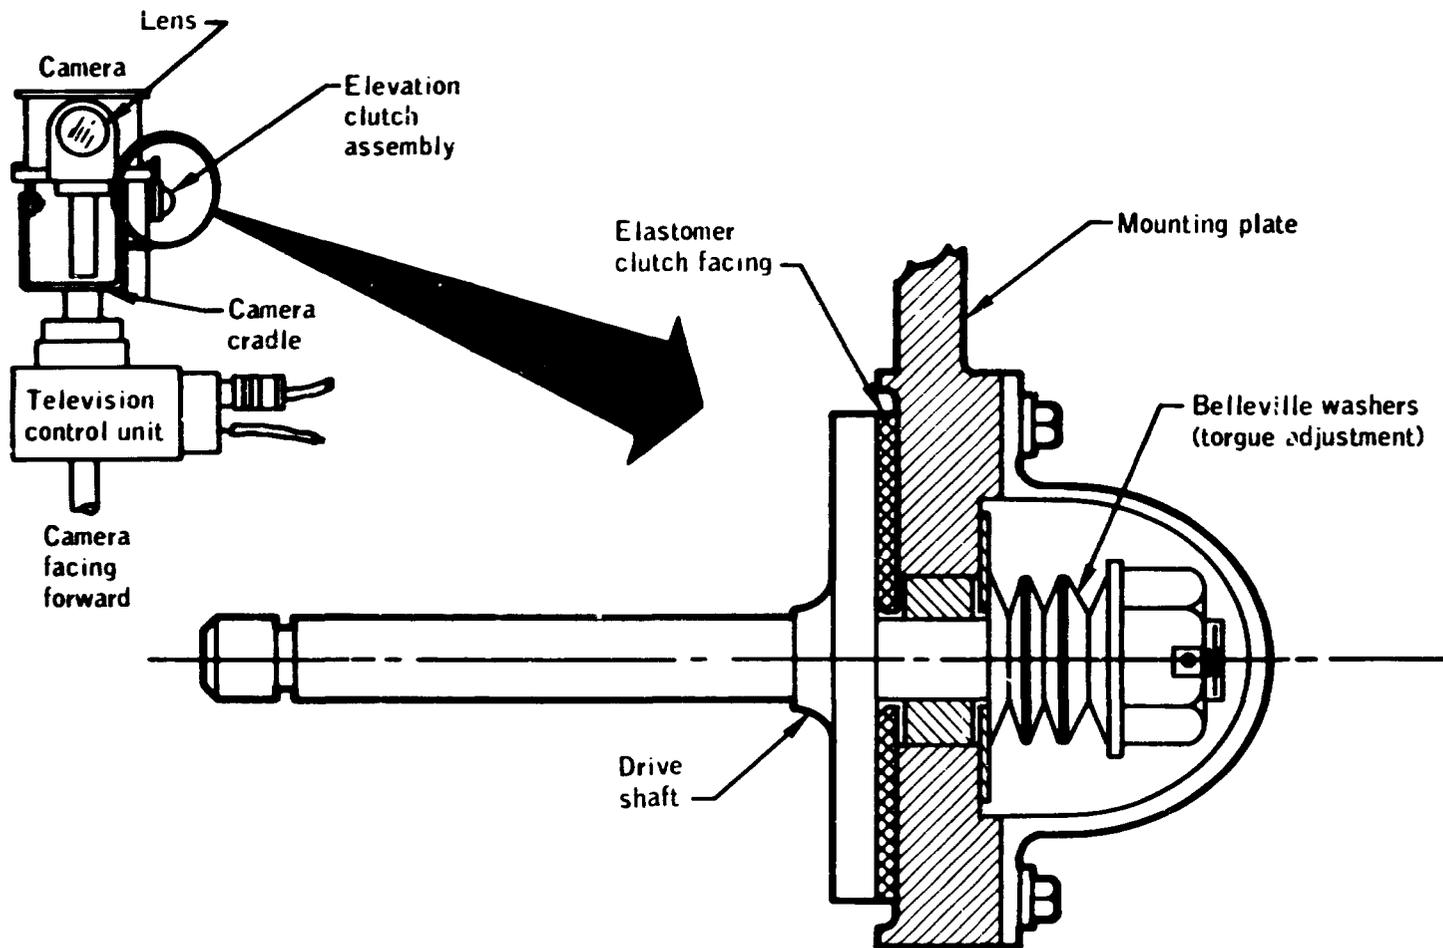
Figure 14-47.- Camera elevation control clutch.

During the second extravehicular activity, the camera could not be elevated as the unit approached the upper or lower limits of angular travel. The condition further deteriorated during the third extravehicular activity.

Elevation control is provided to the camera cradle through a friction clutch (fig. 14-47) which allows manual override of the ground-commanded camera positioning. The camera-cradle pivot point is approximately 3 inches below the center of gravity of the cradle with the camera mounted. As the camera moves away from the horizontal position, the unbalanced moment becomes progressively greater, and a higher torque load must be supported by the clutch mechanism.

The elastomer clutch-facing material provided the required stable friction properties in the specification and qualification test temperature range (122° F, maximum). However, the maximum temperature on the television control unit during the third extravehicular activity has been calculated as approximately 180° F. Materials specifications show that the compressive strength of the elastomer degrades rapidly at this temperature, and ground tests with flight unit 4 verify severely degraded performance with time at elevated temperature.
