APOLLO 15 MISSION REPORT

MANNED SPACECRAFT CENTER  
HOUSTON, TEXAS  
DECEMBER 1971

Mission Evaluation Team

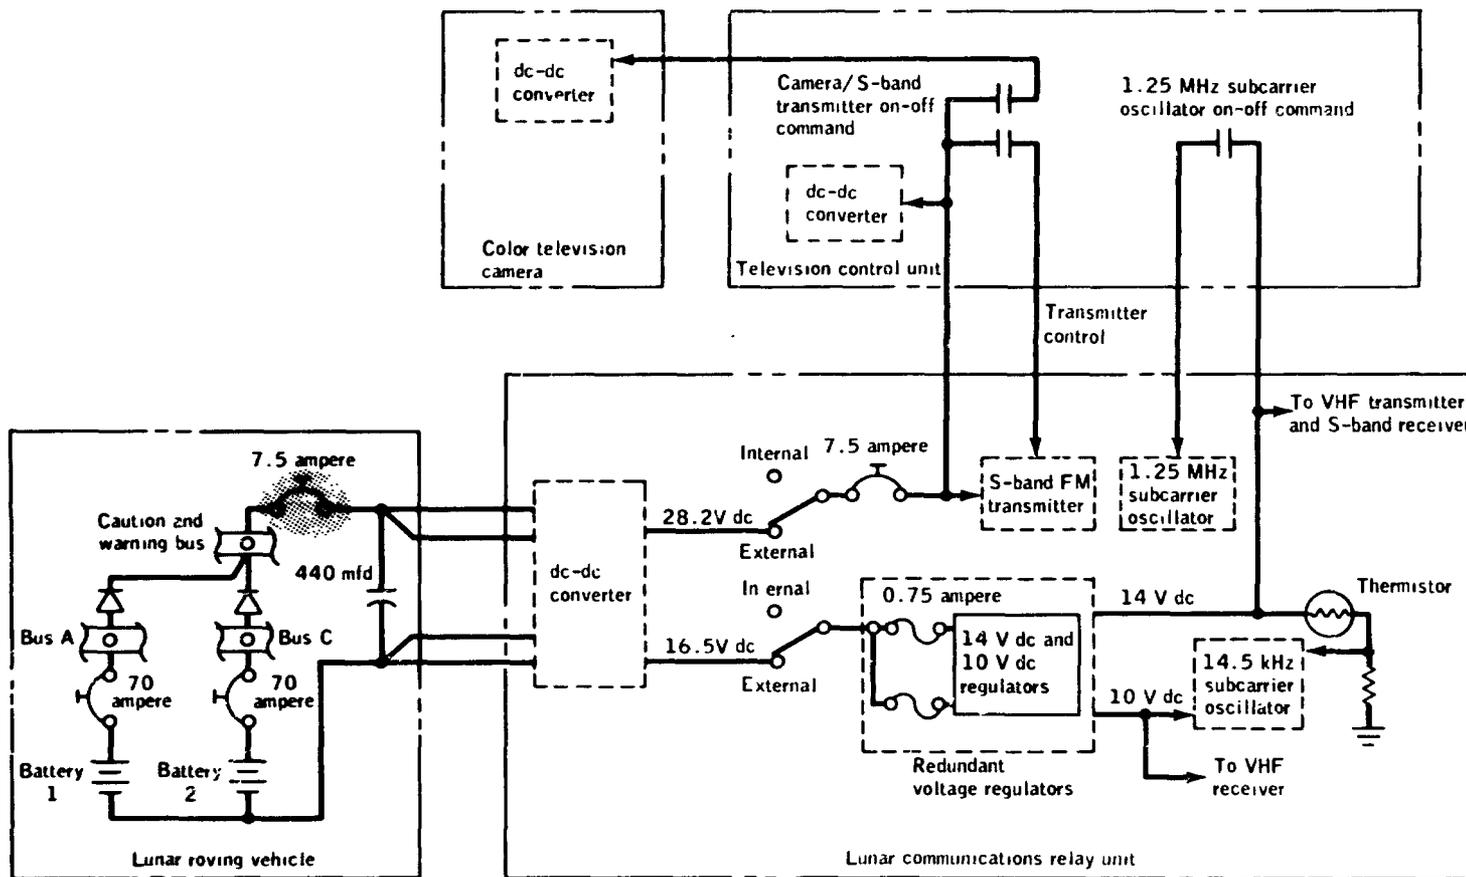
Figure 14-48.- Lunar roving vehicle/lunar communications relay unit/ground controlled television assembly power distribution.

In laboratory tests, the fault which duplicated the flight data was the opening of the lunar roving vehicle power line prior to the 440-microfarad capacitor (figs. 14-48 and 14-49). The tests show that the decay time of the lunar communications relay unit 28-volt and 14-volt power is increased by discharging the 440-microfarad capacitor. Other induced faults resulted in shorter power decay times, affecting the received signal accordingly. The temperature measurement output (see thermistor in fig. 14-48) is proportional to the decay in 14-volt power. Consequently, the 6-percent decay of the flight temperature measurement corresponds to a 1.4-volt decay. This characteristic was duplicated when the lunar roving vehicle power line was opened. The 28-volt power decayed to 21.8 volts dc as the 14-volt power decayed to 12.6 volts. The RF transmitter power at this voltage will be decreased by 6.4 dB, and accounts for the total signal loss at this time since the ground receiver would be below its operating threshold.

The lunar roving vehicle power line has a 7.5-ampere circuit breaker forward of the 440-microfarad capacitor (fig. 14-48). Testing a 7.5-ampere circuit breaker under elevated temperatures (180° F) and at vacuum conditions showed that the current capacity is also dependent on the connecting wire size because the wire provides a heat sink to the circuit breaker thermal element. The rover 7.5-ampere breaker used 20-gage connecting wire. Test results show that the breaker, with 20-gage connecting wire, at elevated temperatures and under vacuum conditions, will trip at 3.3 amperes. This corresponds to the calculated lunar communication relay unit load at the time of power failure.

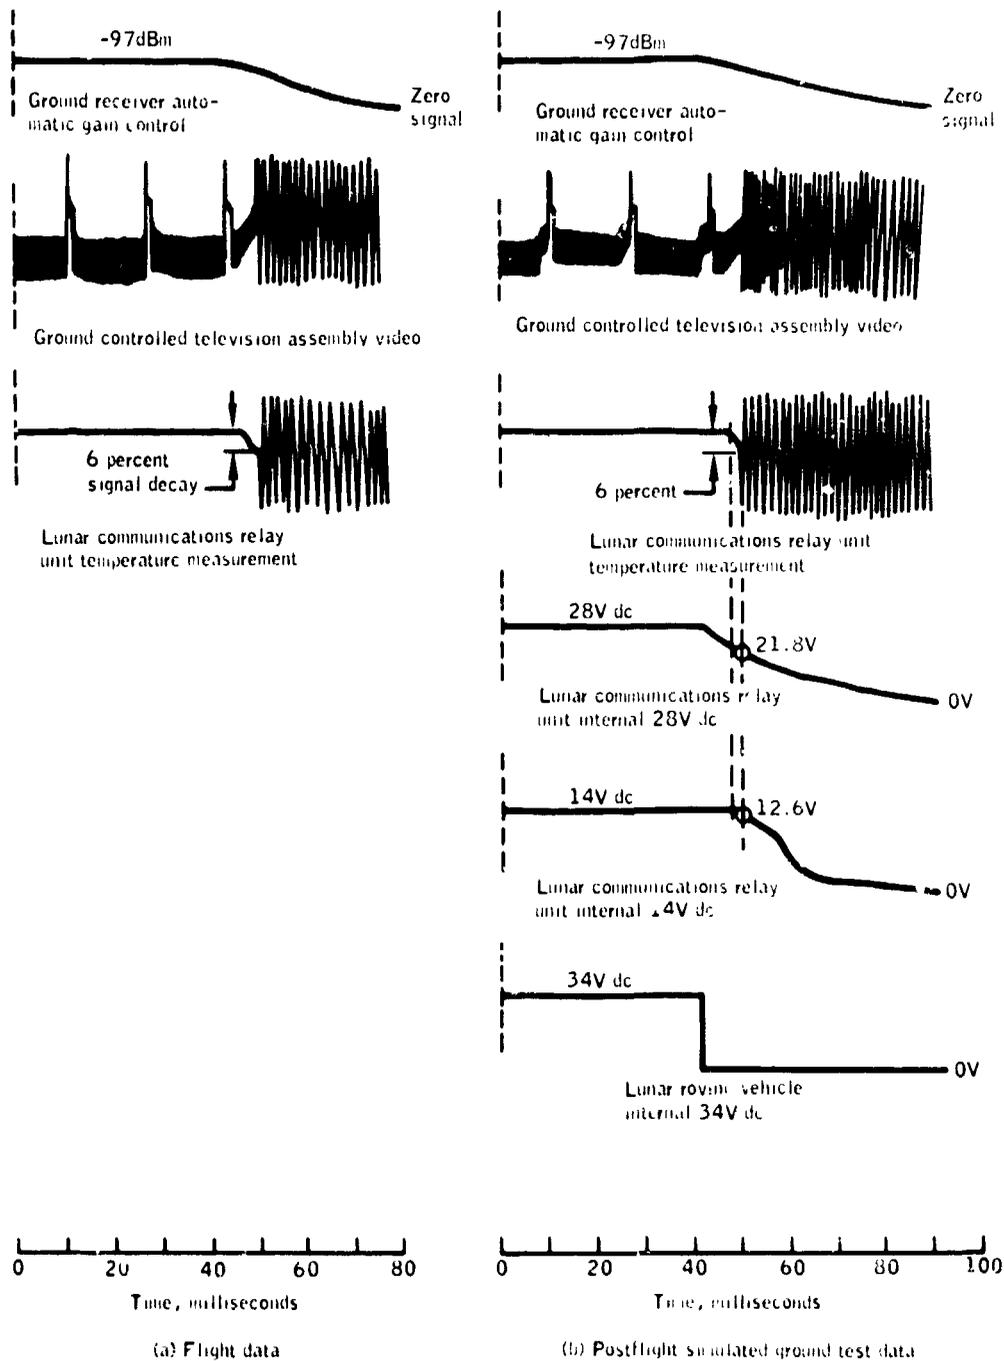
Figure 14-49.- Comparison of signal deterioration characteristics.

The flight data (fig. 14-49) shows that the automatic gain control measurement began to fall followed by the video signal decay. This was followed by the decay of the lunar communications relay unit temperature measurement. The RF signal level then decreased below the ground receiver's threshold as indicated by complete signal loss. The overall loss of the downlink signal within 5 milliseconds is indicative of 28-volt d-c power loss. Decay of the temperature measurement is indicative of 16.5-volt d-c power loss. The lunar communications relay unit dc-to-dc converter (fig. 14-48) supplies both the 28-volt and 16.5-volt d-c power. To verify loss of 16.5-volt power, an uplink voice signal was transmitted to key the VHF transmitter on. No signal was received on the Stanford

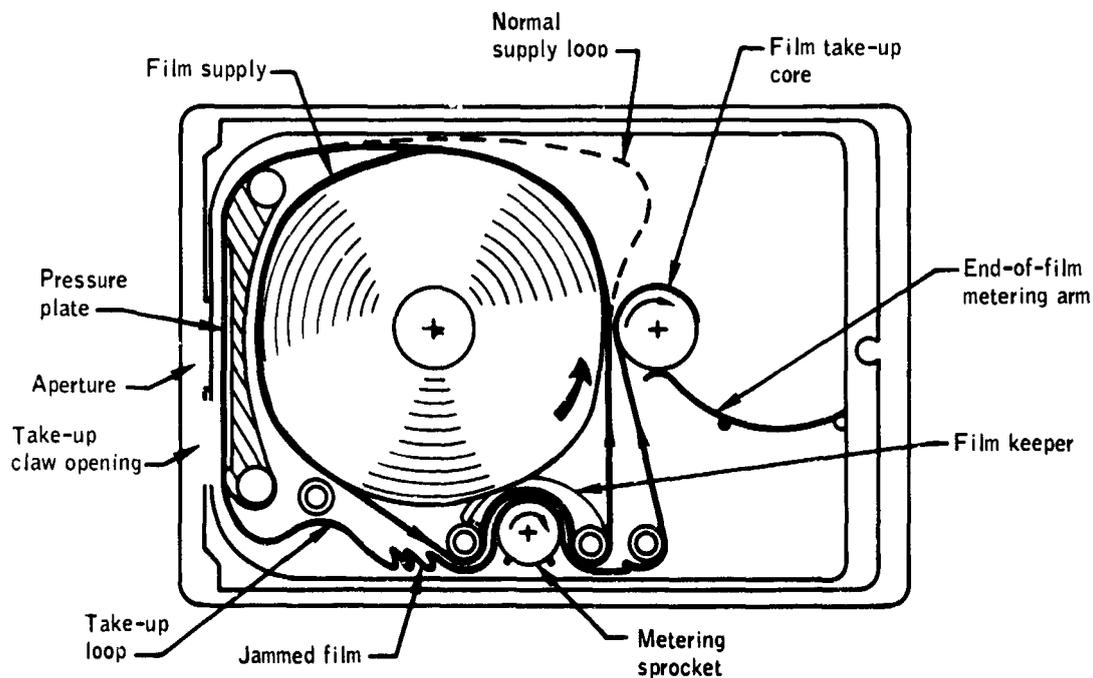
Figure 14-50.- Lunar surface 16mm camera magazine.

a. The first magazine used had drive-spline damage and scratches on the front face, indicating that the installation in the camera was improper and that the magazine and camera were misaligned. Misalignment of the floating female spline of the camera with the male spline of the magazine caused metal to be removed from the brass male spline. In normal camera operation, the take-up claw advances one frame of film for each exposure while the metering sprocket replenishes the supply loop and removes a frame from the take-up loop, thus retaining the same amount of slack film in both loops. When the metering sprocket is not driven because of mis-mating, the camera claw removes film from the supply loop, which is not being replenished, and adds it to the take-up loop, resulting in the jammed condition shown in figure 14-50. Two other magazines had damaged drive

splines, indicating that mismatching occurred on at least three occasions. Lunar surface pictures which include the 16-mm camera show that a strip of tape that is installed for latch stowage protection was not removed prior to installation of a magazine. Leaving the tape strip in place could have contributed to the camera/magazine mismatching.

b. During troubleshooting between extravehicular activities, the crew manually advanced the film through the aperture in all remaining magazines. The amount of manual advancement varied from five to twenty-one frames in the jammed magazines. The film supply loop (fig. 14-50) normally contains three to five excess frames. The normal procedure is to inspect the magazine for proper frame alignment in the aperture area, and manually advance the film not more than one frame, if required to obtain proper alignment. The excessive manual advancement depleted the film supply loops in all magazines.

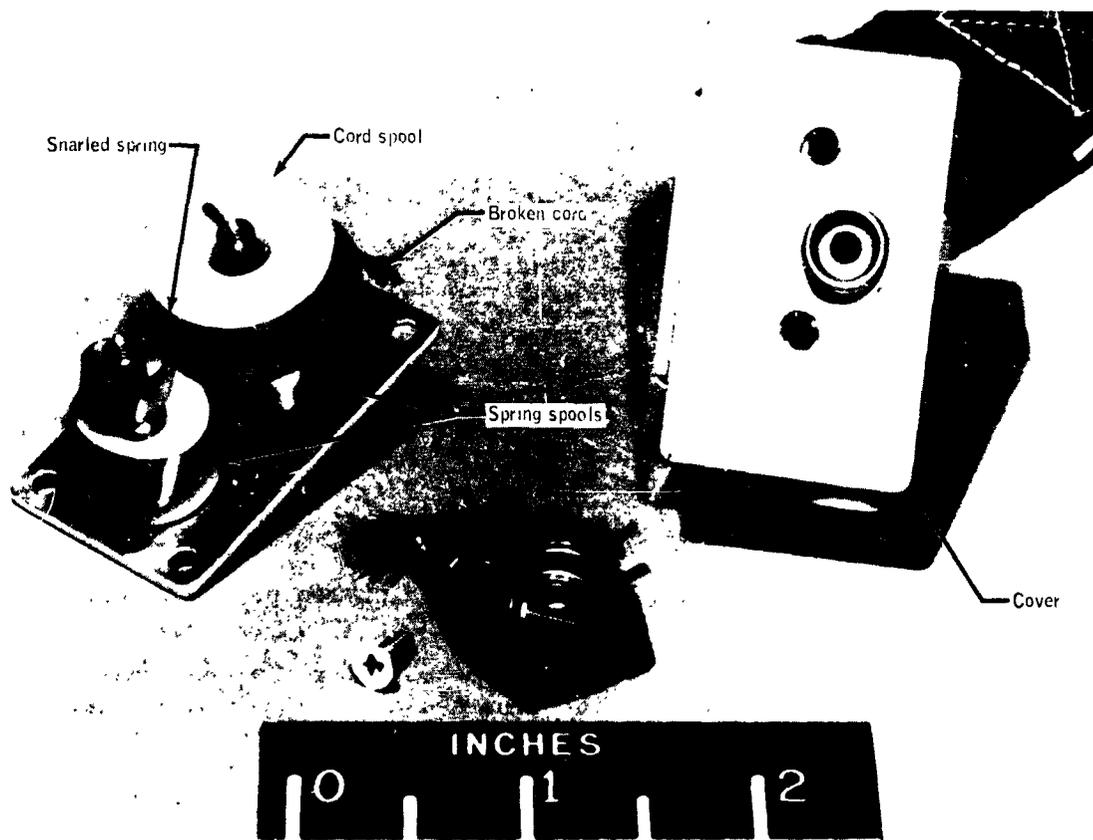
Figure 14-52.- Commander's tether (cover removed).

Both retractable tethers failed during lunar surface operations; the Commander's tether cord broke during the first extravehicular activity, and the tool clamp came off the end of the Lunar Module Pilot's tether. The Commander carried the standard 3/8-pound pull tether which consists of a case, a negator spring wound reel-to-reel on two spools, and a 30-pound cord wound on a spool mounted to one of the spring spools (fig. 14-52). A tool clamp is attached to the external end of the cord. The Lunar Module Pilot carried the optional, somewhat larger, 1-pound pull tether of the same design.

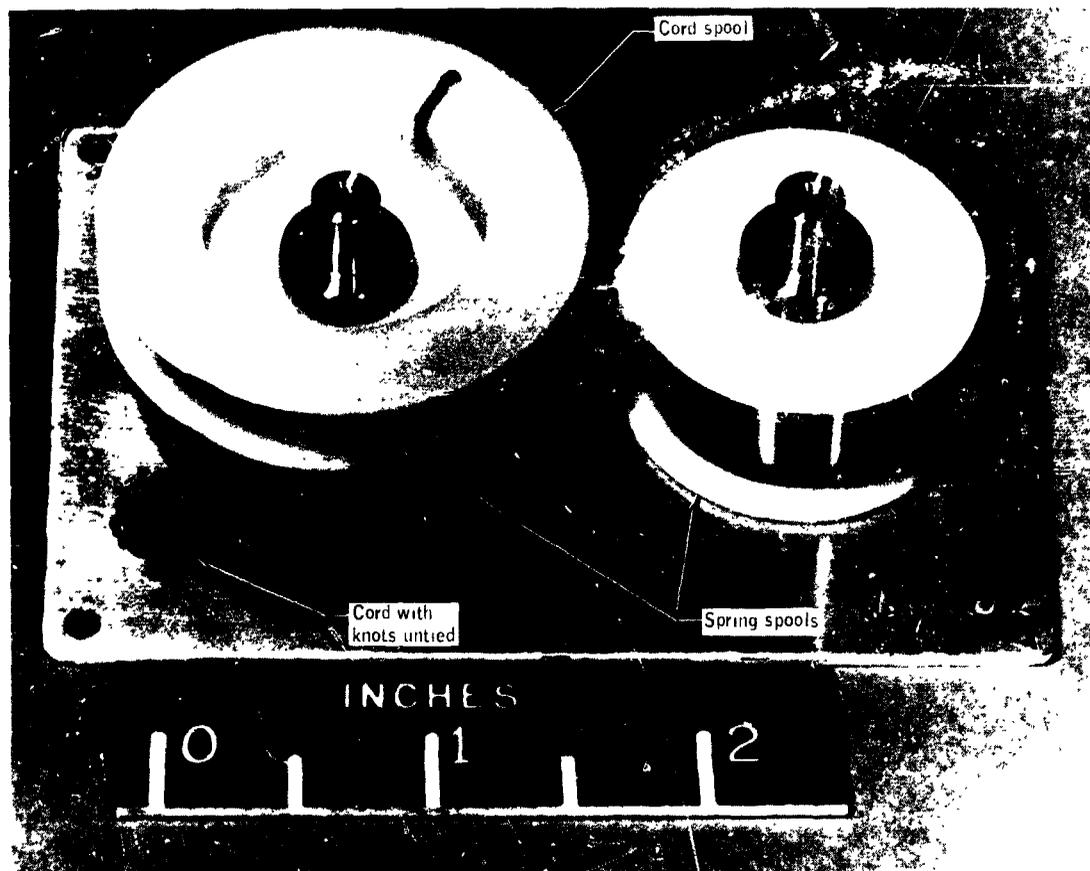
Figure 14-53.- Lunar Module Pilot's retractable tether (cover removed).

Disassembly of the Commander's tether showed that the spring had expanded off the spool, snarled, and jammed against the case as the result of a no-load release of a slack cord (fig. 14-53). The cord had broken against a sharp edge of the spring when an attempt was made to extend the tether after the jam. The failure mode with the release of the slack cord is repeatable. Disassembly of the Lunar Module Pilot's tether showed that both the bowline and the figure-eight knot attaching the cord to the clamp had untied (fig. 14-53) and this allowed the cord to retract into the housing. Changing this knot to an improved clinch knot will provide a more secure and permanent attachment. Crew training will emphasize proper use of the tethers.

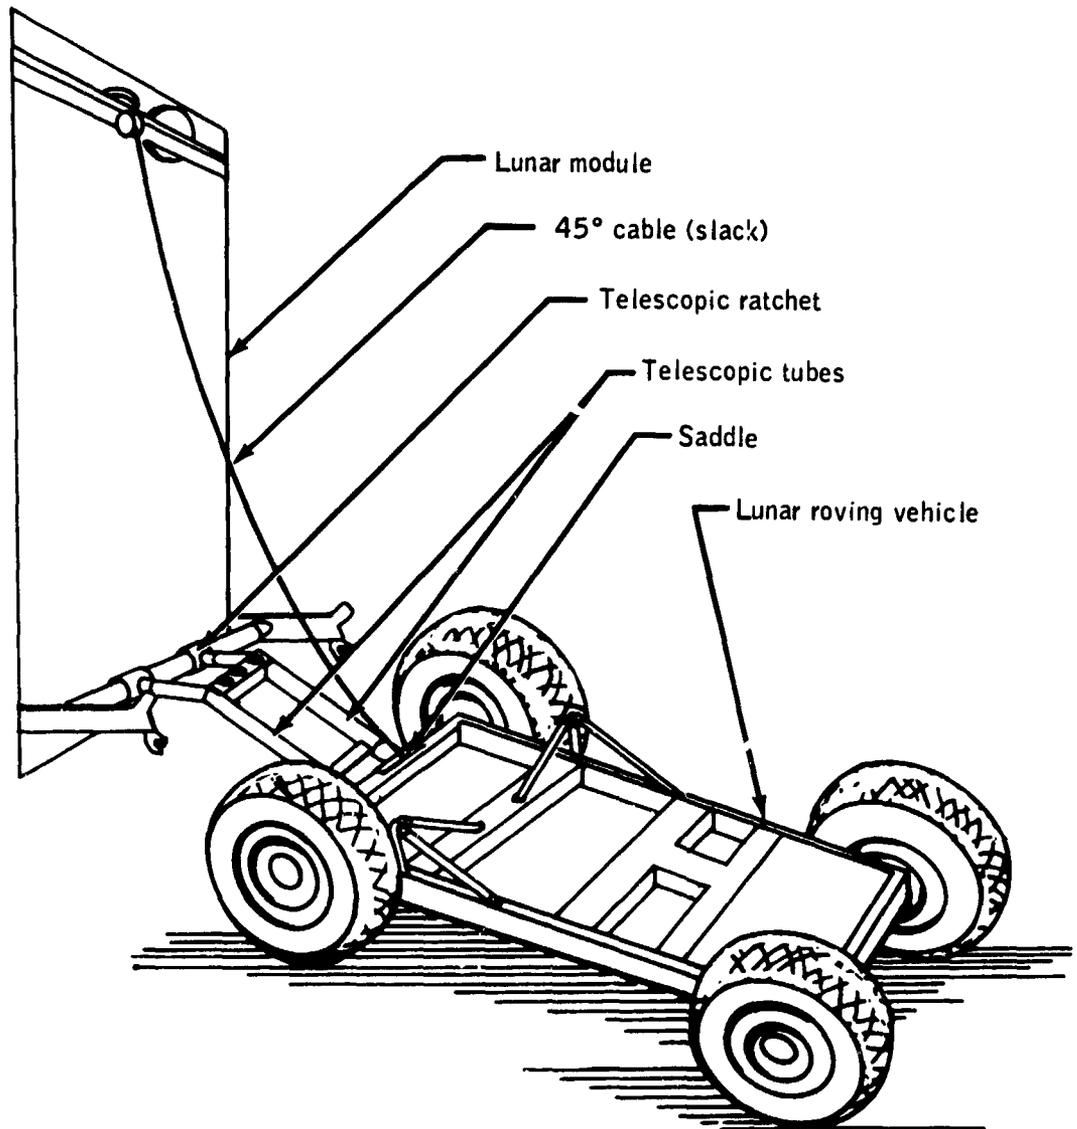
Figure 14-55.- Lunar roving vehicle deployment.

Ground tests have shown that if the partially deployed lunar roving vehicle resting on the surface but not yet detached from the saddle (figure 14-55) and lunar module, is rolled either to the left or right, the saddle/rover chassis interface will bind. The interface can be released, and the saddle dropped to the ground by one crewman adjusting the roll back to zero while the other taps the saddle with a hand tool. The corrective action is to insure adequate crew training.

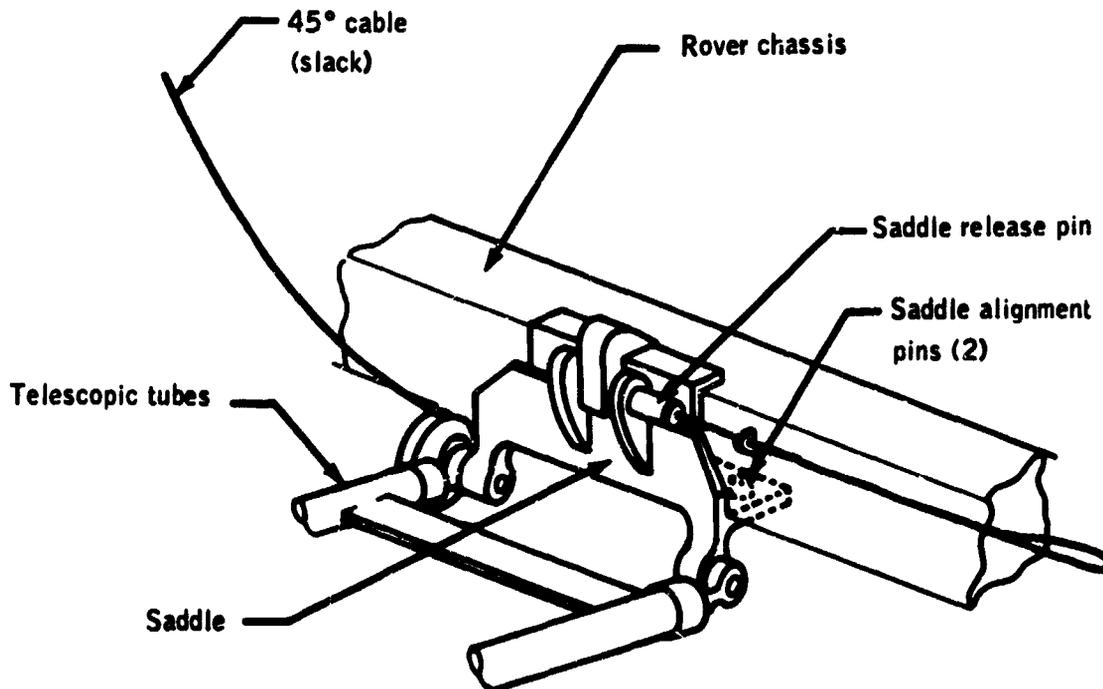
Figure 14-54.- Saddle/lunar roving vehicle interface.

The causes of this problem are twofold and interrelated.

a. The saddle-to-vehicle connection (fig. 14-54) has close-tolerance interfaces to provide the rigidity required to prevent release-pin distortion and permanent binding. This design requires the vehicle/saddle interface to be completely free of stress to permit easy separation.

b. The tilt of the lunar module to the rear and sideways, together with an uneven lunar surface, provided some stress preloading of the vehicle/saddle interface. Attempts by the crew to improve the rover position by moving and pulling on it may have aggravated this situation. The crew was aware that the interface had to be free of stress, and when this was accomplished, the saddle separated.
